**Upper Pajaro River
Sediment Assessment**

February 2004

FALL CREEK ENGINEERING, INC.

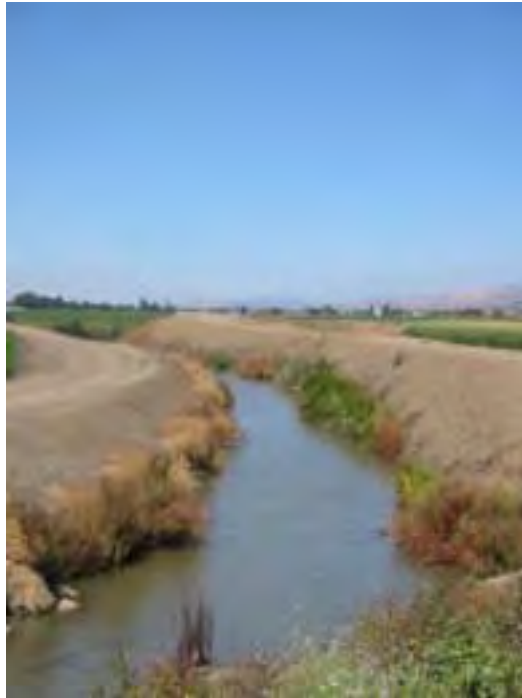
Figure 4.3. The stream assessment identified Jones Creek as an example of a non-Functioning system.

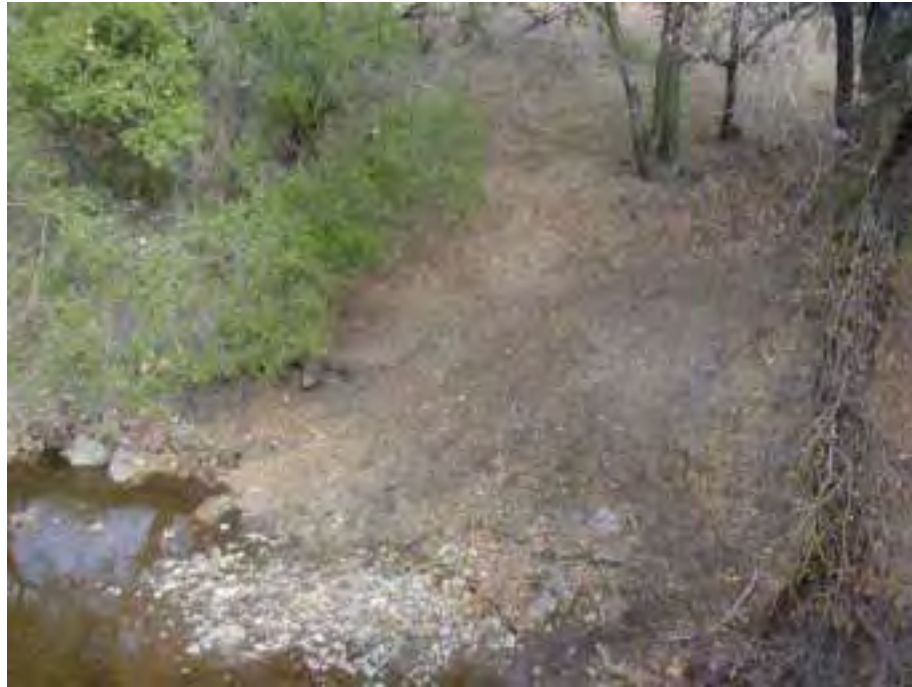
Figure 4.7. Animal access location observed upstream of Oak Glen Road on Llagas Creek.

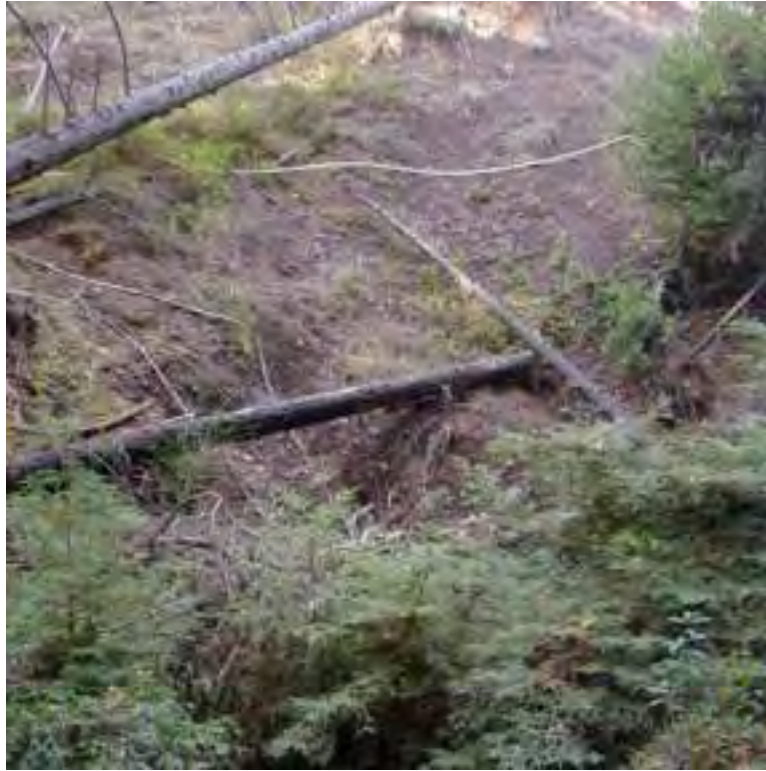
At one location a landslide in the channel was observed. It appeared to have removed three (3) to four (4) large trees and deposited a large amount of soil into the creek channel.

Figure 4.10. Landslide adjacent to Llagas Creek and Casa Loma Road in the Upper Llagas Creek Sub-Area.

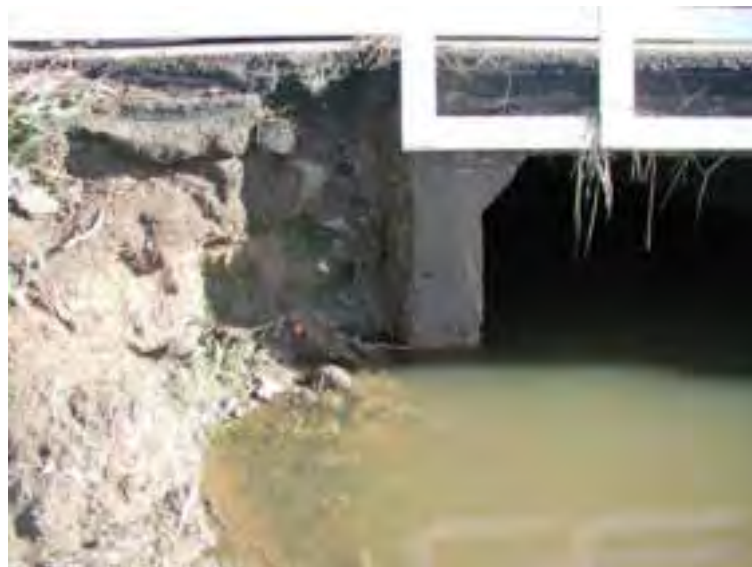
South of LaCrosse Drive approximately 1000 feet West Little Llagas Creek makes a 90-degree bend east, leaving the engineered channel that continues another 800 feet to Watsonville Road. This continuation of the engineered channel and a bridge on Watsonville Road are to be used in the future modification of West Little Llagas Creek. Where the creek turns away from the engineered channel it is channelized around a residential development and fallow agricultural fields until crossing Watsonville Road, approximately 180 feet west of Monterey Highway. In this stretch of creek the channel narrows and deepens and is primarily grassed with no upper canopy vegetation. At Watsonville Road, the creek channel is narrow and showed evidence of channel incision and erosion downstream of the road culvert. In discussions with stakeholders it was learned that this location is also known as an area of regular flooding.

Figure 4.11. Bank erosion and scour pool development south of Watsonville Road on West Little Llagas Creek.

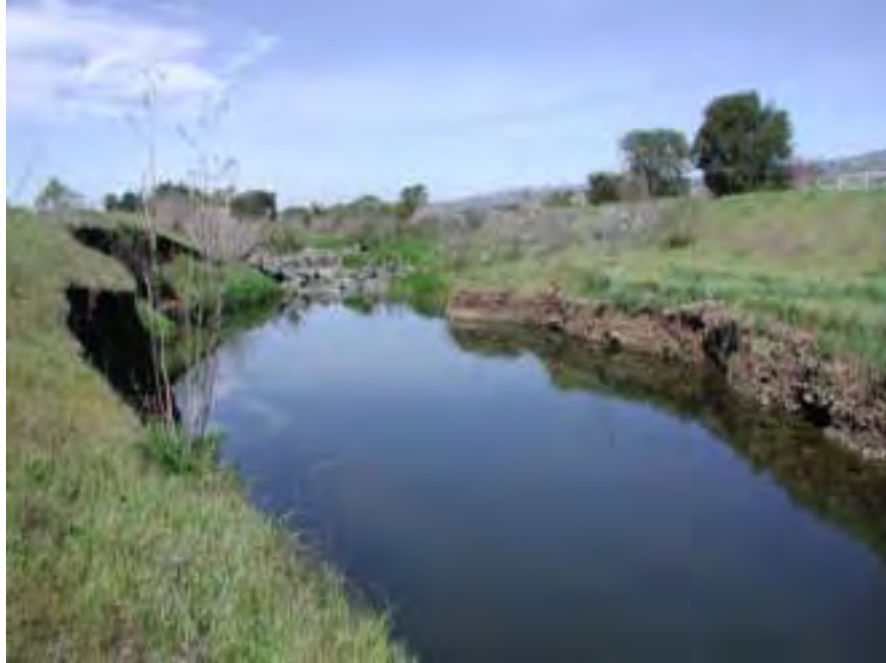
Figure 4.13. Bank and channel erosion on East Little Llagas Creek downstream of the confluence with Corralitos Creek.

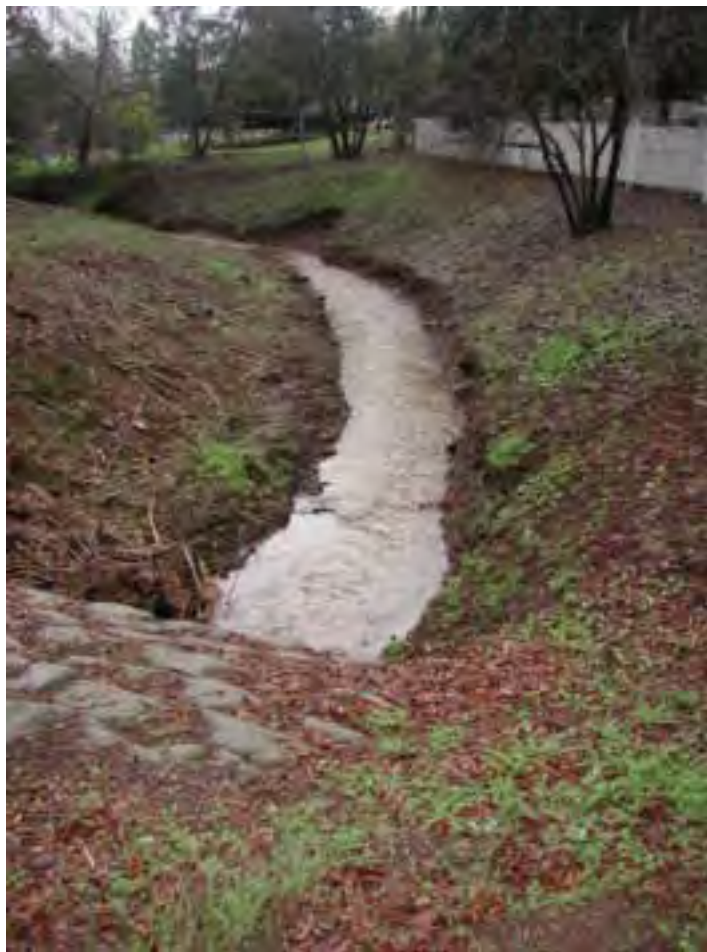
Paradise Creek borders rural residential developments and roads for most of its length. The vegetated cover and SRA in most locations appear intact, though erosion and diminished vegetation density were observed in proximity to adjacent land uses. Exposed bank and channel areas were observed in proximity to Llagas Road and where adjacent land uses encroached onto the channel.

Figure 4.20. Bank failure on Paradise Creek on Llagas Road.

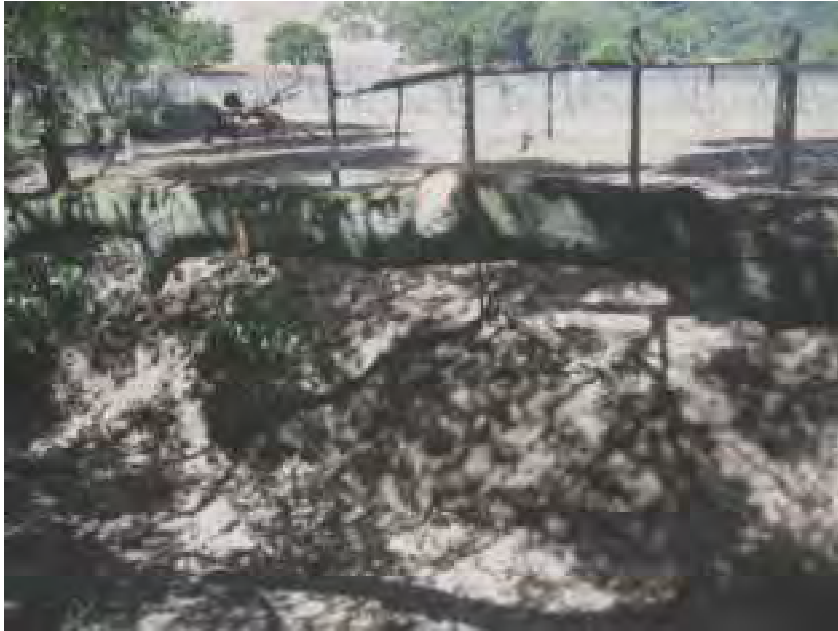
Downstream of Ashby Avenue and west of Sycamore Avenue, Machado Creek crosses land used for animal grazing. Animals access the channel in some locations. At these locations channel degradation and depletion of riparian vegetation density was observed. Further downstream Machado Creek enters lands used for vines and row crops. The vegetation density of the channel in this reach is high, though occasional channel disturbances were observed from Oak Glen Avenue. For example, at one location it appeared that channel bank vegetation had been cleared and herbicide applied. As a result the soils were left bare and loose. At this location a fence has been installed directly above the channel, encroaching on the channel bank.

Figure 4.21. Machado Creek upstream of Oak Glen with bare banks with loose soils.

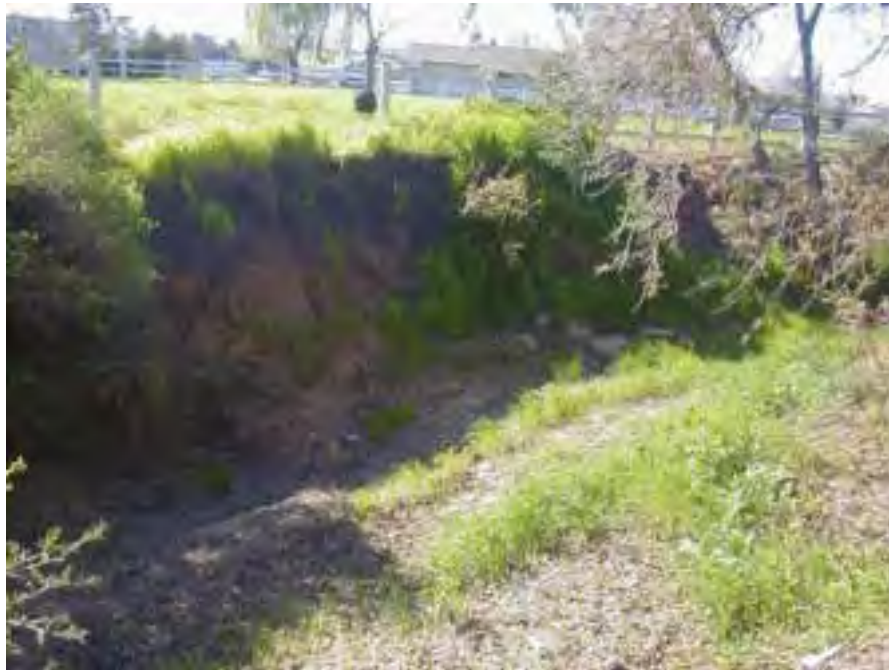
Observations of Erosion and Sedimentation. Erosion was observed as bank failure and channel incision. The bank failure was generally associated with animal access and culverts. Erosion associated with culverts was observed at scour pools downstream of culverts or at locations where the capacity of the culvert was exceeded. In one location the capacity of a culvert was exceeded causing flows to back up and eventually flow over the road and re-enter the channel. At the location where the water re-enters the channel the right and left channel bank were bare, vertical and eroded. On the right channel bank, rip-rap had been installed for bank protection. Channel incision was observed in San Martin Creek downstream of San Martin Avenue to the confluence with East Little Llagas Creek. The channel incision ranged from one to three feet. The channel bed generally appeared armored with gravel with substrate material consisting of fine to gravel material.

Figure 4.23. Bank erosion downstream of Columbet Avenue where water re-enters the channel from upstream into San Martin Creek.

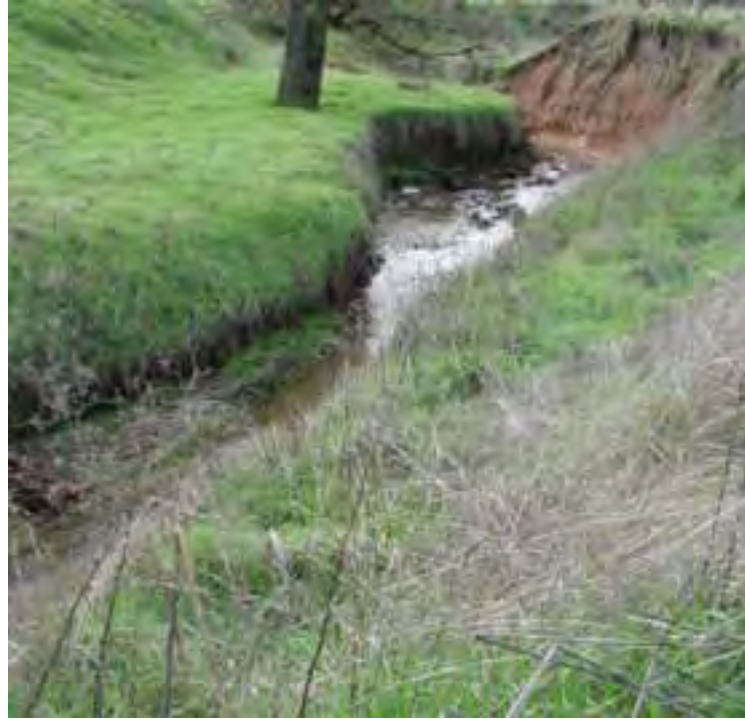
The New Creek channel has maintained most of its original sinuosity, though it is channelized in some locations with channel encroachment from adjacent land use, which is primarily agricultural. The channel profile is generally deep and narrow with intact sinuosity. Bank slumping and channel incision were observed at a number of locations resulting in bare and vertical or near vertical channel banks.

Figure 4.25. Bank erosion on New Creek at Foothill Avenue.

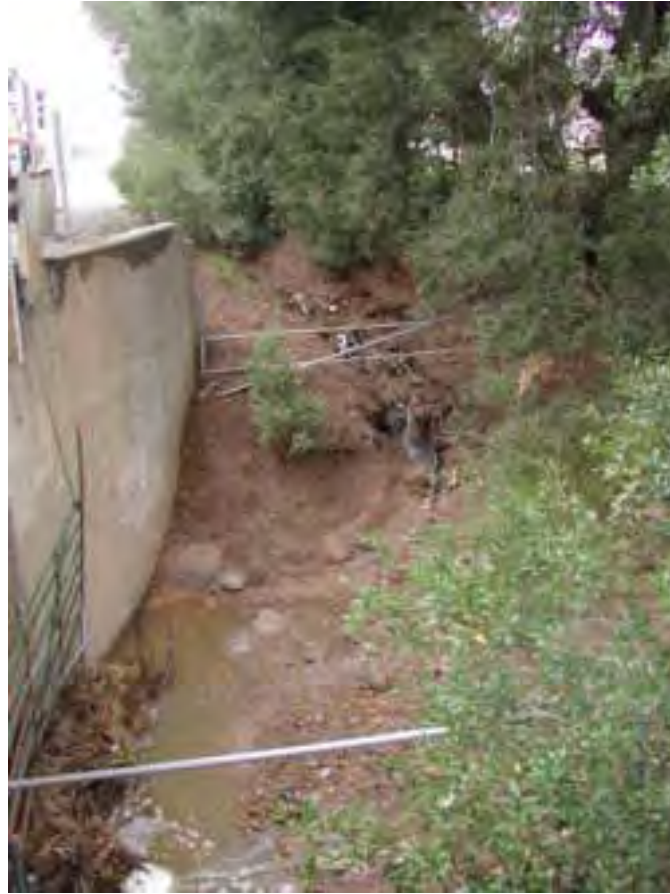
At New Avenue where a road ditch enters the channel, an observed elevation difference, up to four feet, separate the channel bed and the road ditch. As a result of this elevation difference the channel bank and road ditch show signs of rill and gully development. The erosion at this location resembles the slow migration of a head cut up the road ditch, an attempt to reduce the slope between the two channels. At some locations riprap or rock weirs have been placed over these head cuts in an attempt to strengthen the slopes, act as grade control structures, reduce water velocities, and reduce the slope between the road ditch and creek channel.

Figure 4.26. A road ditch on New Avenue entering Church Creek.

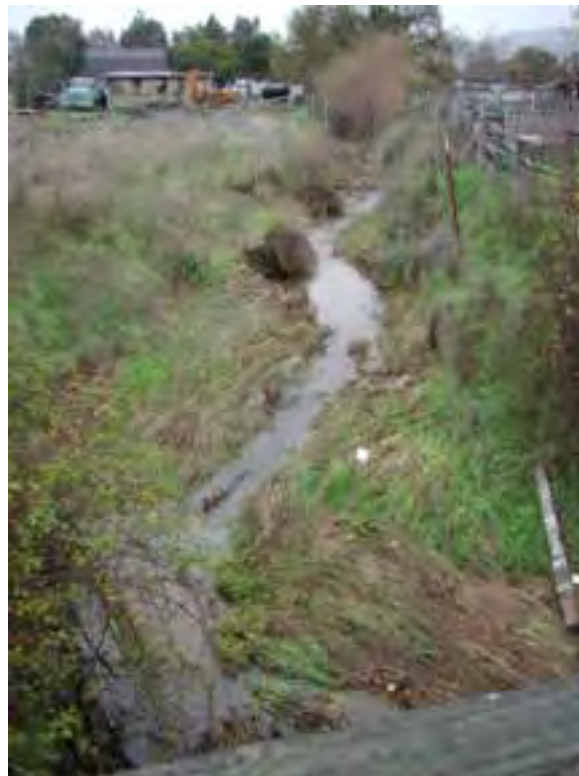
The distance between the channel and fences along Rucker Creek was variable. At Rucker Avenue a fence adjacent to an equestrian area encroaches onto the creek. As a result the bank is steepening and over time the fence will likely slump into the creek. Fencing crossing the channel was observed in a number of locations.

Figure 4.27. Fence adjacent to Rucker Creek upstream of Rucker Avenue.

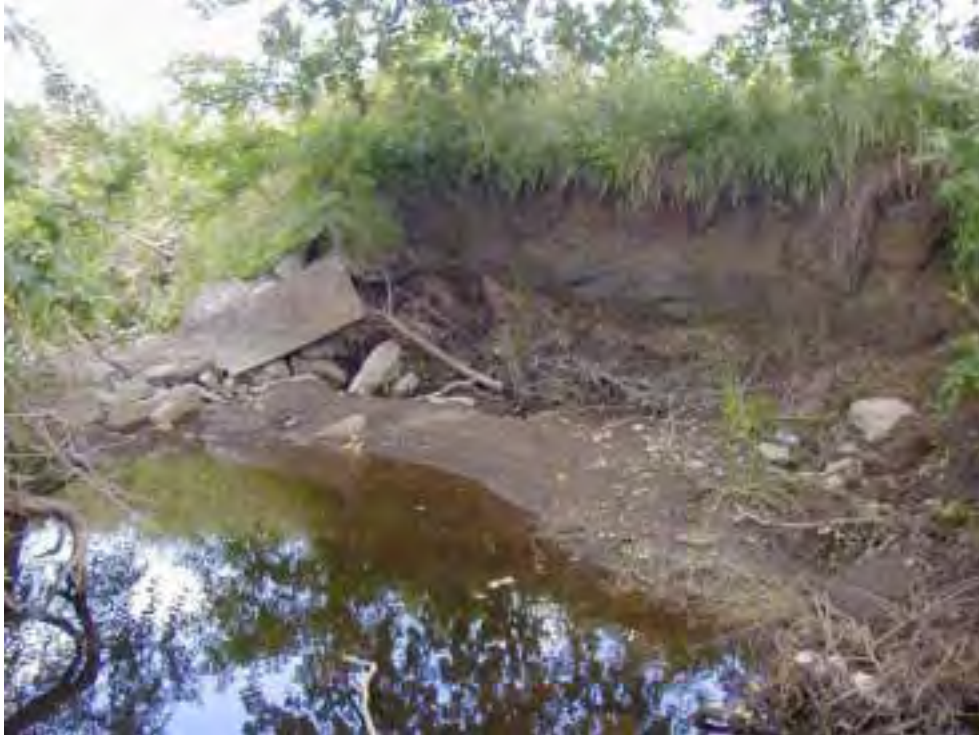
Approximately 1,015 feet east of Santa Theresa Avenue West Branch Llagas Creek crosses to the south of Highland Avenue. Downstream of this location significant scour and bank erosion was observed downstream of the road culvert outlet where the channel makes a 90 degree bend east along Highland Avenue. The apron downstream of the culvert also showed signs of erosion, and large rip-rap cobbles had been placed downstream of the culvert and along the eroding channel banks. Bank erosion is threatening existing tree roots.

Figure 4.30. Bank scour on West Branch Llagas Creek downstream of Highland Avenue.

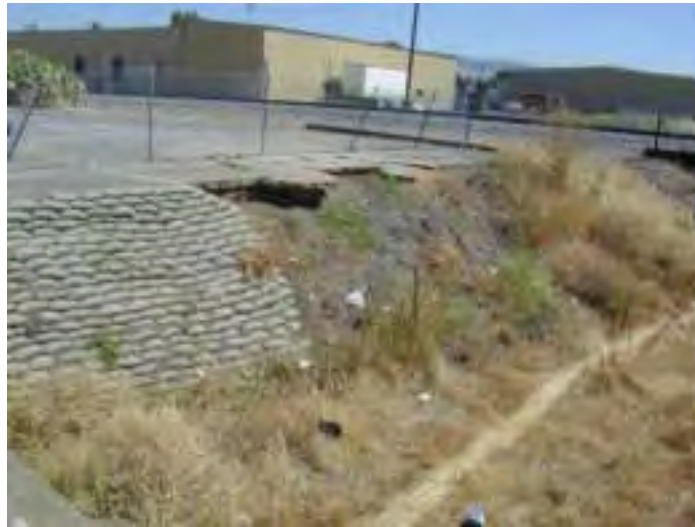
Figure 4.35. Bank and parking lot erosion east of Monterey Road on Upper Miller Slough.

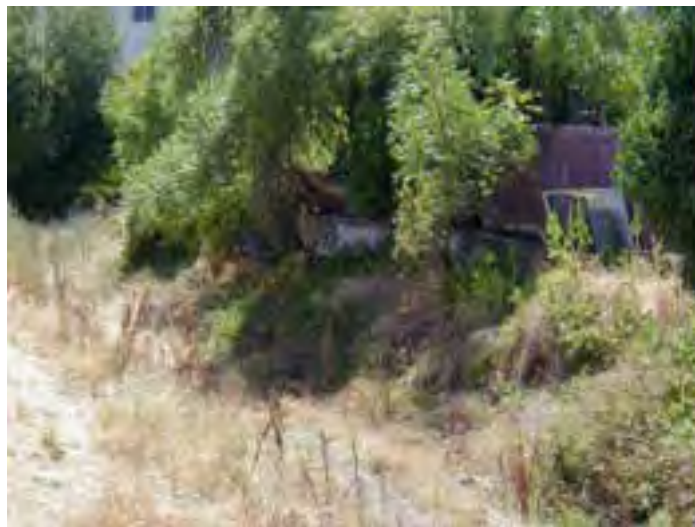
Figure 4.36. Encroachment of residential properties on the banks of Upper Miller Slough downstream of Lewis Avenue.

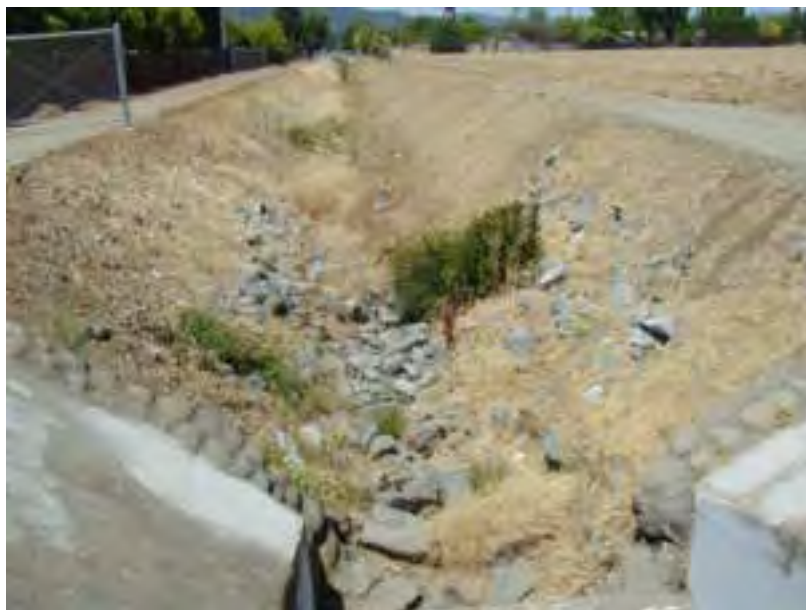
Figure 4.48. Riprap slumping into Princevalle Drain upstream of Monterey Highway.

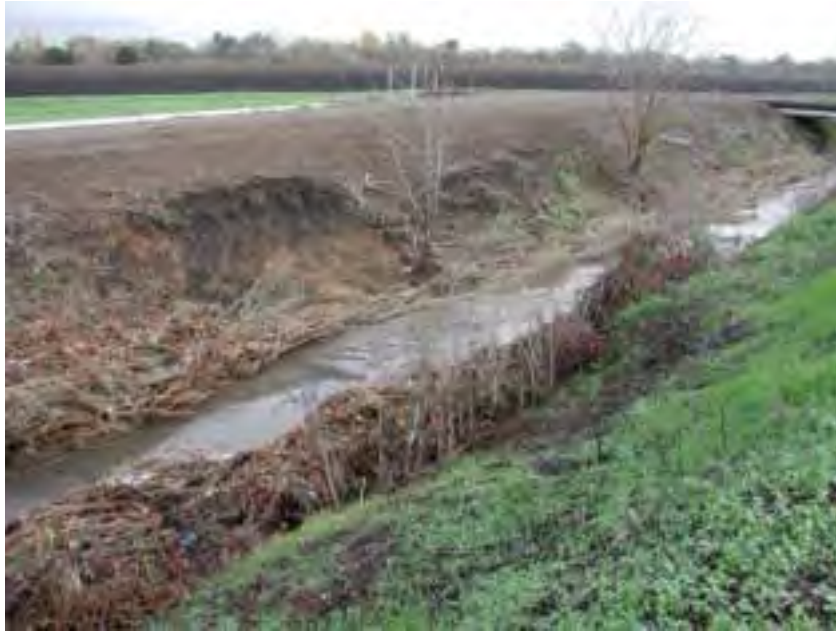
Figure 4.49. Bank slumping on Lower Miller Slough channel.
