# Snapshot Day

May 5<sup>th</sup>, 2018

Final Report

**Central Coast Snapshot Day 2018**  
**organized by:**

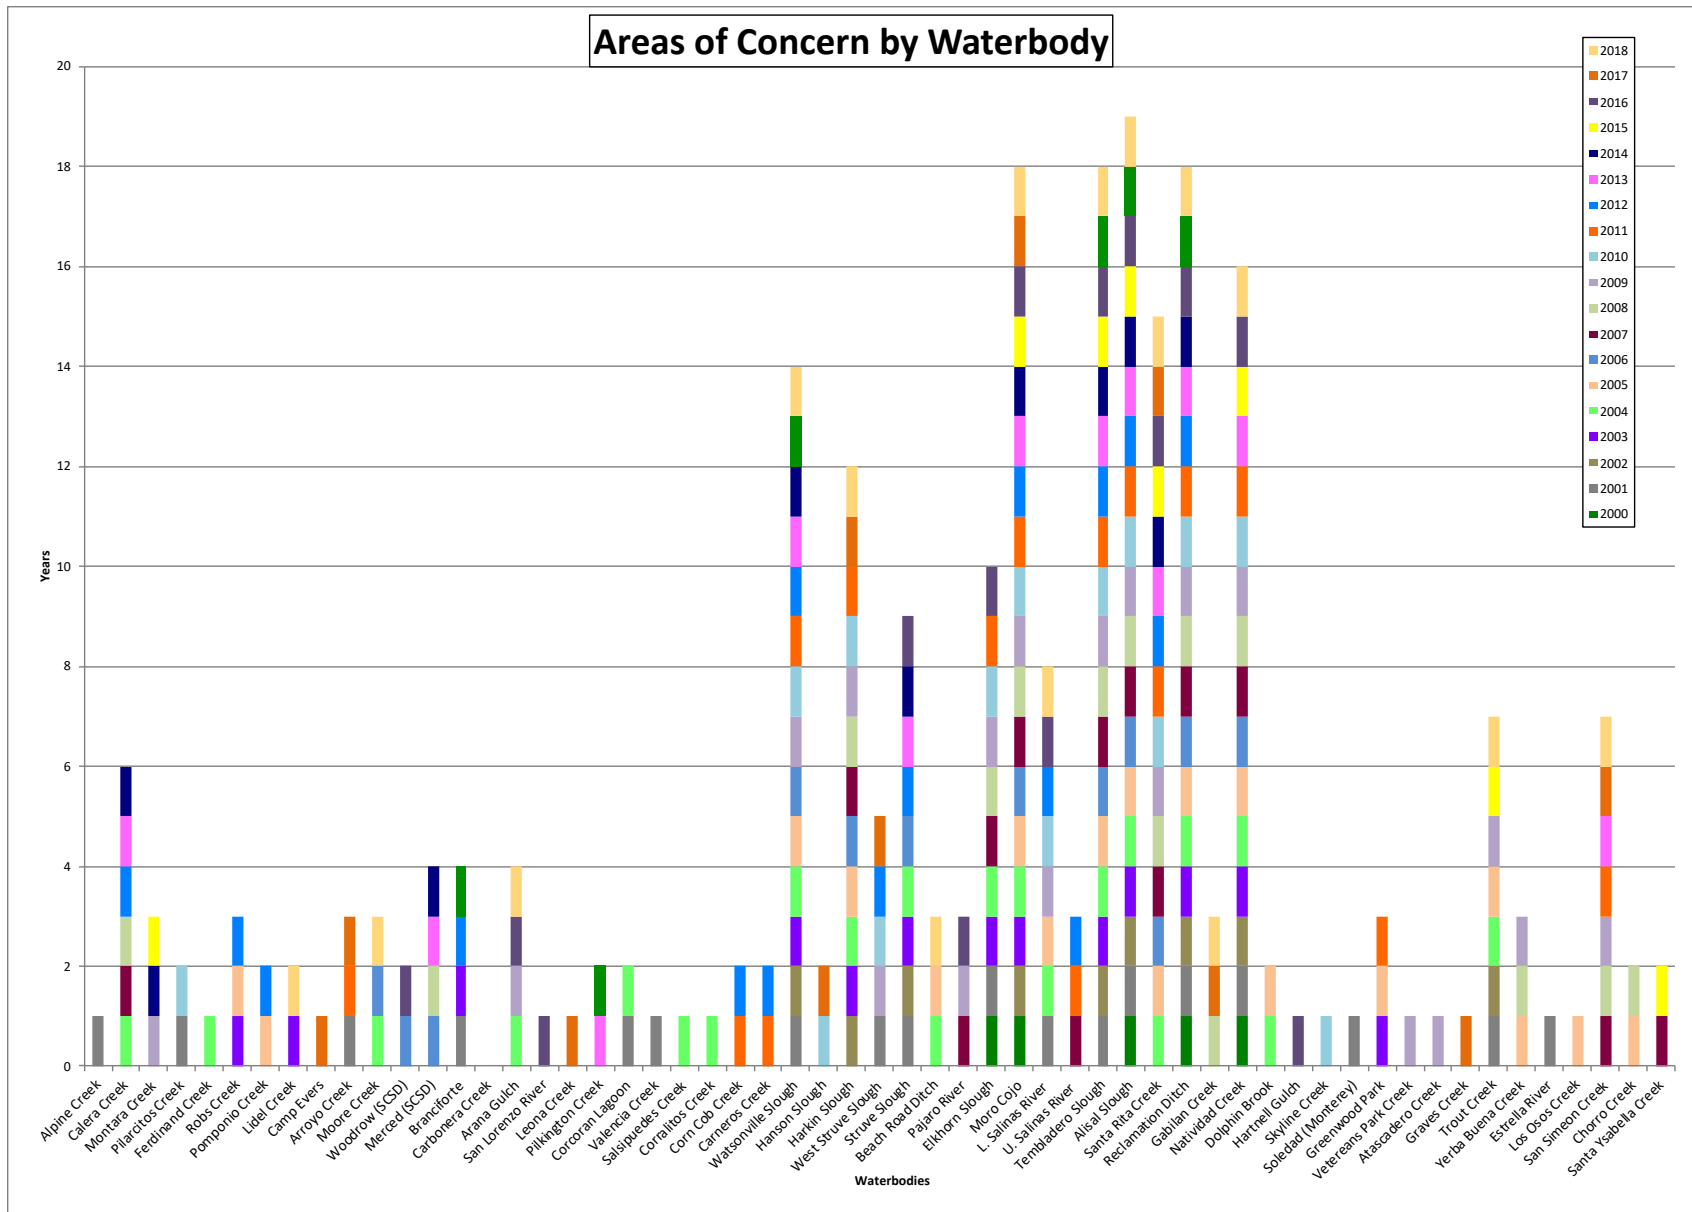
Figure 5. Areas of concern by waterbody 2000-2018

When lab and/or field results for a single site exceed three or more Water Quality Objectives or Action Levels, the site is labeled an Area of Concern (AoC). Over the past several years, a trend has emerged of more than one AoC per water body. For example, the Tembladero and Moro Cojo Sloughs have more than one site that is monitored along these waterways, and also have more than one AoC along the same waterway. For this reason we have chosen to display the AoC data two ways: by water body (Figure 5) and by site (Figure 6).

In 2018, twenty-two sites (17%) were designated Areas of Concern on sixteen water bodies (Figure 5). The 2018 Areas of Concern include nine of the ten most common Areas of Concern: Watsonville Slough (Santa Cruz County), Harkins Slough (Santa Cruz County), Moro Cojo Slough (Monterey County), Tembaldero Slough (Monterey County), Alisal Slough (Monterey County), Lower Salinas River (Monterey County), Santa Rita Creek (Monterey County), Salinas Reclamation Ditch (Monterey County), and Natividad Creek (Monterey County). This year, Lidel Creek (Santa Cruz County) is on the list for only the second time in nineteen years due to exceedances in *E. coli*, orthophosphate, and dissolved oxygen. Moore Creek (Santa Cruz County) is also on the AoC list for only the third time in nineteen years due to exceedances in *E. coli*, orthophosphate, pH and dissolved oxygen (Figure 6). This year for the third year in a row, there are no sites from San Mateo County listed as AoC.

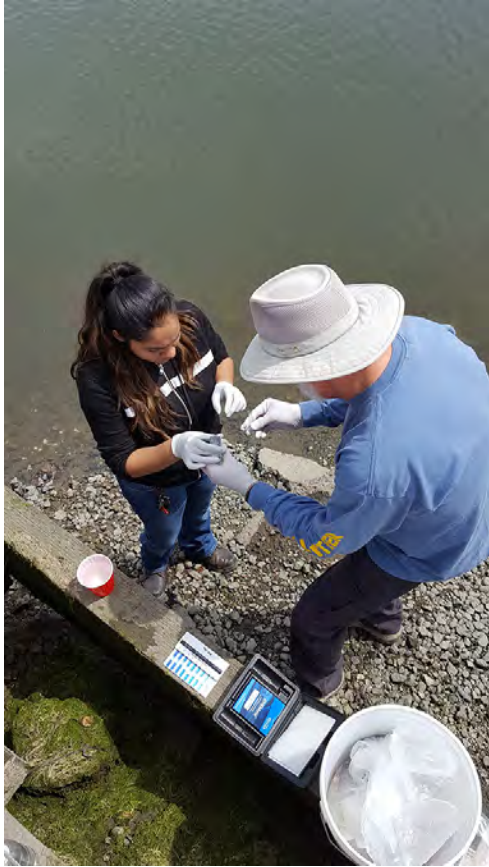
**The Elkhorn Slough team checks dissolved oxygen in Elkhorn Slough, Monterey County.**

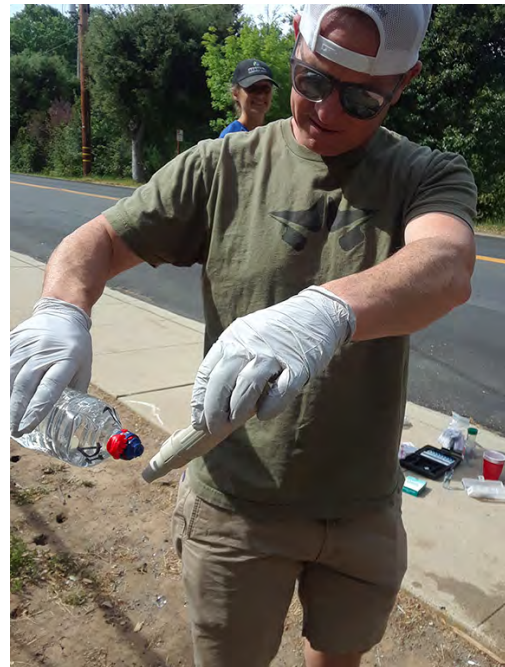
**Rinsing off the conductivity meter in the Upper Salinas watershed.**
