## The Impacts of Coastal Protection Structures in California's Monterey Bay National Marine Sanctuary

February 2005

# **The Impacts of Coastal Protection Structures in California's Monterey Bay National Marine Sanctuary**

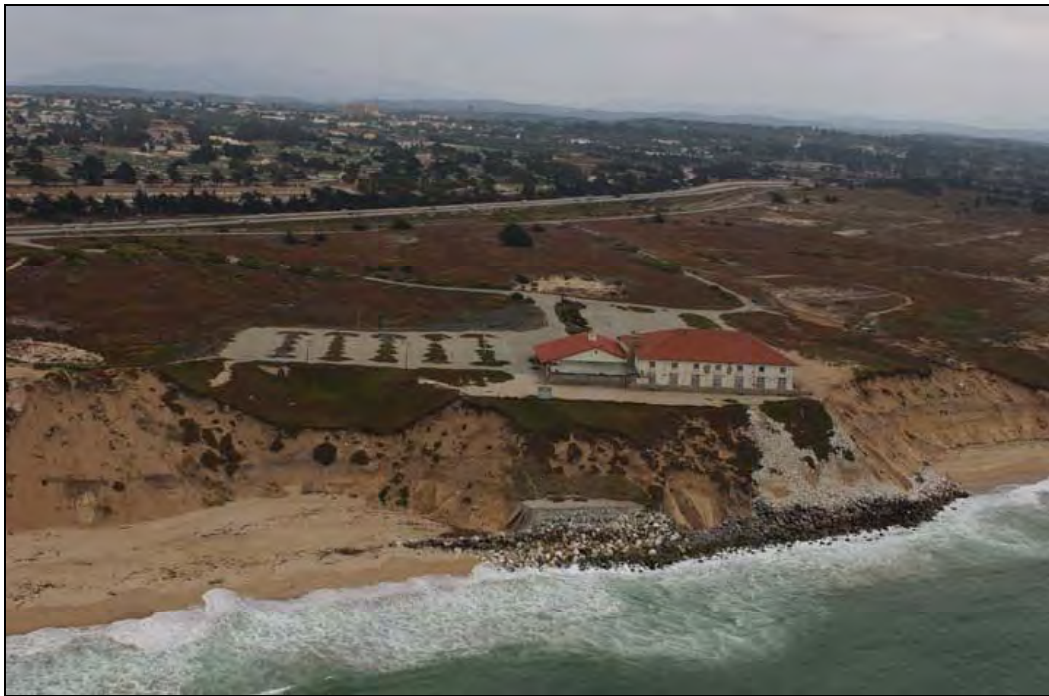
Figure 1a: Oblique aerial photograph of Stillwell Hall in 2002 in Marina, CA. Coastal protection structures placed at the base of the aged building were neither effective nor efficient enough keep up with intense coastal erosion of adjacent bluffs. Photograph copyright © 2002 Kenneth & Gabrielle Adelman (<http://www.californiacoastline.org/>).

Several alternatives have been recognized to deal with the confluence of coastal development and eroding shorelines, none of which are a panacea. In the extreme case, property owners can demolish the building or relocate it landward, either on the same parcel or on an entirely different inland location. Neither of these choices is ideal for property owners, though they should be considered as serious, long-term solutions to this inevitable dilemma, given the rising costs of other alternatives (Griggs 1986). For example, Stillwell Hall, built in the 1940's as the Fort Ord soldier's club in Seaside, California, was torn down in March 2004 because the cost of both coastal armoring and relocating were too high (Figures 1a and b).

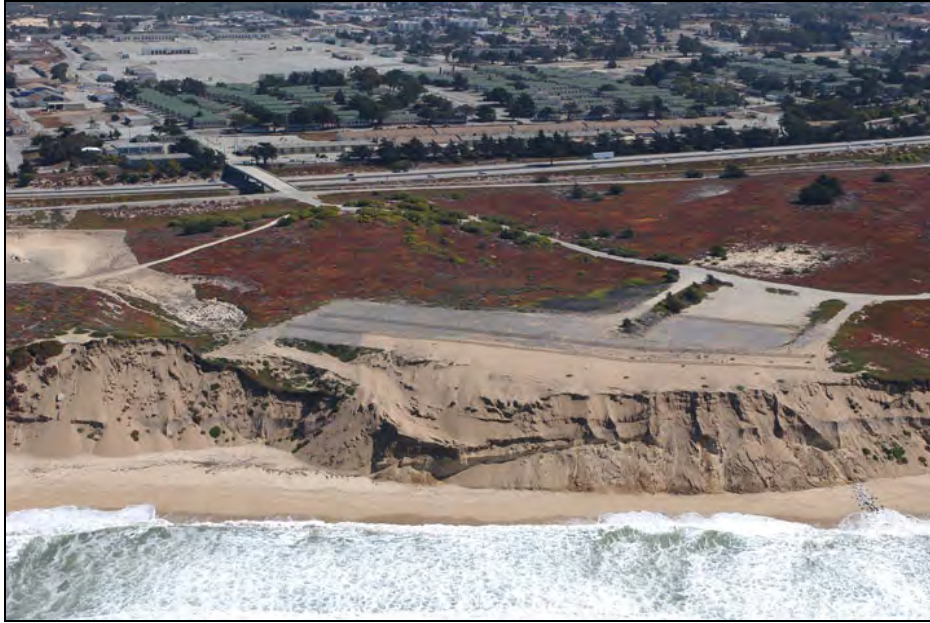
Figure 1b: Oblique aerial photograph of the former Stillwell Hall location after the building and associated coastal protection structures were removed in March 2004. Photograph copyright © 2002 Kenneth & Gabrielle Adelman (<http://www.californiacoastline.org/>).

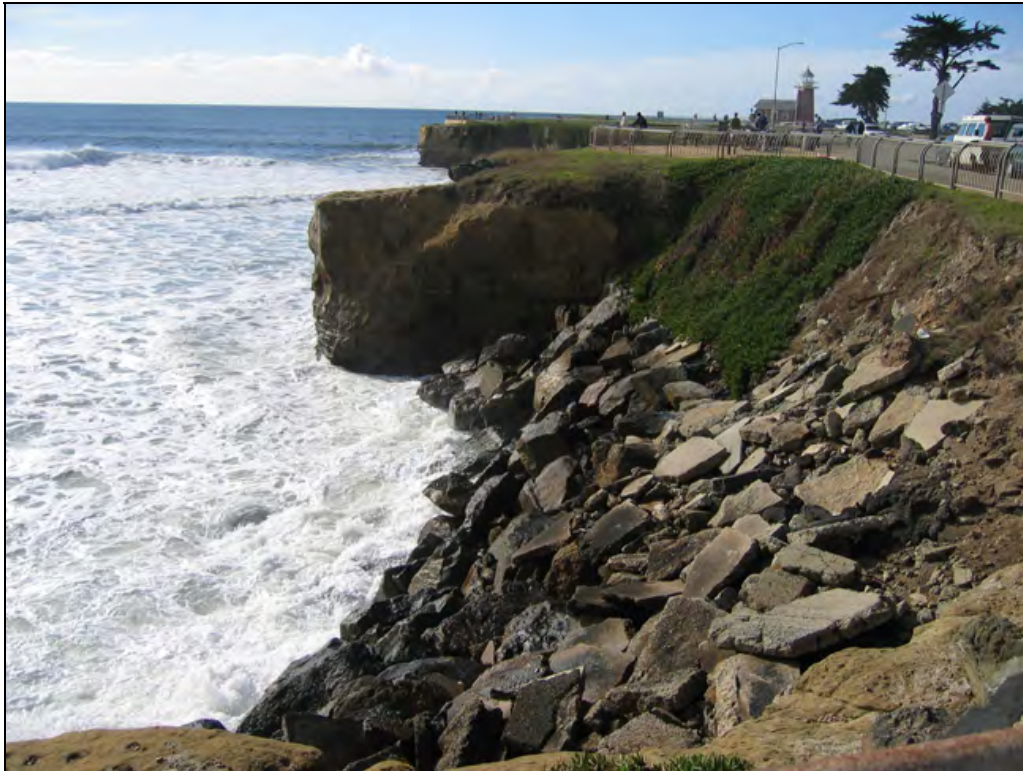
Figure 2: Concrete blocks used as riprap near Lighthouse Point in Santa Cruz, California.

Public outcry over armoring is largely the result of visual impacts, because coastal protection structures often look unnatural or unsightly and can negatively affect recreational beach experiences. In the past, emergency armor has been emplaced with no regard to aesthetics or long-term engineering standards. Slabs of concrete have been dumped at the bases of cliffs, as is the case near Lighthouse Point in Santa Cruz (Figure 2), and several different kinds of structures have been haphazardly used on the same stretch of coast, such as is the case at Opal Cliffs in Capitola (Figure 3).

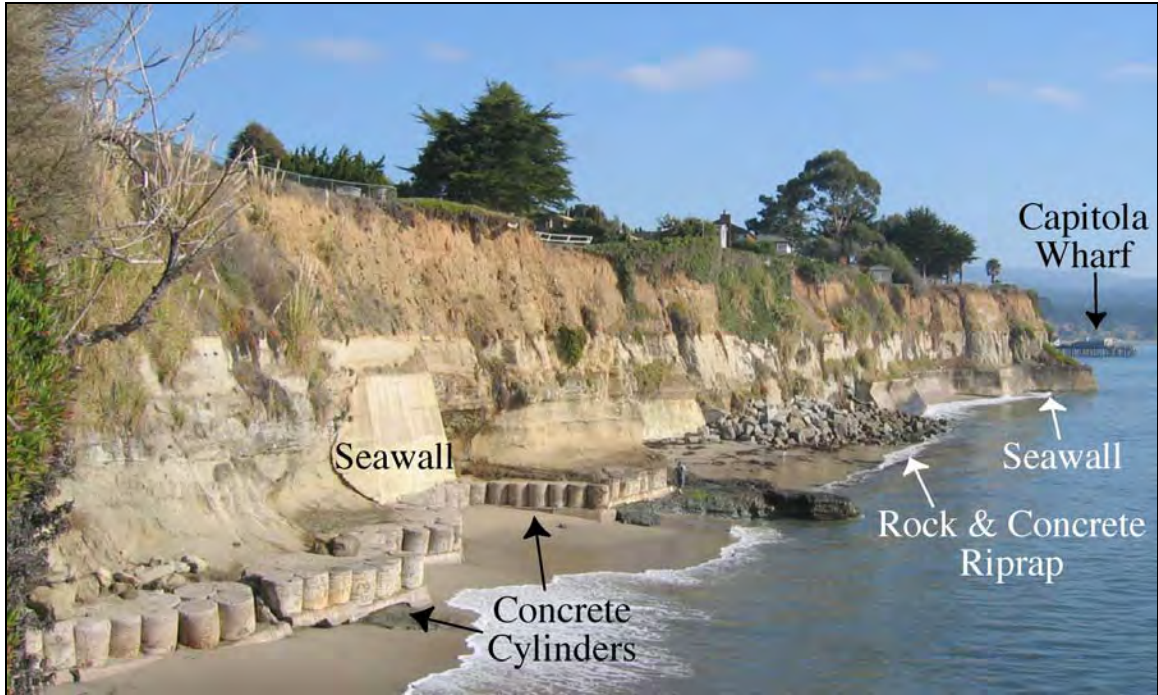
Figure 3: An unplanned assemblage of coastal armoring at Opal Cliffs in Capitola, California can have a visual impact on the beach user.

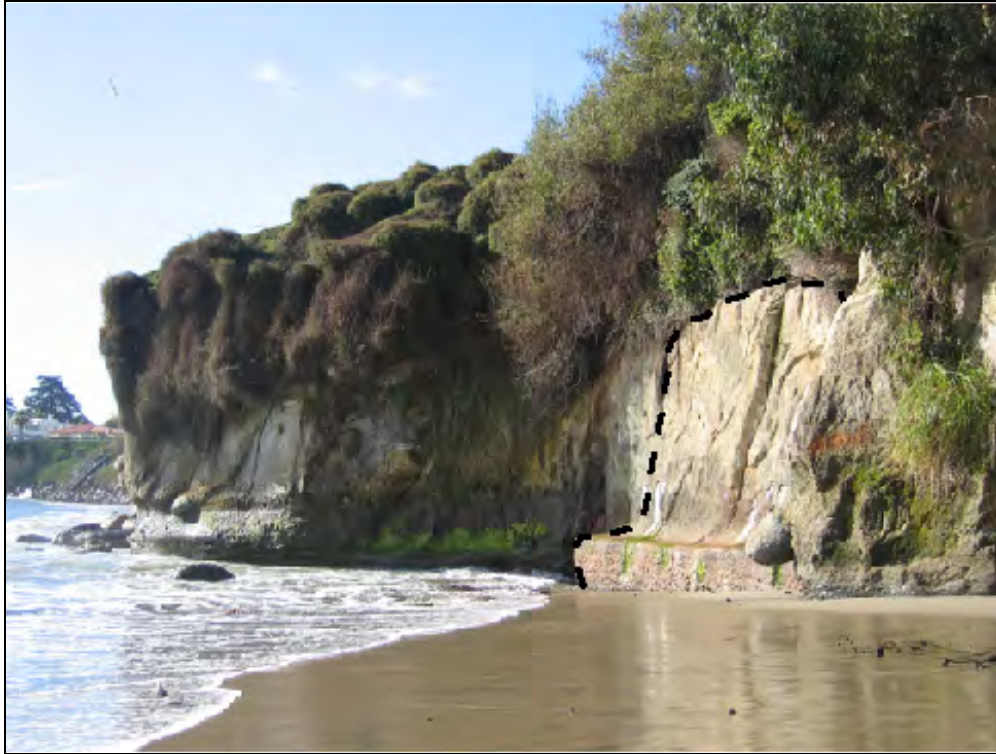
Figure 4: Photograph of cliff stabilization built to fill a seacave at Cowell's Beach in Santa Cruz. The 2004 gunite wall, outlined by the black dashed line, mimics the shape and color of the natural cliff.

There are ways to mitigate visual impacts. New seawall engineering, with faces crafted of gunite or shotcrete, can be sculpted and colored to resemble the surrounding cliff or bluff face. Such walls are already used extensively in cliff stabilization on roadways and are gaining further use in the coastal zone, including a new, natural-looking wall protecting the cliff behind Cowell's Beach in Santa Cruz (Figure 4).

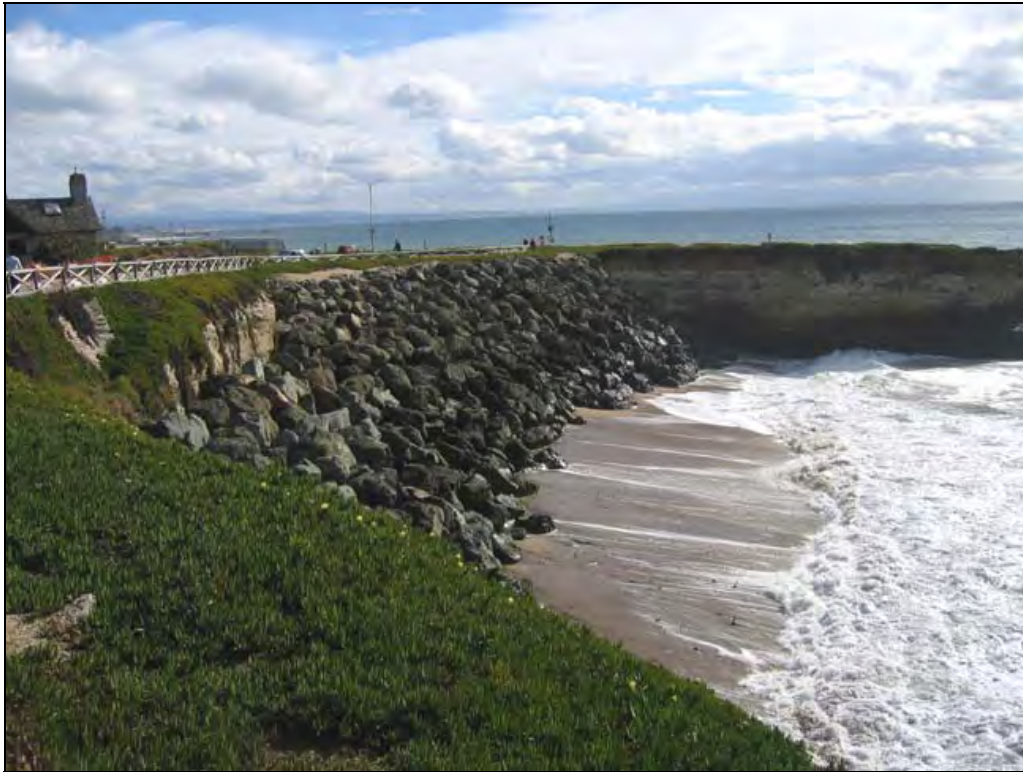
Figure 5: Riprap covering up significant amount of beach area in Santa Cruz, California, near the intersection of Westcliff Drive and San Jose Avenue.

by the shore-parallel length of the riprap yields the square feet of beach lost by impoundment. In this case, if a 20-foot stretch of coast needed to be armored, an average seawall would impound 120 ft<sup>2</sup> of beach (6 ft wide x 20 ft long), while riprap would cover 800 ft<sup>2</sup> of beach (40 ft wide x 20 ft long). Westcliff Drive in Santa Cruz, for example, has had extensive beach loss because of riprap emplacement (Figure 5).

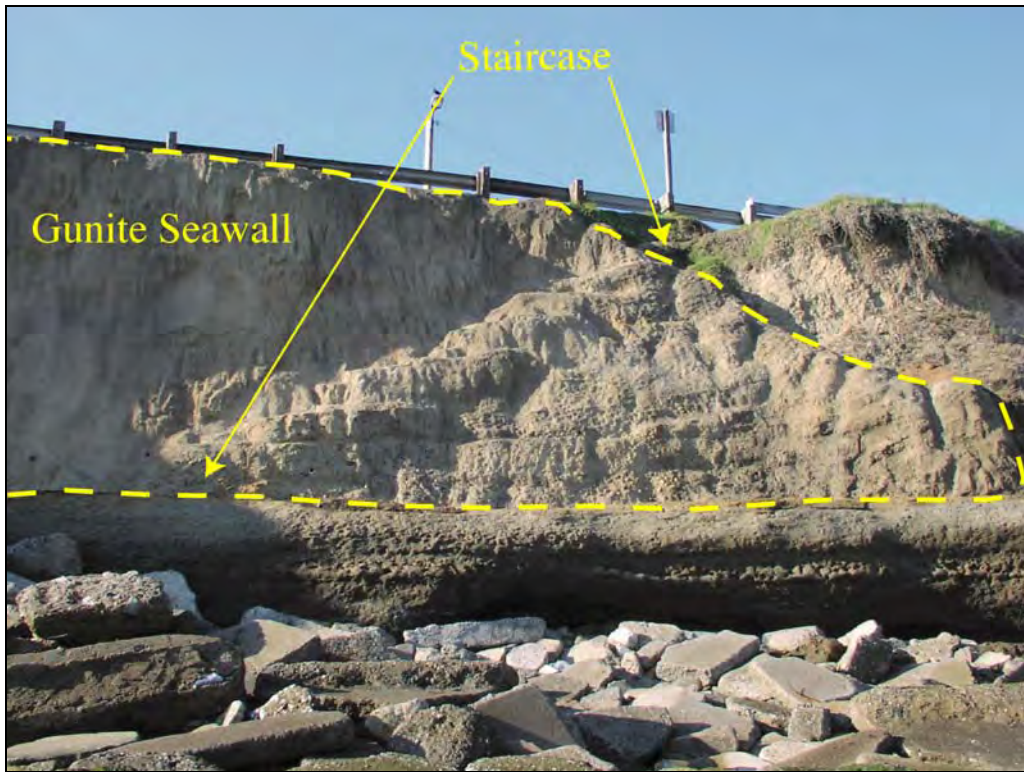
Figure 6: In this bluff stabilization project at Pleasure Point in Santa Cruz, the protective gunite (outlined with dotted line) was colored and textured to match the existing bluff materials, and access steps were built into the structure (Photograph by Gary Griggs).

access to the beach, though maintenance of these paths can become a safety issue over time if the armoring is structurally compromised (Figure 6).

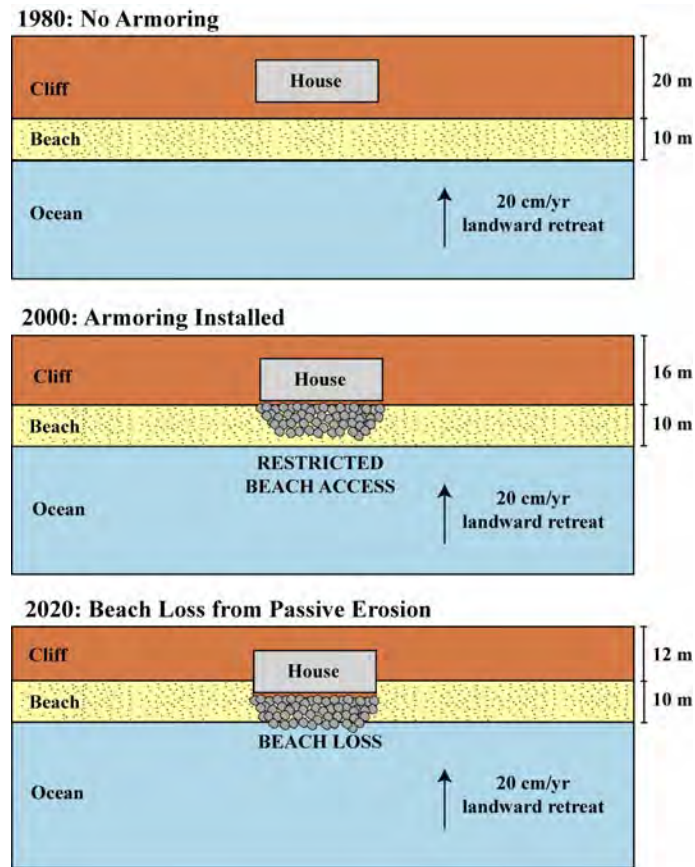
Figure 7: Aerial-perspective, schematic diagram depicting beach loss over time due to fixing the coastline with armor when coastal erosion rates are 20 cm/year, a realistic rate for California. Prior to its removal, Stillwell Hall in Marina, California, was a classic example of passive erosion (see Figure 1).

Passive erosion is perhaps the most significant and the most misunderstood impact of coastal armoring. Eighty-six percent of California's coastline is eroding, the result of which is a landward retreat of beaches, cliffs and other coastal landforms. Yet when a structure, such as riprap or a seawall, is constructed in front of a building to halt erosion, the shoreline is essentially fixed at that location. Adjacent landforms (beaches, cliffs, etc.) will continue to retreat landward, creating an artificial headland out of the armored segment of coast. If armor is placed at the base of a cliff that has a beach in front of it, the beach will continue to migrate landward on either side of the armored area, but there will be no beach in front of the armor, as depicted in Figure 7.

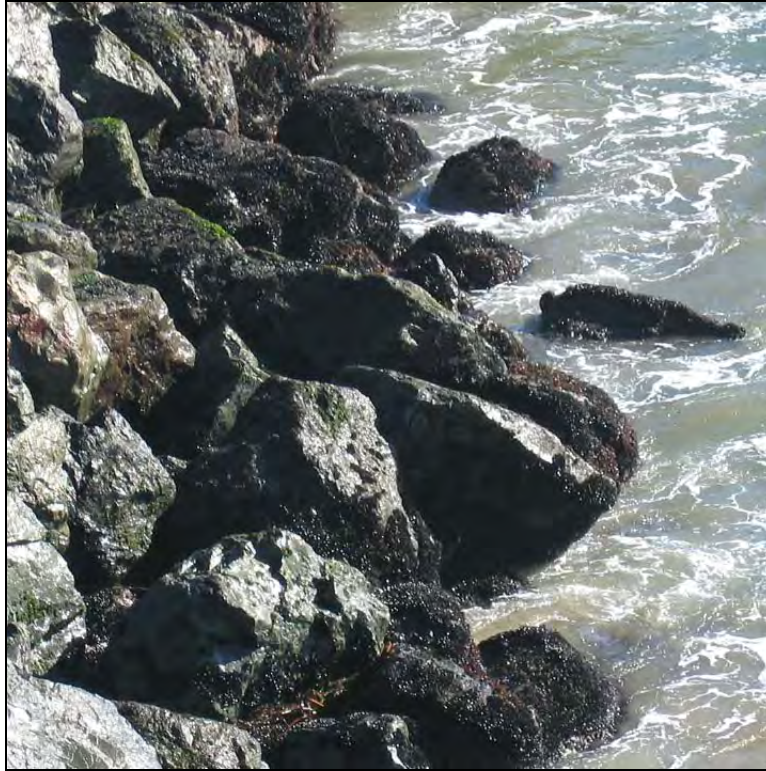
Figure 8: Algae growing on basaltic riprap in Santa Cruz, California. This riprap has covered up a beach, creating an artificial substrate for species recruitment.

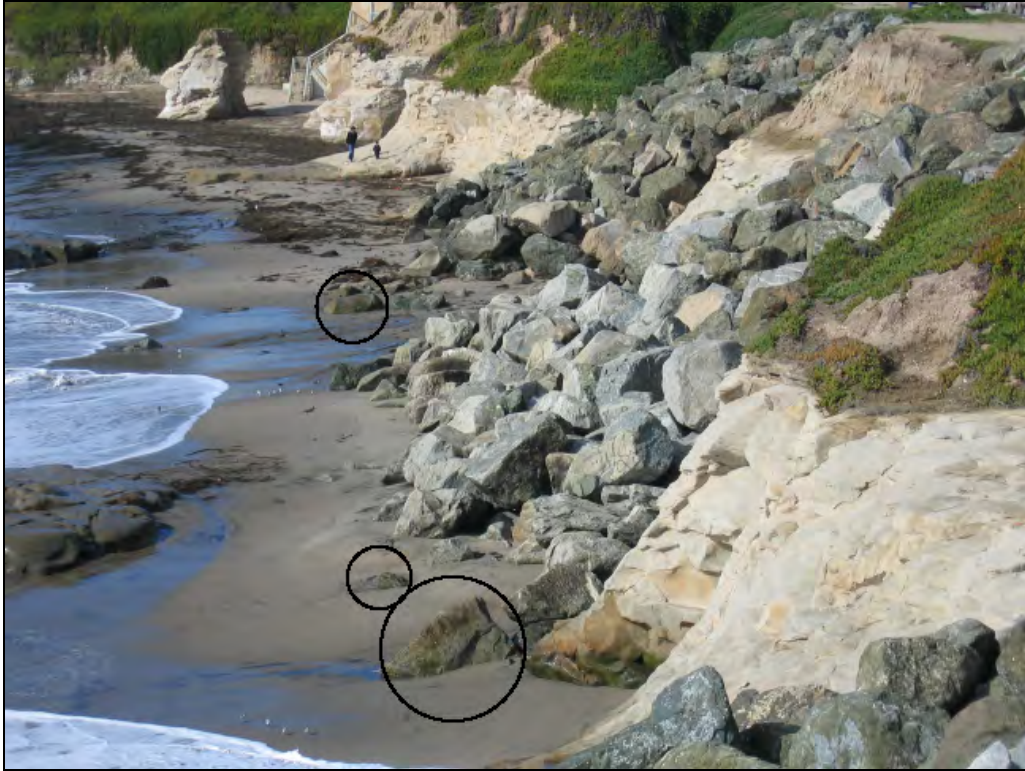
Figure 9: Riprap boulders commonly settle into deep sandy beaches or get buried, as seen here near the intersection of Westcliff Drive and David Street in Santa Cruz, California.

In addition to these engineering specifications, riprap generally requires regular maintenance by adding rocks every 5 to 10 years. These structures can cost over \$1500 per linear foot (in 2003 dollars), with annual maintenance costs of 2-15% of the initial cost. Riprap that is built on top of bedrock platforms generally lasts longer than those placed on beaches, because a significant amount of settling and burial can occur in active beach environments (Figure 9).
