COASTAL EROSION AND ARMORING IN SOUTHERN MONTEREY BAY

A Technical Report in support of the
Monterey Bay National Marine Sanctuary
Coastal Armoring Action Plan

Version 1.1

June 2005

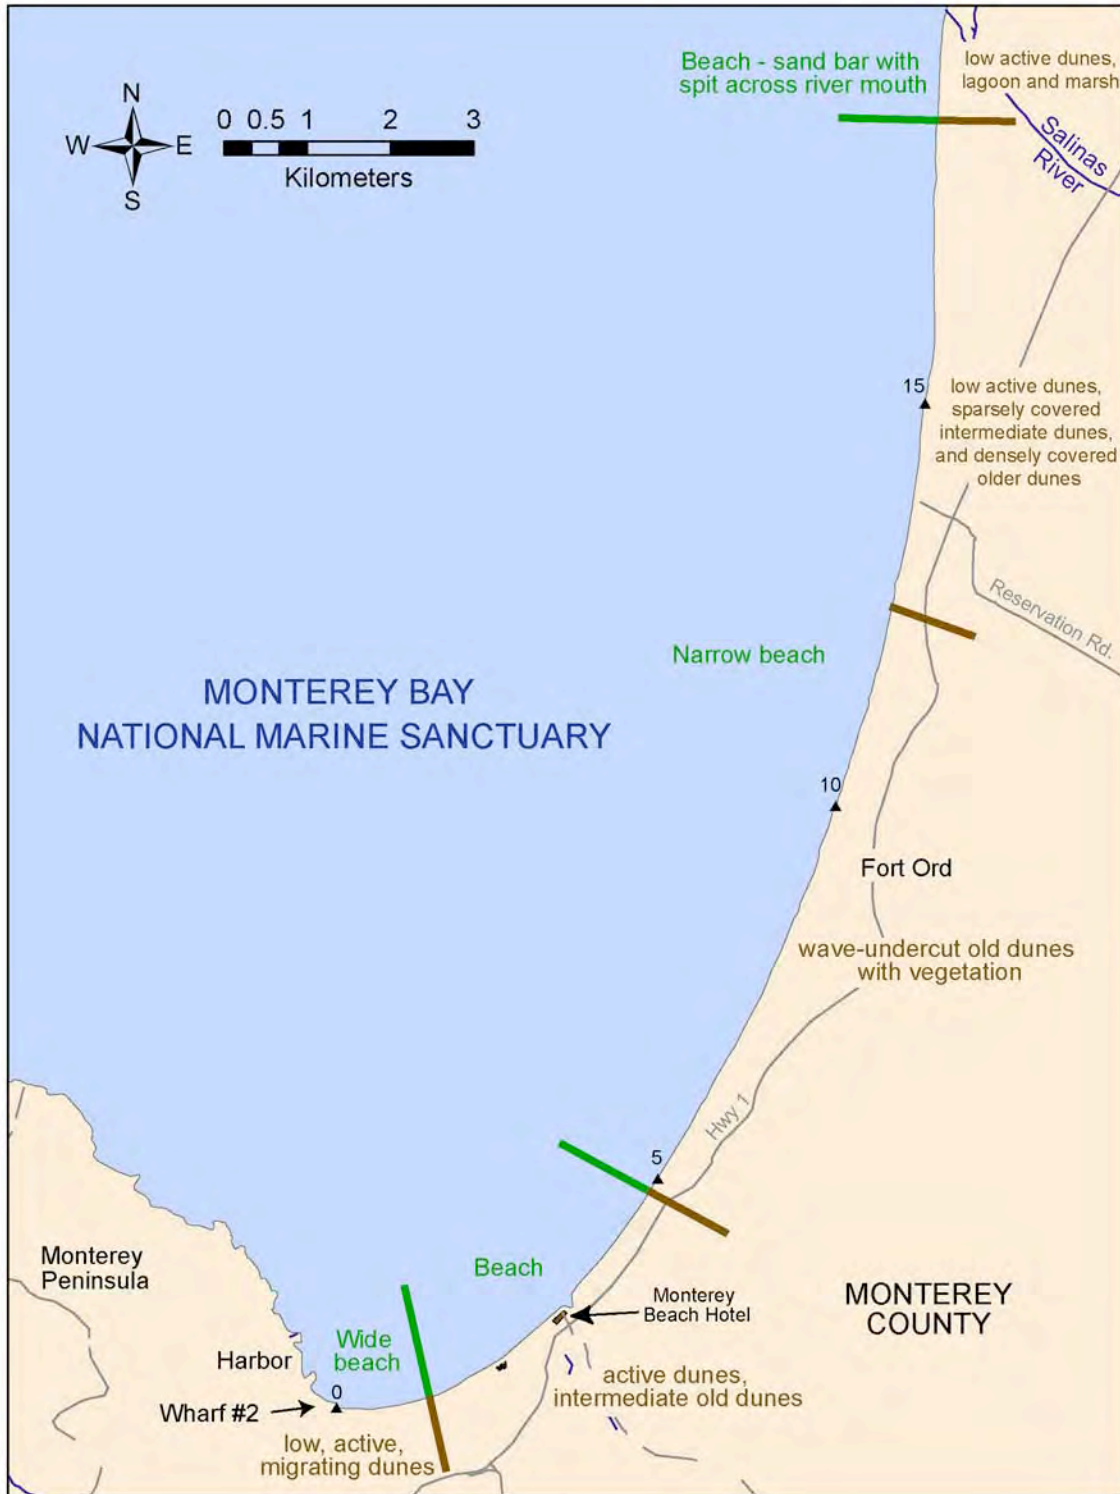
Figure 1.4: Relative beach width (green text) and adjacent dune morphology (brown text) in southern Monterey Bay. Distances from Wharf #2 in Monterey are shown in kilometers (black triangles). Coastline descriptions from Coyne (2001).

The shoreline of SMB is an 18 km stretch of continuous sandy beach, being wider at the southern end than at the northern end (Figure 1.4). The morphology of beaches in this region varies from season to season, but they are generally wider and gently sloping in summer and narrower and steeper in winter. The dunes at the back edge of the beach have an average height of 10.3 m, but can be as high as 46 m (Thornton et al. in press)

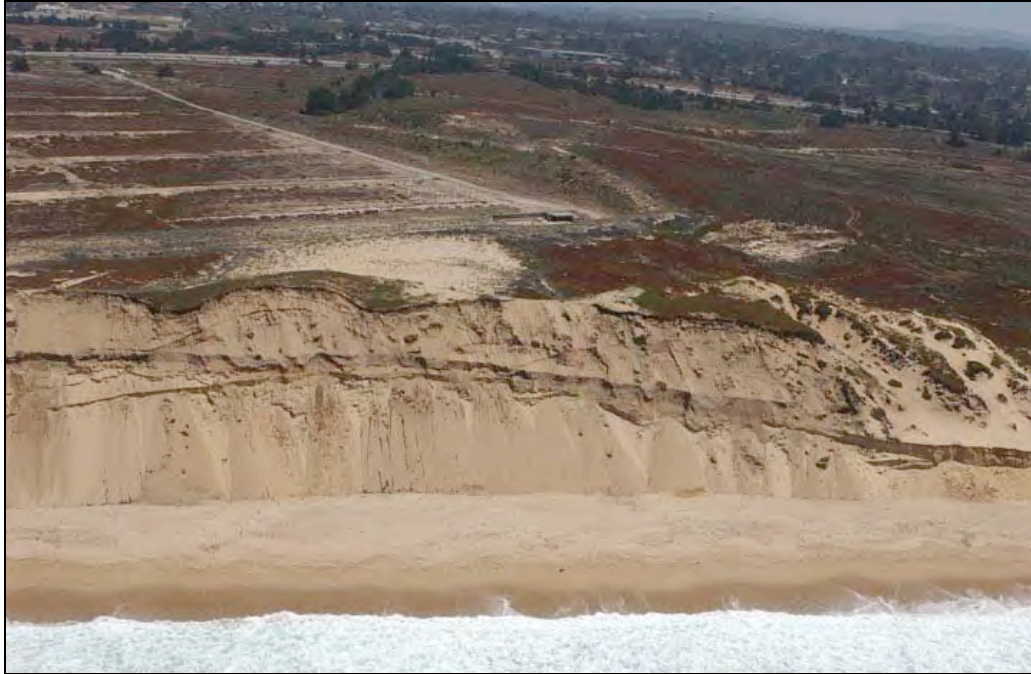
Figure 1.5: Aerial photograph of wave-cut dunes near the relatively undeveloped area of Fort Ord, California. This type of erosion provides much of the sand for the southern Monterey Bay littoral system. Despite the fact that this photograph was taken in summer, the beach is relatively narrow. During storms and/or high tides, waves wash up the beach and undercut the dunes. See Figure 1.4 for location of Fort Ord. Photograph copyright © 2002 Kenneth & Gabrielle Adelman (<http://www.californiacoastline.org/>).

(Figure 1.5). Most of the dune surfaces that are not directly exposed to wave energy are vegetated, indicating that the dunes are stabilized in some areas. Yet, drifting sand across Highway 1 is evidence of some inland dune migration because of prevailing onshore winds (Figure 1.6). Erosion of these dunes, which has been occurring since sea level began to rise at the end of the last glacial period, is the dominant sand supply to the SMB littoral cell (Figure 1.3).

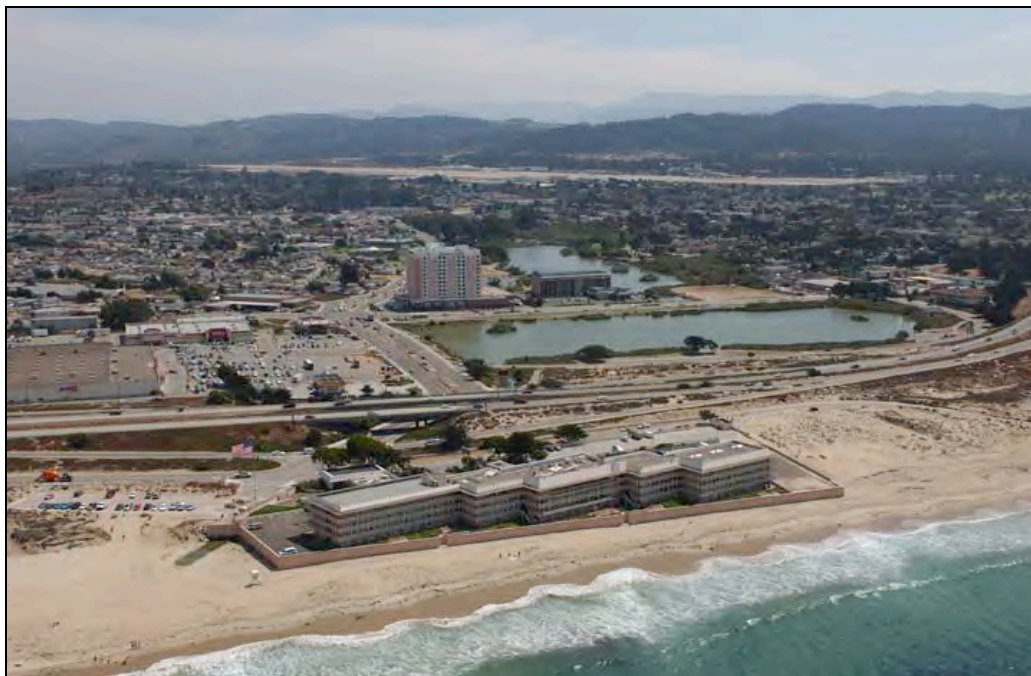
Figure 1.6: Aerial photograph of the Monterey Beach Hotel (Seaside, CA) in summer, showing a wide beach, low back-beach area, and migrating dunes. In contrast to Figure 1.5, there is significant development along this stretch of southern Monterey Bay. See map Figure 1.4 for location of the hotel. Photograph copyright © 2002 Kenneth & Gabrielle Adelman (<http://www.californiacoastline.org/>).

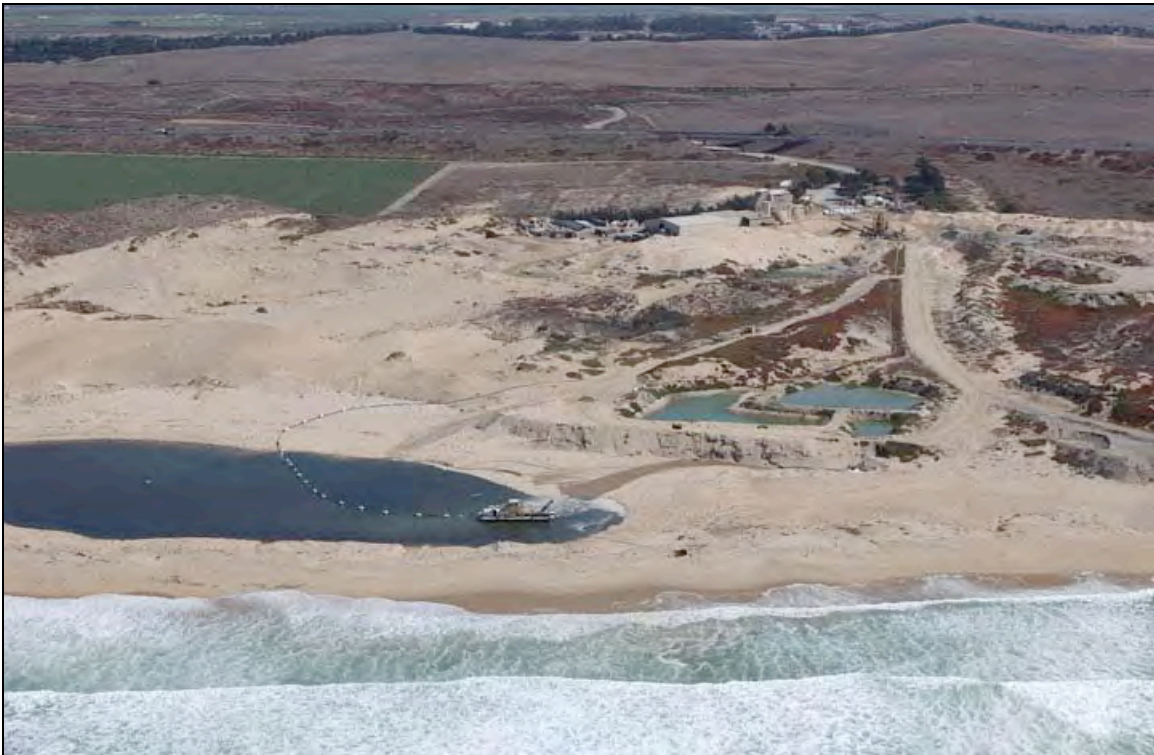
Figure 1.8: Sand mining operations in northern Marina, California. The company has dredged a lagoon from which they extract sand. Some argue that the lagoon actually traps beach material in addition to dune sand. See Figure 1.9 for location of mine. Aerial photograph taken in October 2004; copyright © 2002 Kenneth & Gabrielle Adelman (<http://www.californiacoastline.org/>).

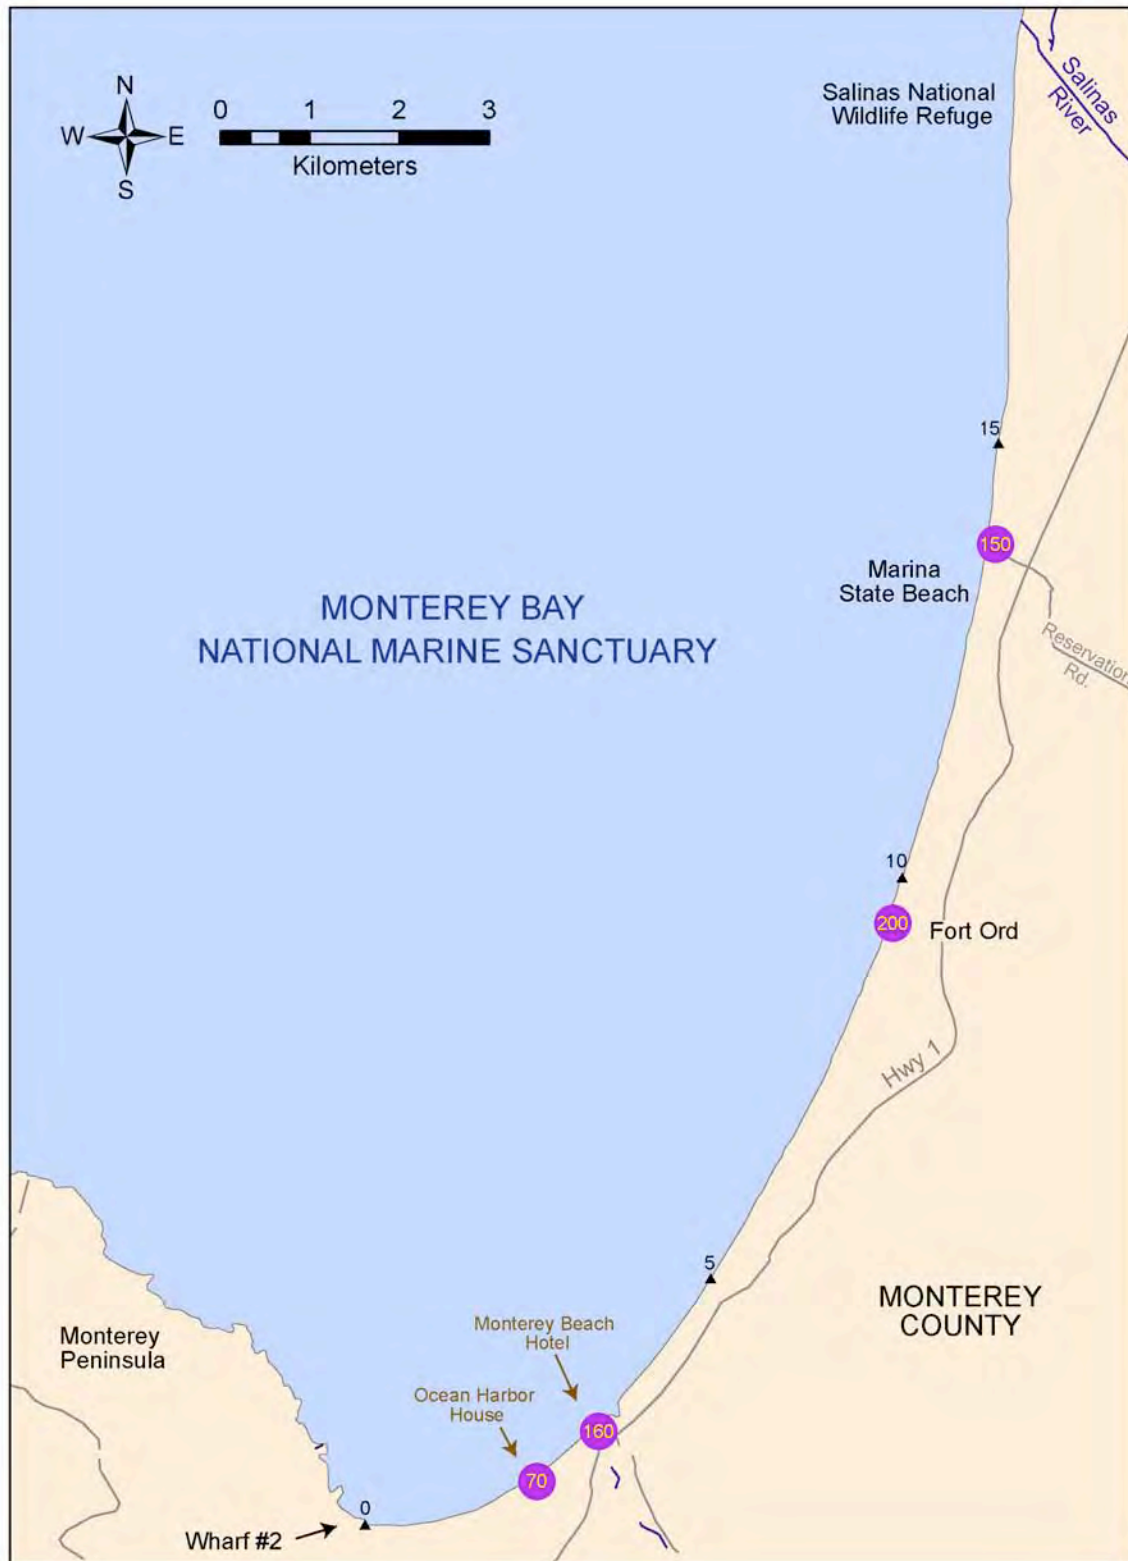
Figure 2.2: Coastal erosion rates reported in centimeters per year (purple circles), as determined by Gref (2004) of CSUMB. Rates were calculated over the years 1976-2004. Distances from Wharf #2 in Monterey are in kilometers (black triangles). For reference, 100 cm=3.28 ft.

For Marina State Beach, at the end of Reservation Road, Gref calculated rates along 10 shore-normal transects and found a total retreat rate of 150 cm/yr (4.9 ft/yr) (Figure 2.2). Near the former Stilwell Hall site, on Fort Ord coastal property, 14 transects were averaged to yield an erosion rate of 200 cm/yr (6.6 ft/yr). Erosion across 14 transects for the 4 years of measurements was 160 cm/yr (5.2 ft/yr) near the Monterey Beach Hotel in Seaside. Rates were calculated for the areas adjacent to, not in front of, the hotel's seawall, because the seawall has fixed the coastline since 1968. Finally, Gref determined

erosion rates along 6 transects in front of, and adjacent to, the Ocean Harbor House condominiums, calculating an average retreat rate of 70 cm/yr (2.3 ft/yr). Riprap placed in front of the condominiums since 1984 has slowed erosion; therefore natural coastline retreat rates at this site may actually be greater than 0.7 m/yr.

The rates calculated by Gref support the general patterns documented by other researchers. Erosion has been most severe at Fort Ord, with Marina State Beach and Monterey State Beach having slightly less retreat. Yet across the region, coastal erosion creates hazardous conditions, with average rates from 2.3 to 6.6 feet per year. The role of coastal protection structures (armoring) is very important in the areas highlighted by Gref and will be discussed in detail later in this report.

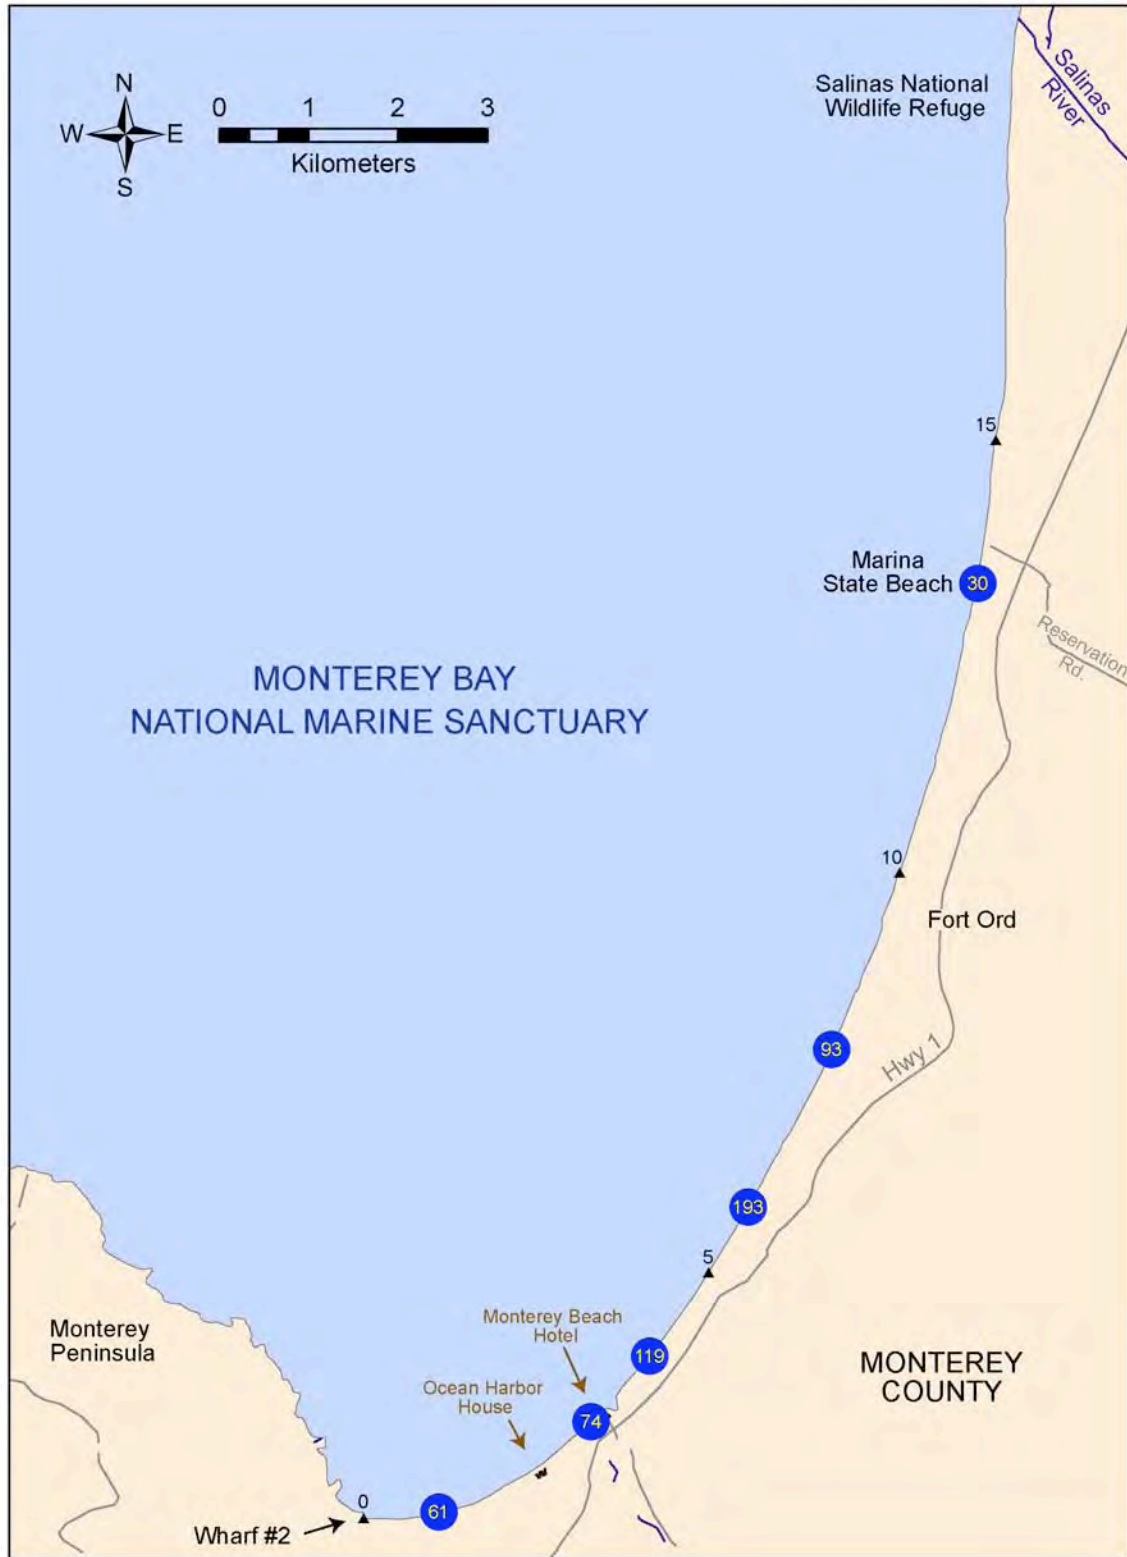
Figure 2.3: Coastal erosion rates in centimeters per year (blue circles) for the time period 1940-1984, as documented by Thornton et al. (in press). Distances from Wharf #2 in Monterey are in kilometers (black triangles). For reference, 100 cm=3.28 ft.

Thornton et al. presented their data in several ways that may be useful for land use planning. Results are split up into two time periods, 1940 to 1984 and 1984 to 2004, based on the cession of swash-zone sand mining in the 1980's (see Section I-e). An estimated 128,000 m³/yr of sand was removed from the littoral system between 1940 and 1984 because of mining, which is nearly 50% of the total annual volume of sand eroded

from dunes over the same time period (270,000 m³/yr). This interval also included two El Niño events (1956-57 and 1982-83) and linear coastal erosion rates ranged from 30 to 193 cm/yr (1.0 to 6.3 ft/yr). Erosion was most severe near Fort Ord, with slightly more subdued erosion to the north and south (Figure 2.3). Smith et al. (2005) also provide a comprehensive evaluation of this study in the context of shoreline management.

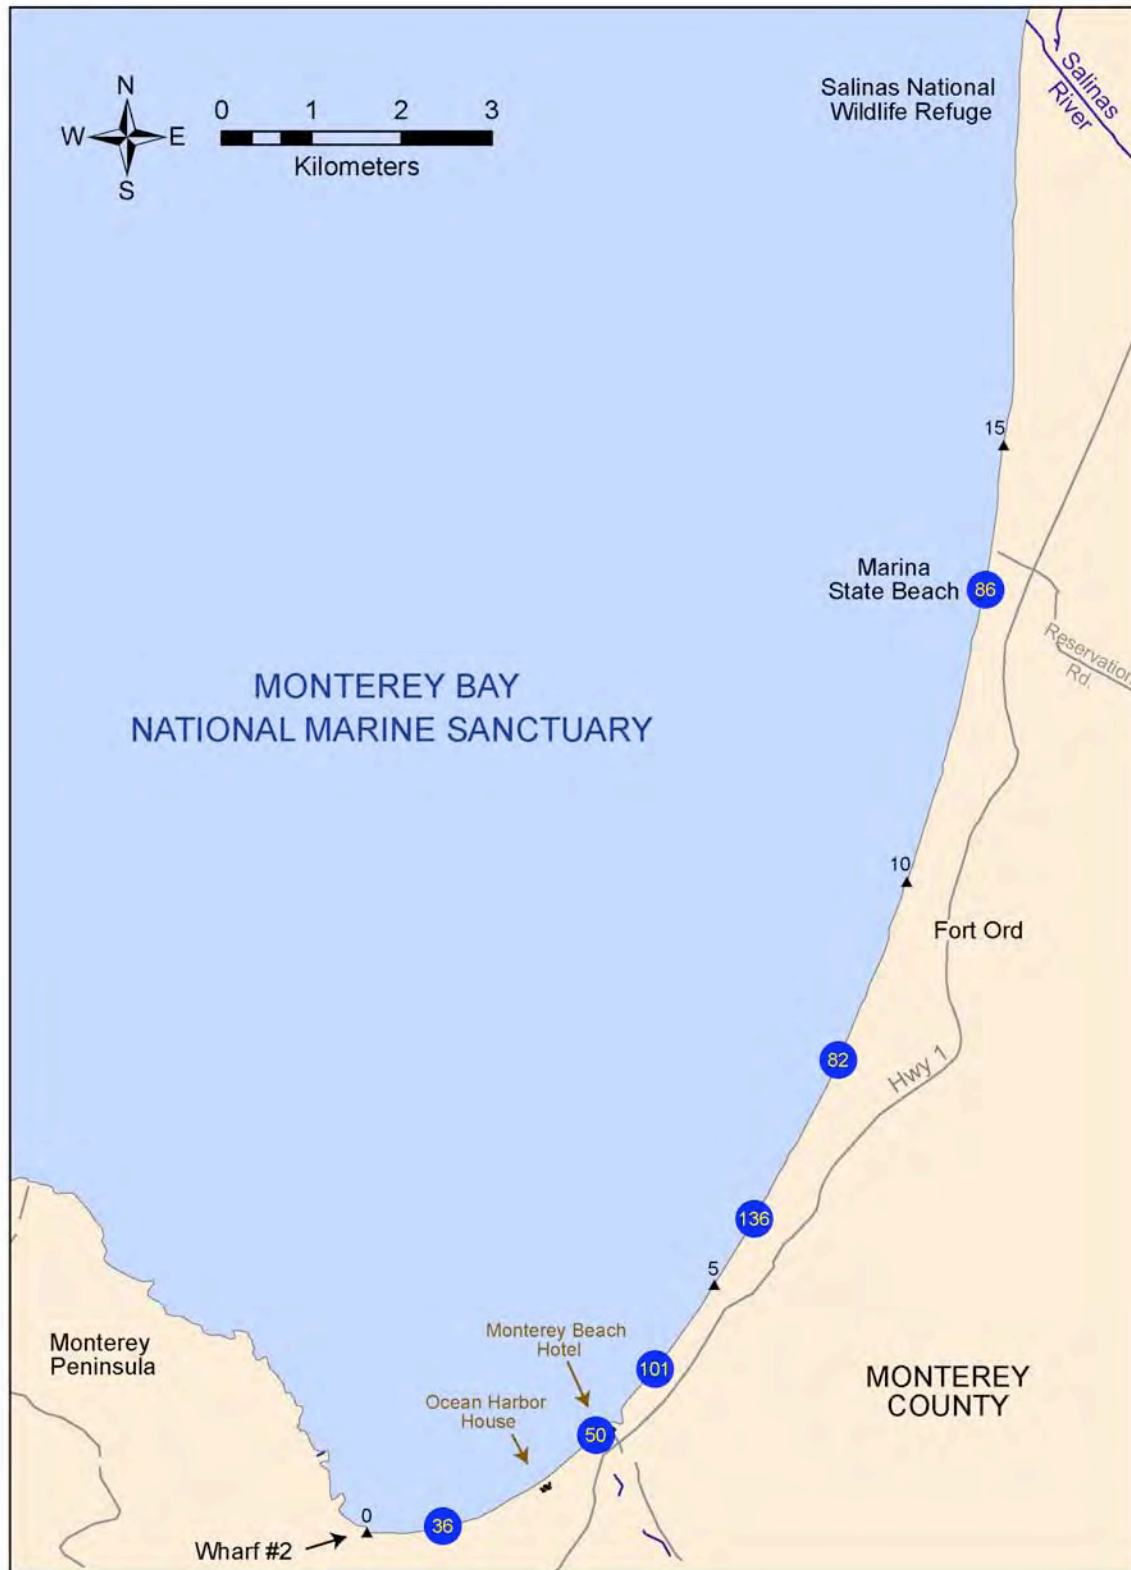
Figure 2.5: Coastal erosion rates in centimeters per year (blue circles) for the time period 1940-2004, averaged from Thornton et al. (in press). Distances from Wharf #2 in Monterey are in kilometers (black triangles). For reference, 100 cm=3.28 ft.

Planners will have to decide what their goal is when using the data presented by Thornton et al: if they want to compare this study with other studies that go back prior to 1984, it appears that an averaged (1940-2004) rate would be the most appropriate; if they want to get an idea of what current coastal retreat rates are, the 1984-2004 rates may be relevant. Yet Thornton et al. stress that caution should be taken when relying upon just the 1984-2004 rates because only 4 data sets were used in the calculation. Given the episodic nature of dune erosion in this region, a more conservative estimate of erosion would come from more robust, longer-term data (e.g., 1940-2004), despite the cessation of sand mining (Figure 2.5).

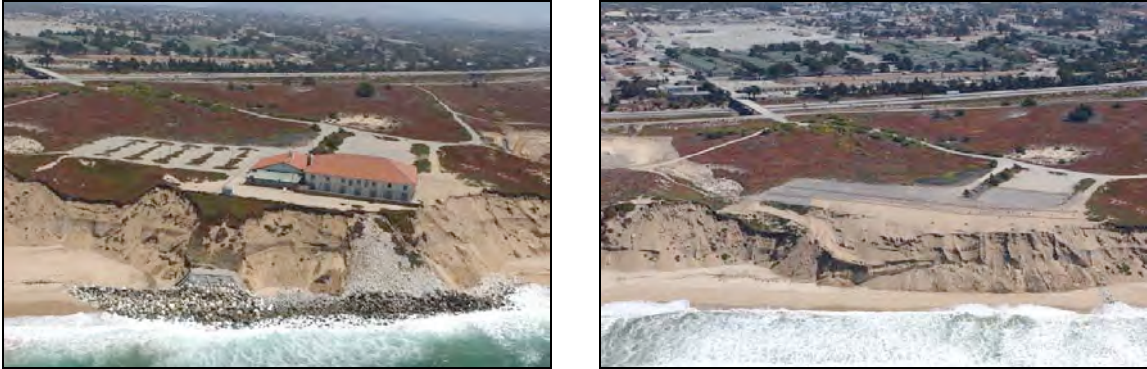
Figure 4.1: The former Fort Ord soldier's club, Stillwell Hall, was demolished in 2004 because attempts to save the structure from collapsing into the ocean by emplacing riprap in front of the dunes proved to be too costly and ineffective. Left photo taken August 2003, prior to demolition. Right photo taken October 2004 after removal of structure and all riprap. Photographs copyright © 2002 Kenneth & Gabrielle Adelman (<http://www.californiacoastline.org/>). See Figure 5.1 for location.

the Fort Ord soldier's club in Seaside, California, was torn down in March 2004 because the cost of both coastal armoring and relocating were too high (Figure 4.1).

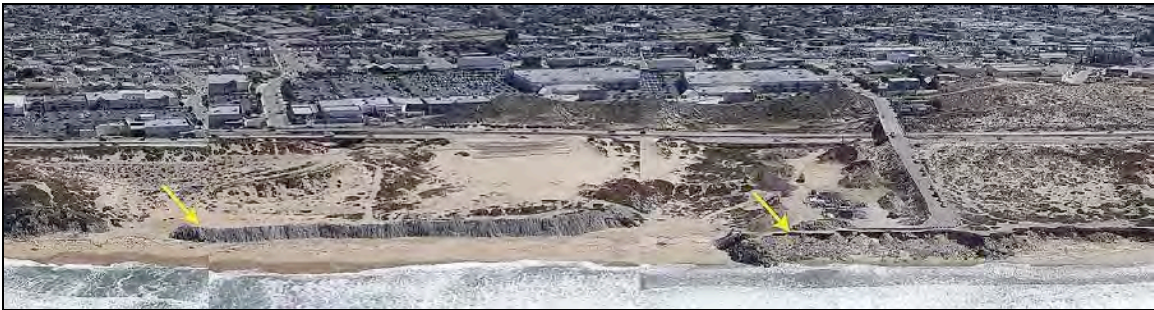
Figure 5.2: Aerial photo mosaic of the concrete slurry “ridge” and other hard structures (indicated with yellow arrows) at the end of Tioga Road in Sand City, California. Photographs taken October 2004; copyright © 2002 Kenneth & Gabrielle Adelman (<http://www.californiacoastline.org>).

Remnants of a cement mixing facility are located at the end of Tioga Road in Sand City that forms make-shift coastal armoring (Figures 5.1 and 5.2). Concrete slurry was dumped here in a linear, shore-parallel pattern. The ridge formed by this cement is over 200 meters long and acts much the same way as a seawall (Thornton et al. in press). The impacts of this structure are similar to that of engineered coastal armoring in terms of blocking access, preventing natural shoreline retreat, and losing beach area both for recreation and as a habitat (HKA 2003a). The structure is an eye-sore to the community. In addition, riprap, composed mostly of un-engineered cement blocks, has been emplaced on the seaward side of Tioga Road as it turns parallel to shore.

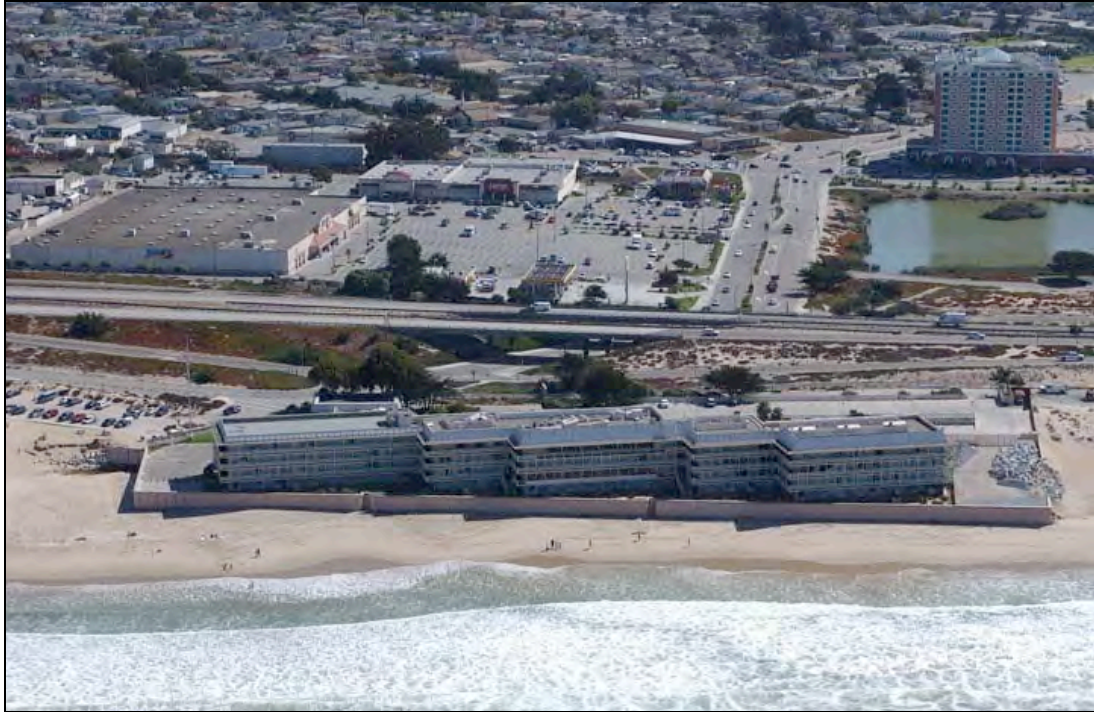
Figure 5.3: Aerial photograph of the seawall and riprap (at the far right end of the seawall) protecting the Best Western Monterey Beach Hotel in Seaside, California. Photograph taken October 2004; copyright © 2002 Kenneth & Gabrielle Adelman (<http://www.californiacoastline.org/>).

In 1968, a 196-room, 4 story hotel was built directly on the beach in Monterey, which included a large, 100-m long seawall along three sides of the building (Griggs et al. in press; Thornton et al. in press) (Figures 5.1, 5.3, 5.4 and 5.5). The wall is composed of 6-foot wide keyed concrete panels that are jettied into place and anchored into shallow concrete mat slabs on which the hotel building itself is founded. Therefore, the stability

Given that this is known to be an eroding coast, it is not surprising that the Monterey Beach Hotel seawall came under attack in the early 1980's. In fact, the extreme waves of the 1982-83 El Niño event undermined the concrete and lead to a loss of fill behind the wall. More recently, storm waves coinciding with high tides during the winter of 2002 broke through the south wall and forced the hotel to place emergency riprap in the gap to prevent further damage (Figure 5.4). Large scour holes formed on the inside of the wall, as water penetrated between the panels. Excessive corrosion has occurred because of this damage. The hotel is becoming a prime example of the "peninsula effect:" while the adjacent coastline is retreating due to natural erosion, the seawall has fixed the coastline and is creating an artificial headland out of the hotel (Figure 5.5). As the hotel becomes further isolated, it will experience more and more damage from wave action. In addition, the fronting beach, which is a major attraction of the hotel, will be lost due to this passive erosion.

The alternative recommended by HKA was to build a new vertical sheet pile wall approximately 2 feet seaward of the existing perimeter wall. The wall would be longer than the current structure and would incorporate corrosion prevention measures. In addition, it was recommended that the wall be colored and textured to mimic surrounding natural conditions.

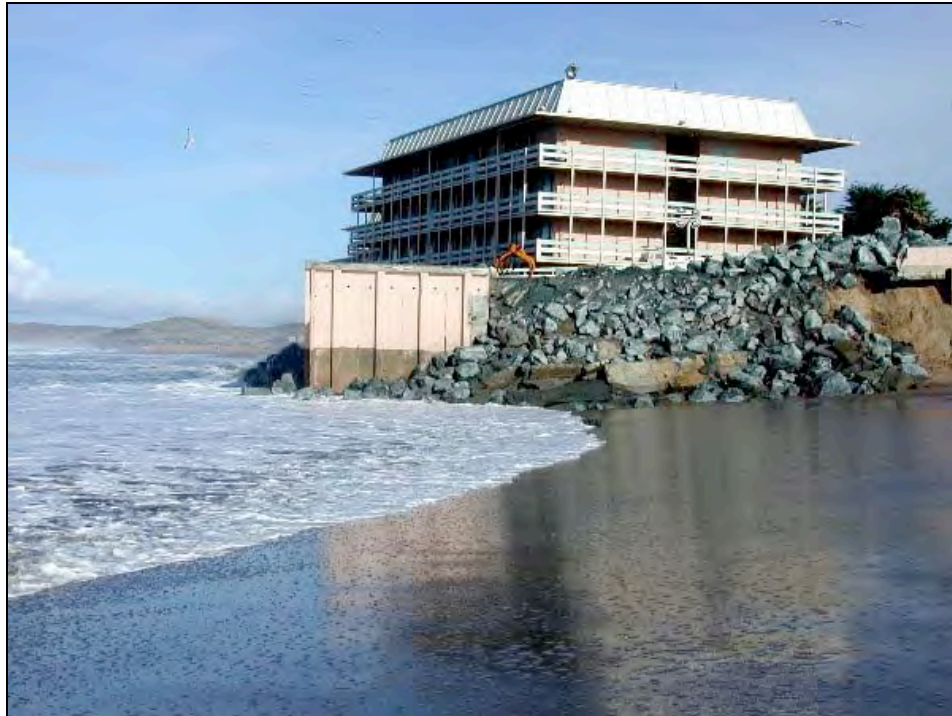
Figure 5.4: Wave run-up against the Monterey Beach Hotel seawall and riprap during the winter of 2002. Lateral access is cut off because of this coastal armoring. Photo: Doug Smith, CSUMB.

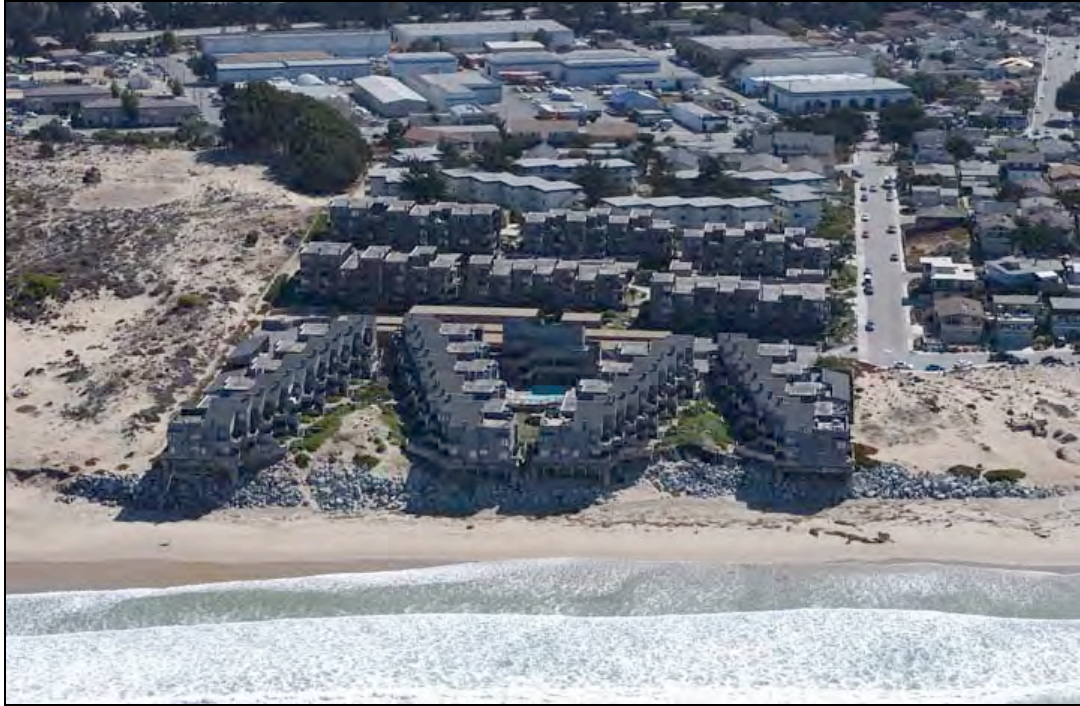
Figure 5.6: Aerial photograph of extensive riprap in front of the Ocean Harbor House Condominiums in Monterey, California. Photograph taken October 2004; copyright © 2002 Kenneth & Gabrielle Adelman (<http://www.californiacoastline.org/>).

time, Ocean Harbor House was converted to condominiums, increasing the number of stake-holders from 1 to 172. Coastal retreat continued and, despite the reinforcements, additional riprap was needed to protect the front condominium units after the 1997-98 El Niño winter (Griggs et al. in press). The riprap is once again on city property and impacts the habitat and beach users in a variety of ways. In addition, the riprap emplaced in the late 1990's appears to be failing, as rocks settle into the sand and disperse (Figure 5.6 and 5.7).

The 172 owners of Ocean Harbor House have proposed removing the riprap and building a concrete seawall to protect their property from wave attack. This plan was approved by the California Coastal Commission, with substantial mitigation fees. The MBNMS has sent official letters of comment regarding the construction of a seawall in this region, requesting serious evaluation of other alternatives, such as planned retreat of the front units.

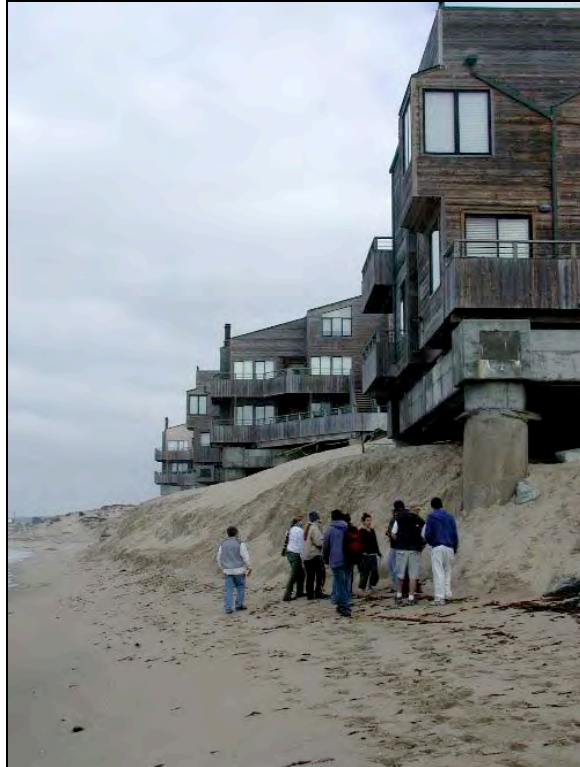
Figure 5.7: Exposed pilings at the Ocean Harbor House condominiums in Monterey. Photo: Doug Smith, CSUMB.

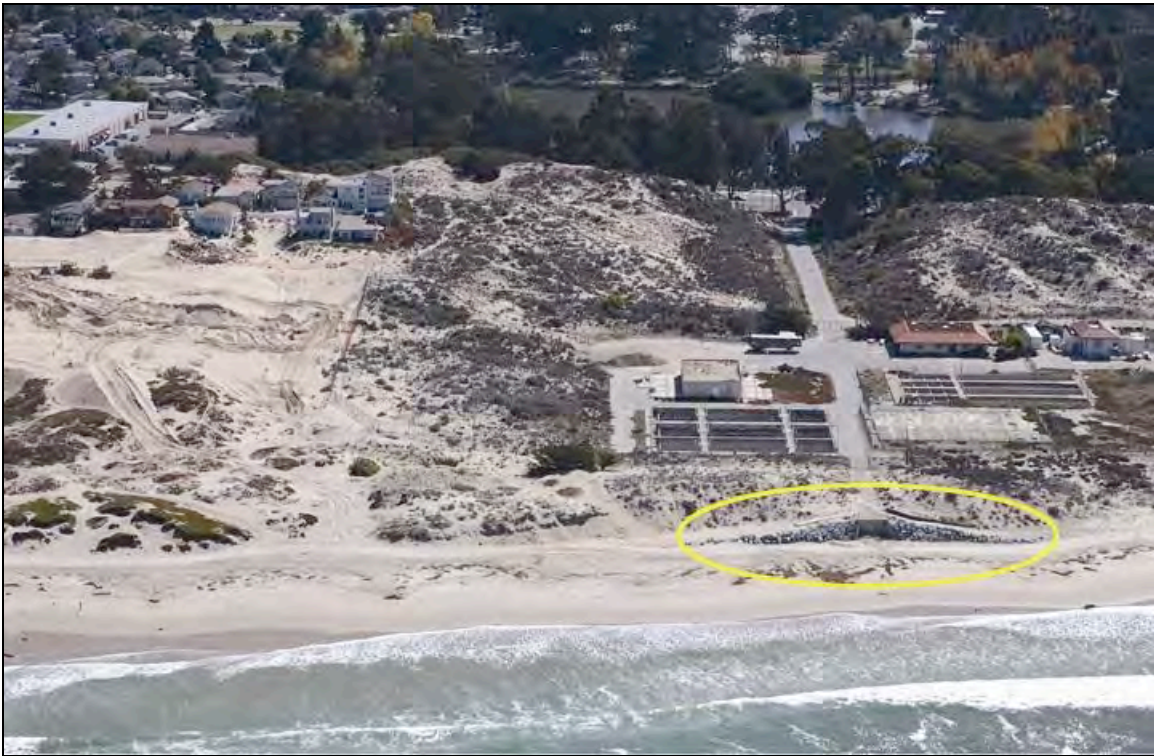
Figure 5.8: Aerial photograph of riprap on either side of a storm drain for the Naval Postgraduate School in Monterey, California. Photograph taken October 2004; copyright © 2002 Kenneth & Gabrielle Adelman (<http://www.californiacoastline.org/>).

A storm drain on the Naval Postgraduate School (NPS) grounds in Monterey has required emplacement of approximately 50 m of riprap to prevent wave damage (Figures 5.1 and 5.8). There is very little documentation on the history or future of this structure.
