FIGURES

Appendix A Figure 1: Plots of nitrate, orthophosphate and *E. coli* at sites that exceeded WQOs for three or more water quality parameters for at least 5 years.

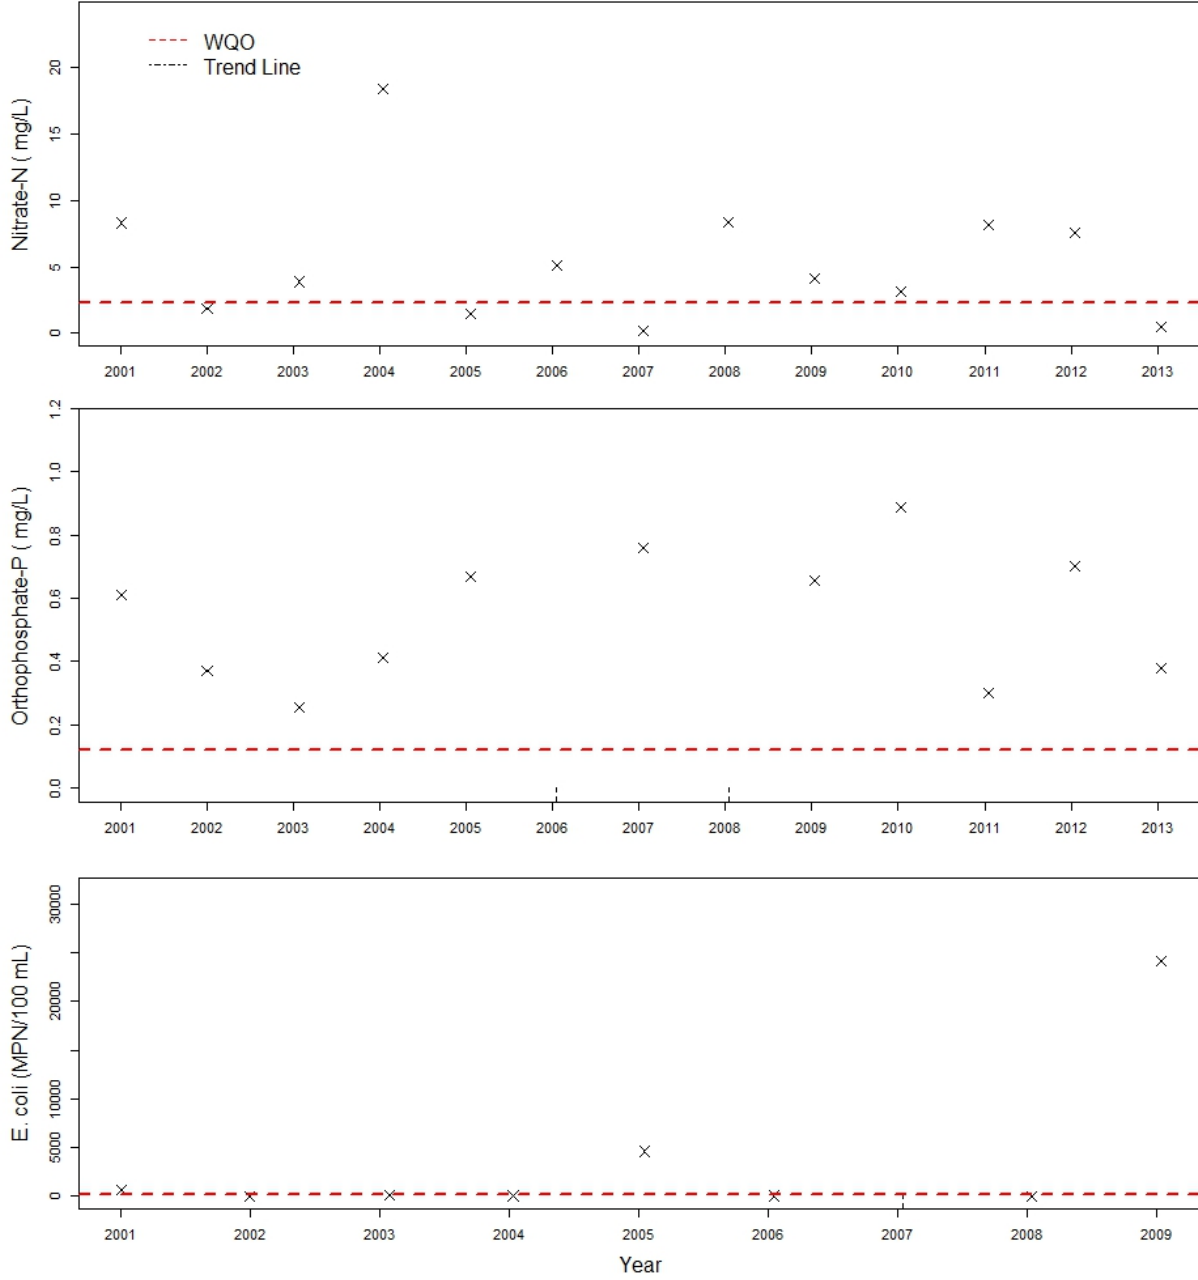
305-WATSO-22

Appendix A Figure 1 (cont'd): Plots of nitrate, orthophosphate and *E. coli* at sites that exceeded WQOs for three or more water quality parameters for at least 5 years.

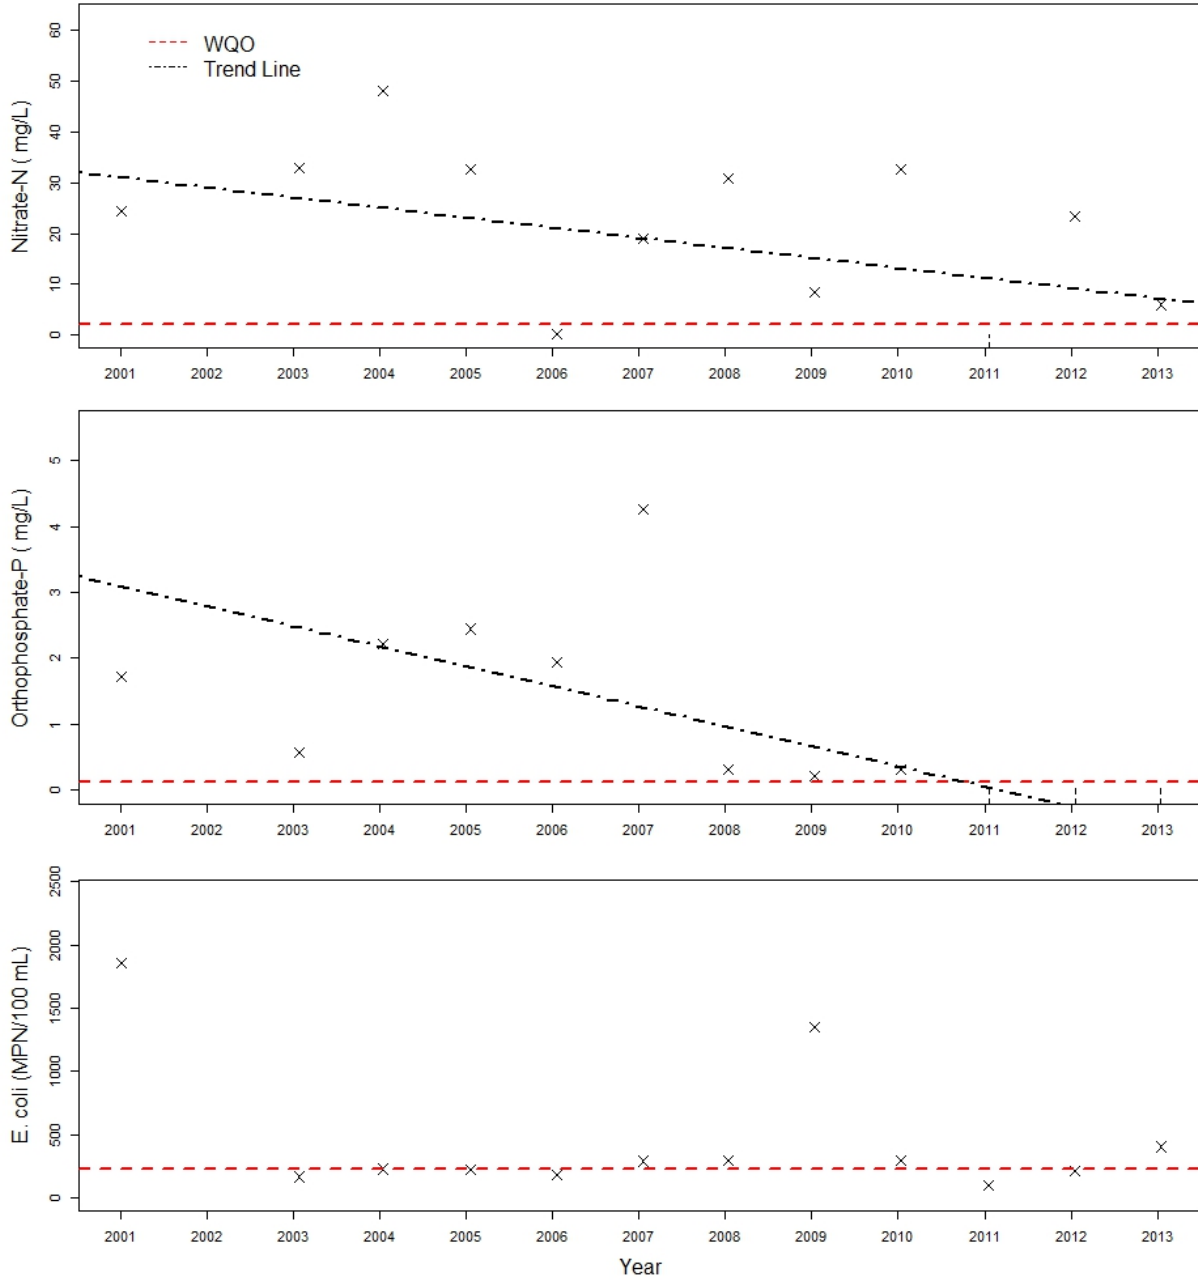
306-ELKHO-34

Appendix A Figure 1 (cont'd): Plots of nitrate, orthophosphate and *E. coli* at sites that exceeded WQOs for three or more water quality parameters for at least 5 years.

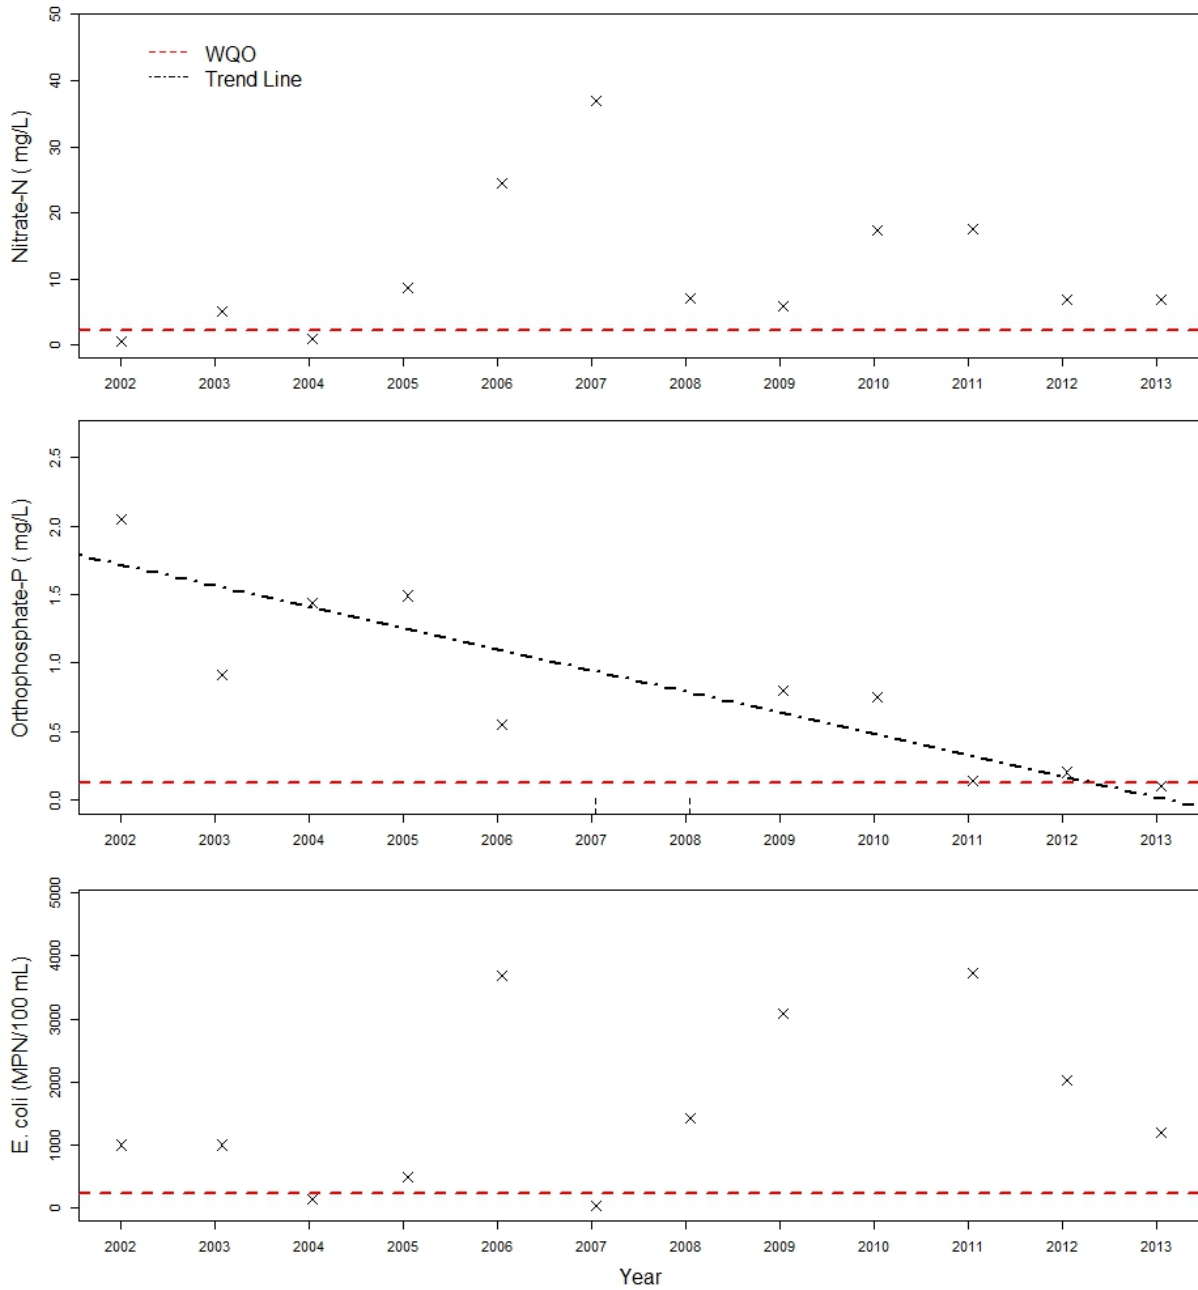
306-MOROC-31

Appendix A Figure 1 (cont'd): Plots of nitrate, orthophosphate and *E. coli* at sites that exceeded WQOs for three or more water quality parameters for at least 5 years.

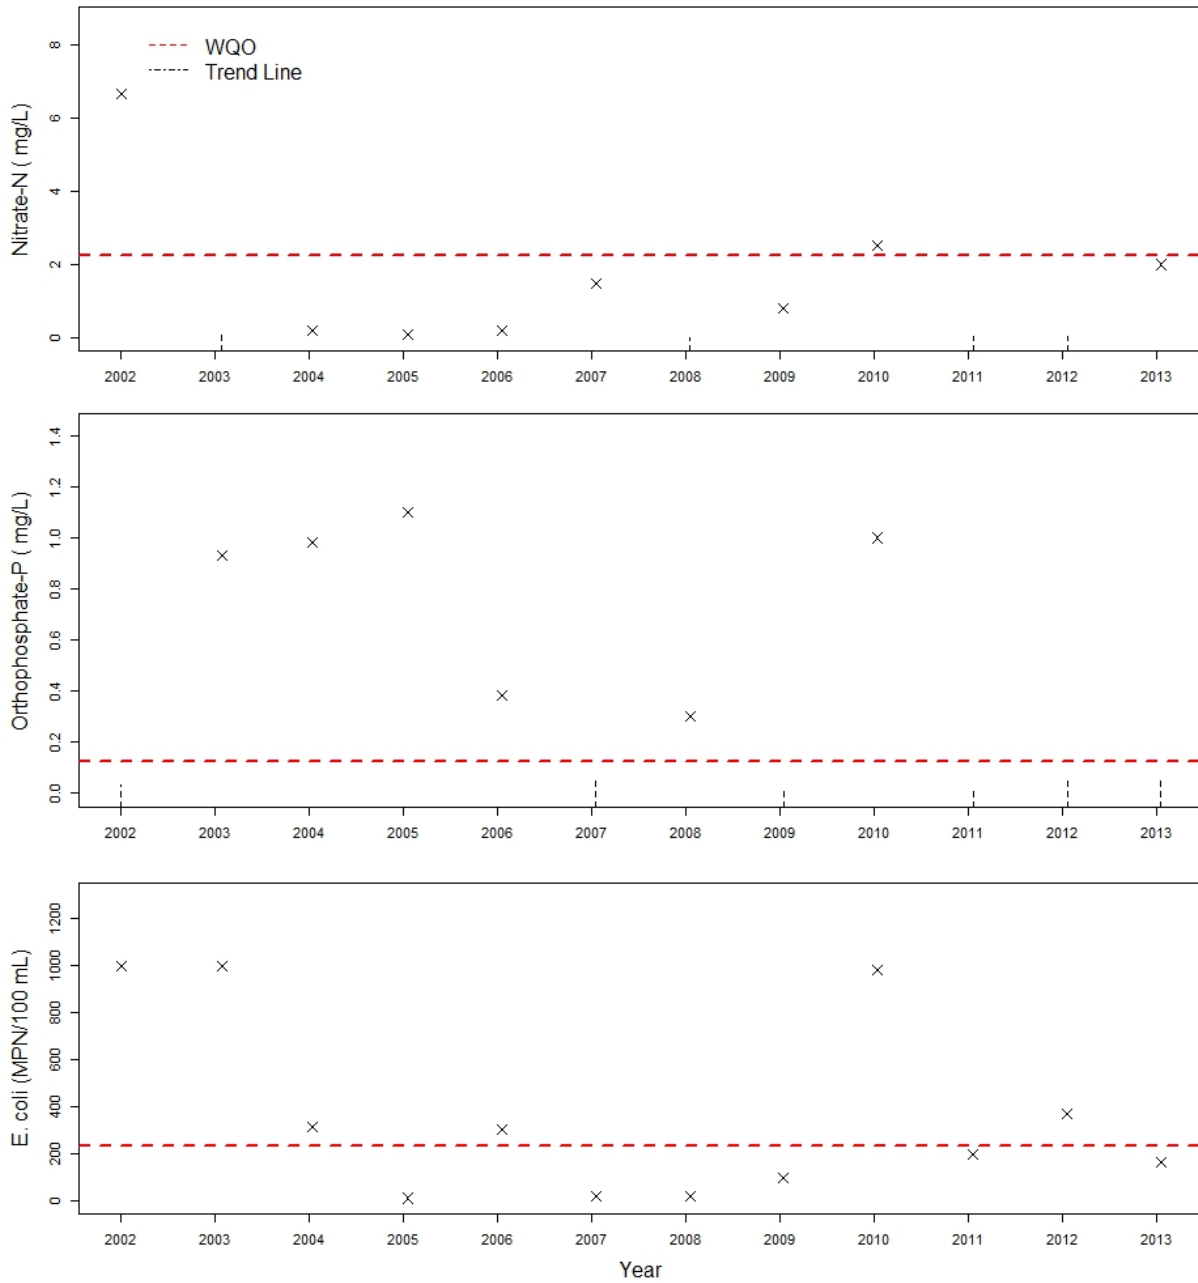
306-MOROC-32

Appendix A Figure 1 (cont'd): Plots of nitrate, orthophosphate and *E. coli* at sites that exceeded WQOs for three or more water quality parameters for at least 5 years.

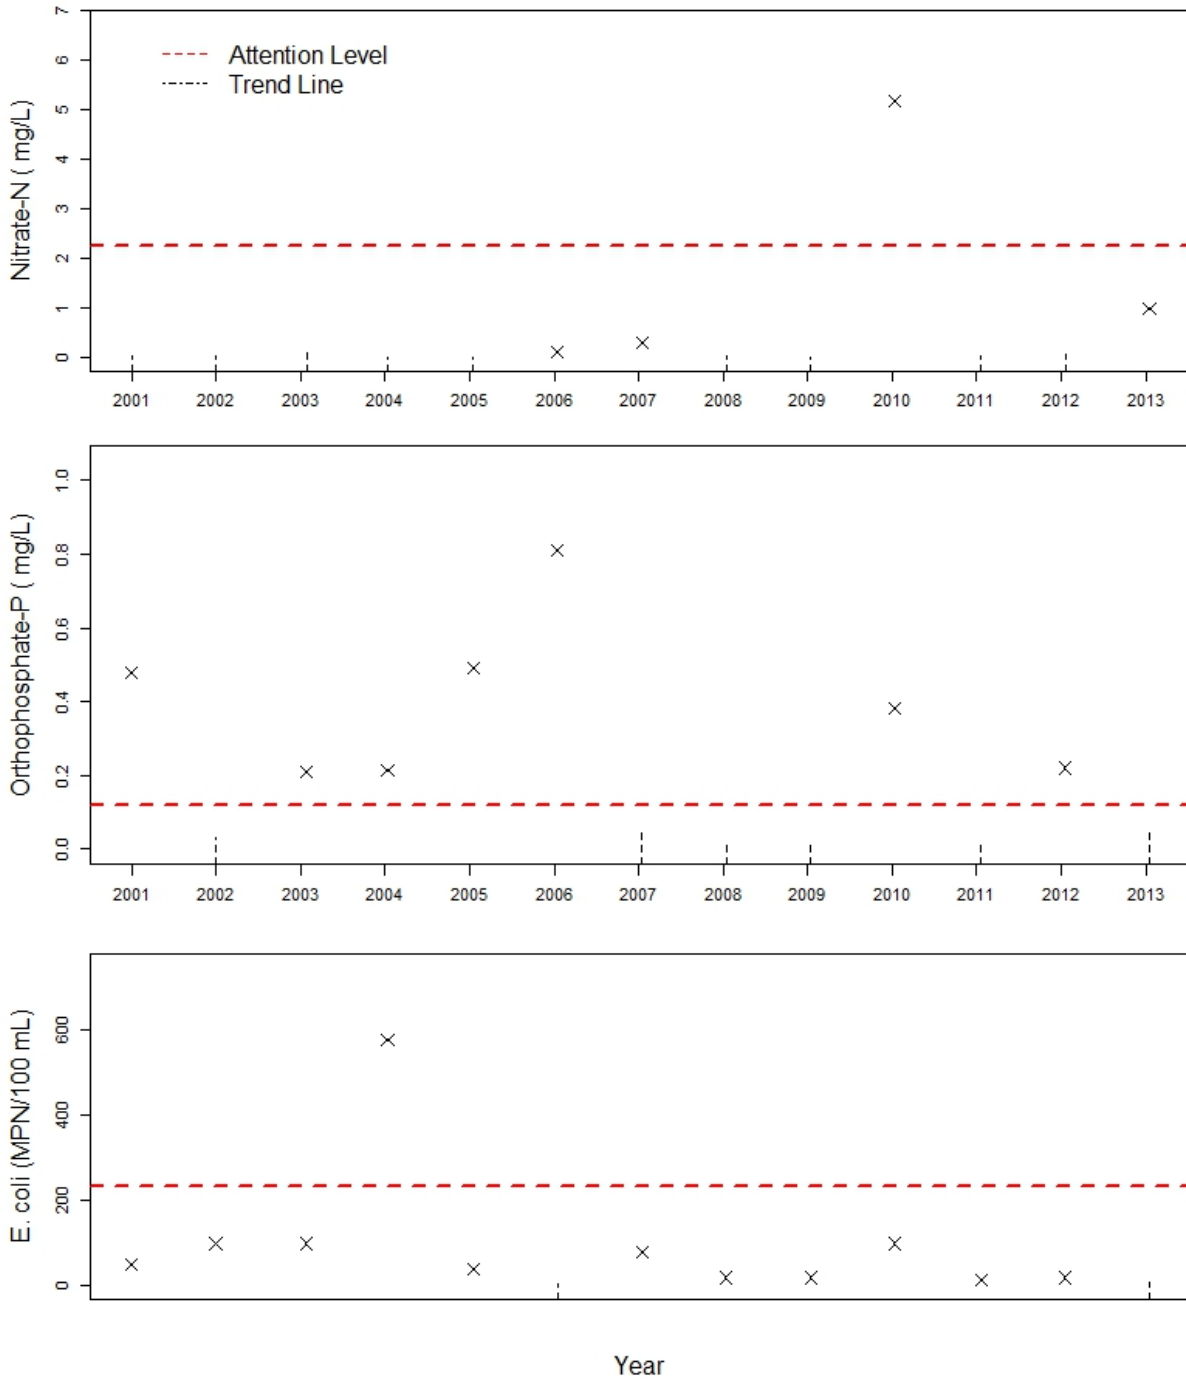
306-MOROC-33

Appendix A Figure 1 (cont'd): Plots of nitrate, orthophosphate and *E. coli* at sites that exceeded WQOs for three or more water quality parameters for at least 5 years.

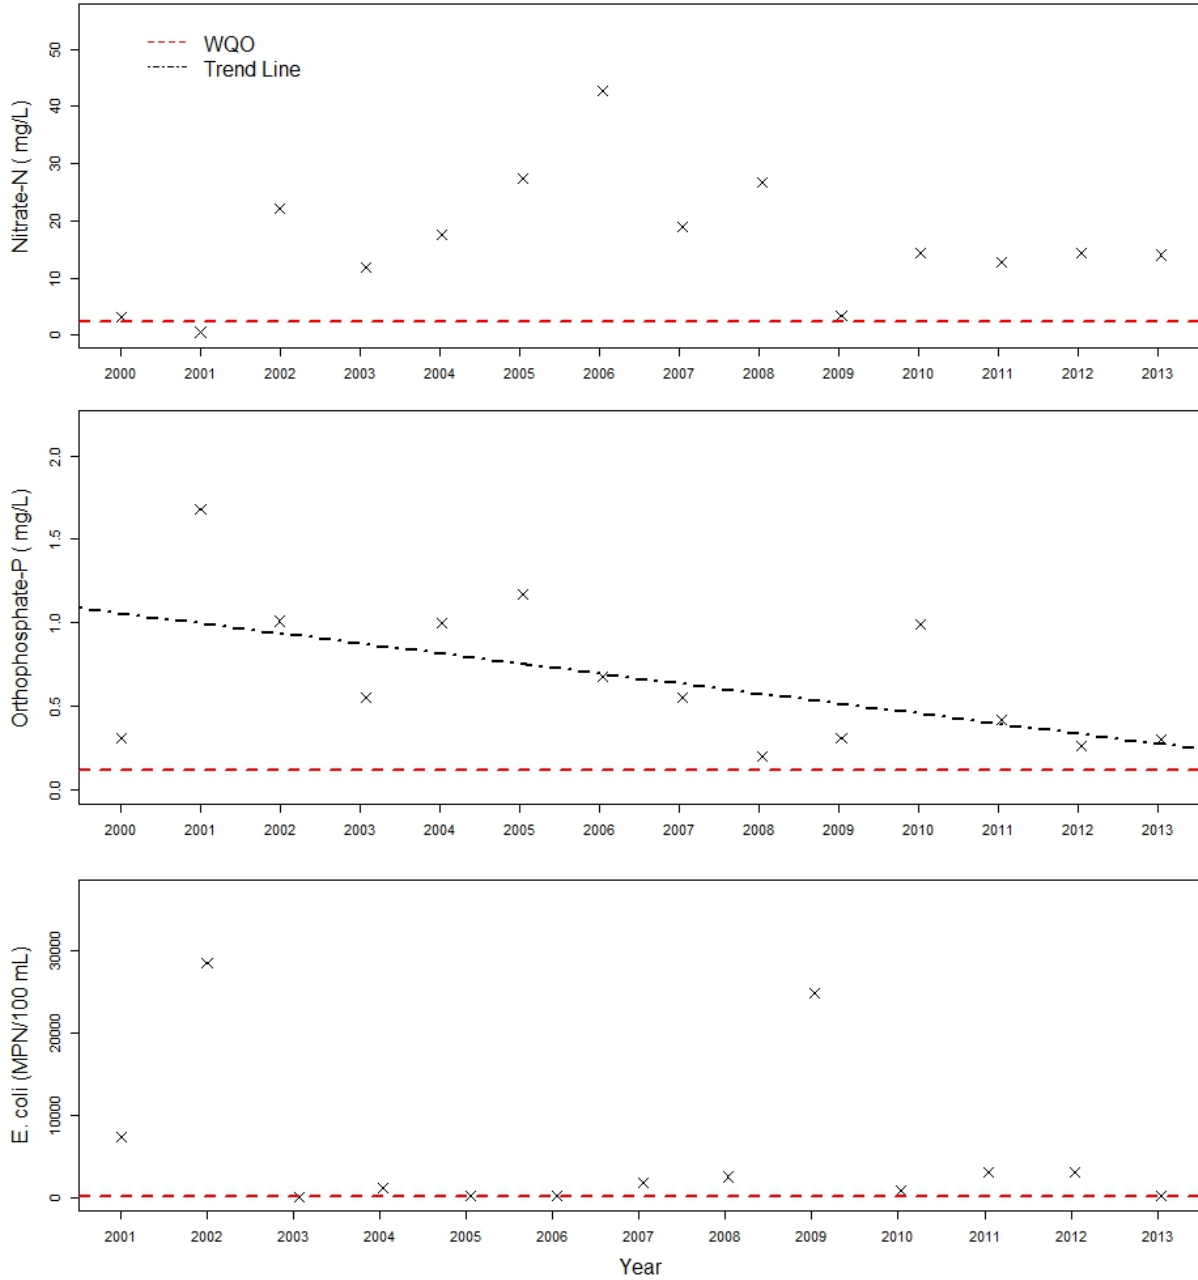
309-ALISA-32

Appendix A Figure 1 (cont'd): Plots of nitrate, orthophosphate and *E. coli* at sites that exceeded WQOs for three or more water quality parameters for at least 5 years.

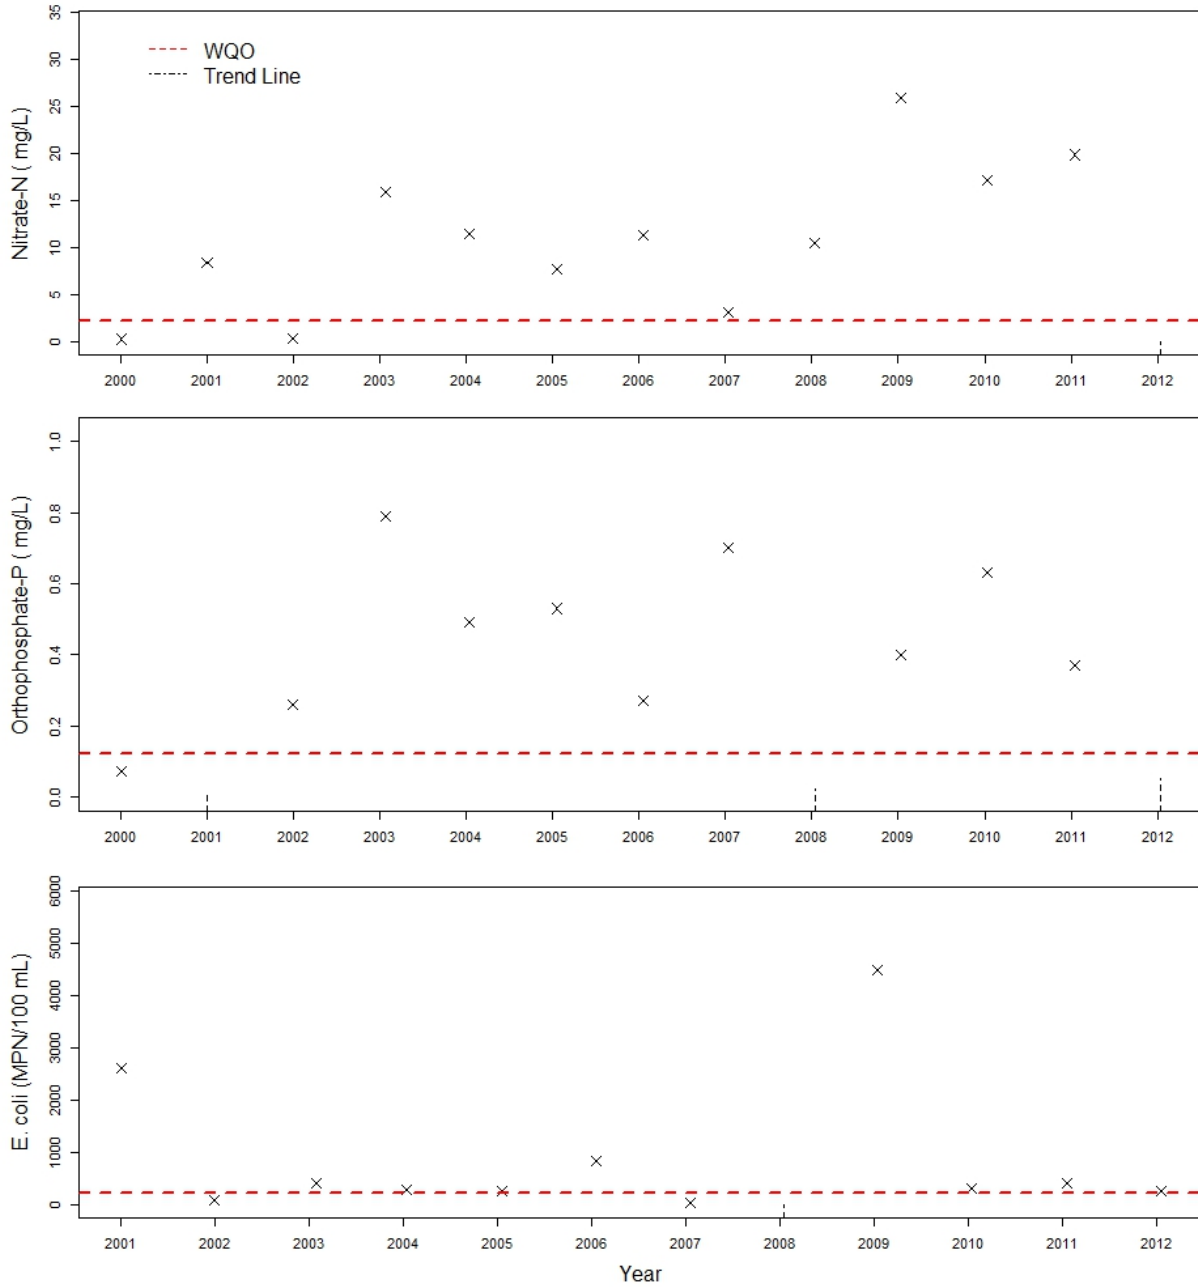
309-NATIV-31

Appendix A Figure 1 (cont'd): Plots of nitrate, orthophosphate and *E. coli* at sites that exceeded WQOs for three or more water quality parameters for at least 5 years.

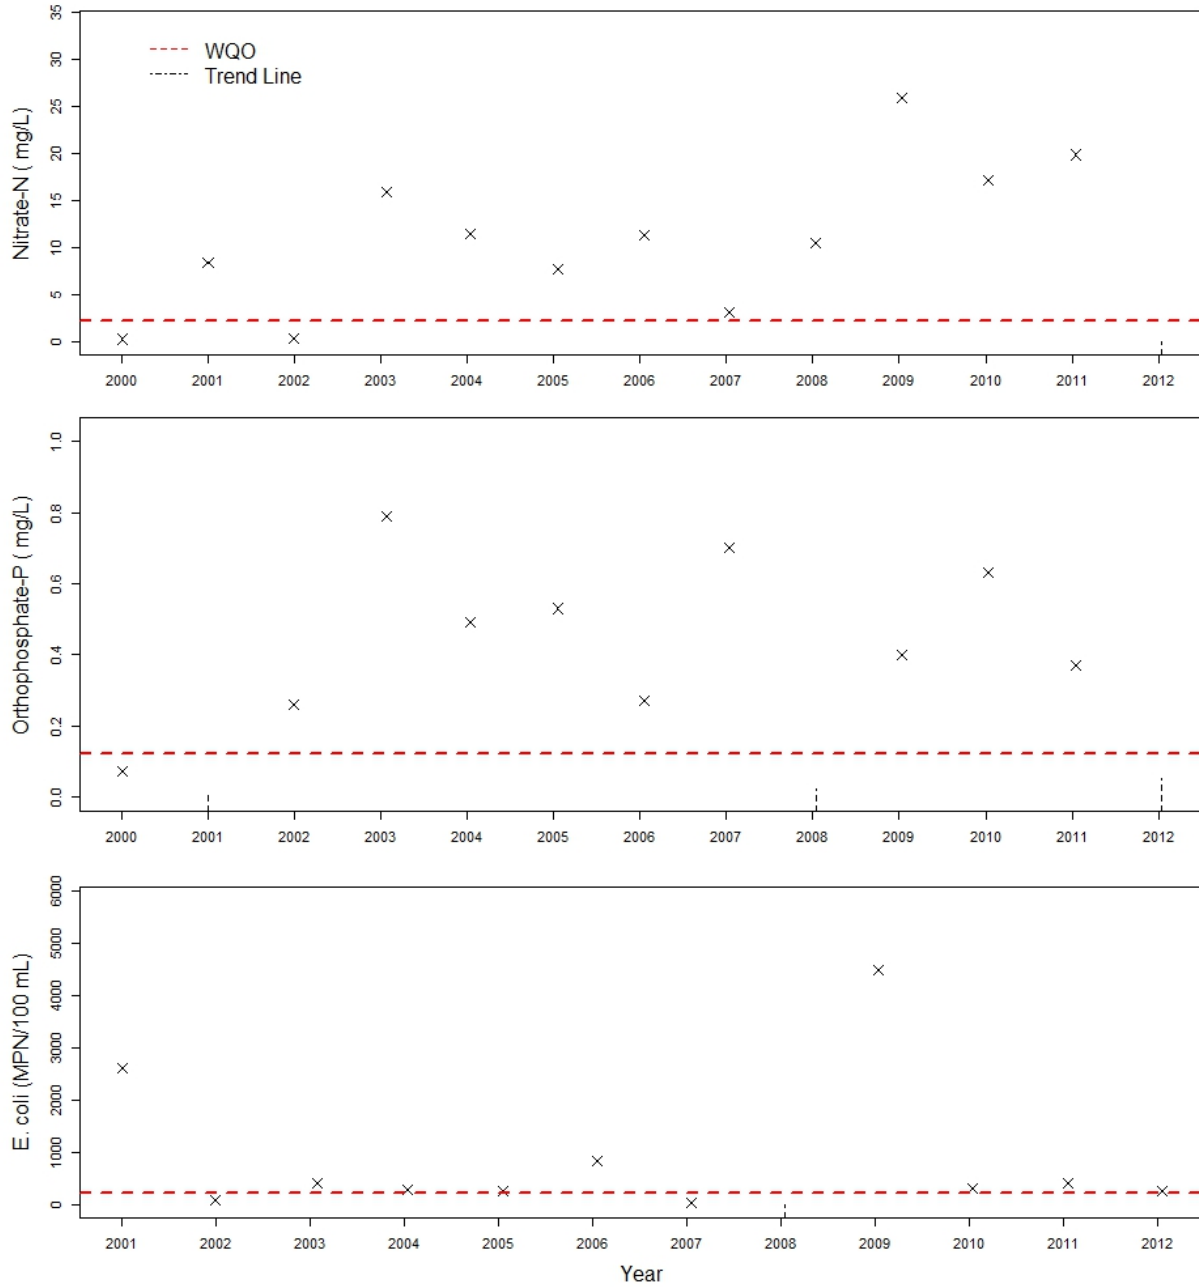
309-NATIV-31

Appendix A Figure 1 (cont'd): Plots of nitrate, orthophosphate and *E. coli* at sites that exceeded WQOs for three or more water quality parameters for at least 5 years.

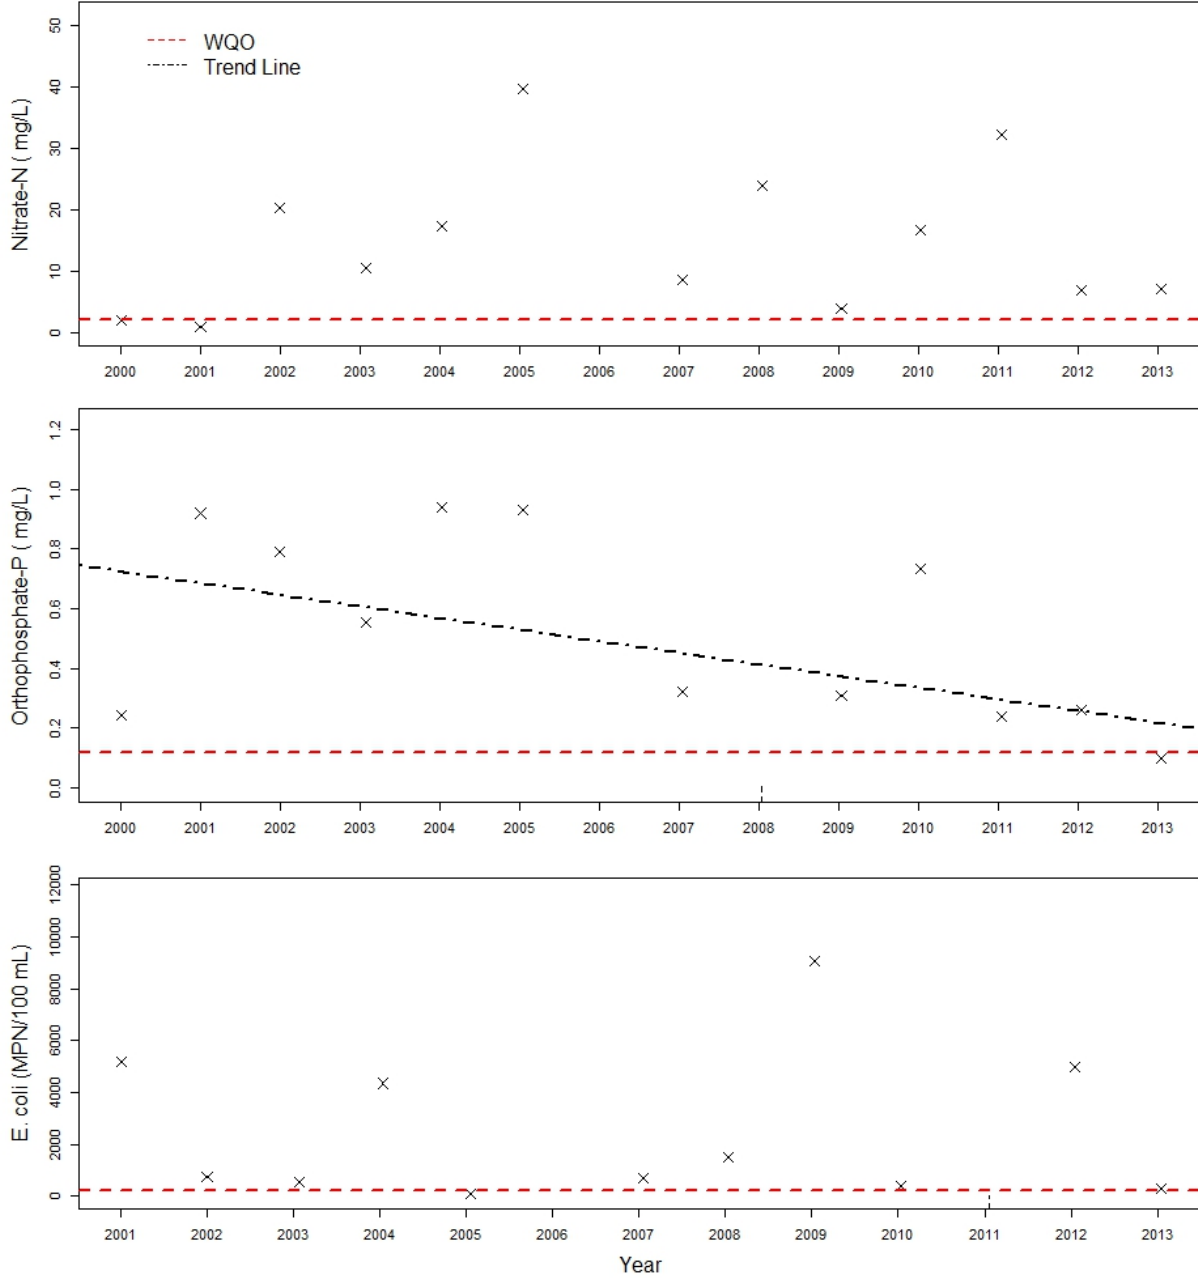
309-RECDI-31

Appendix A Figure 1 (cont'd): Plots of nitrate, orthophosphate and *E. coli* at sites that exceeded WQOs for three or more water quality parameters for at least 5 years.

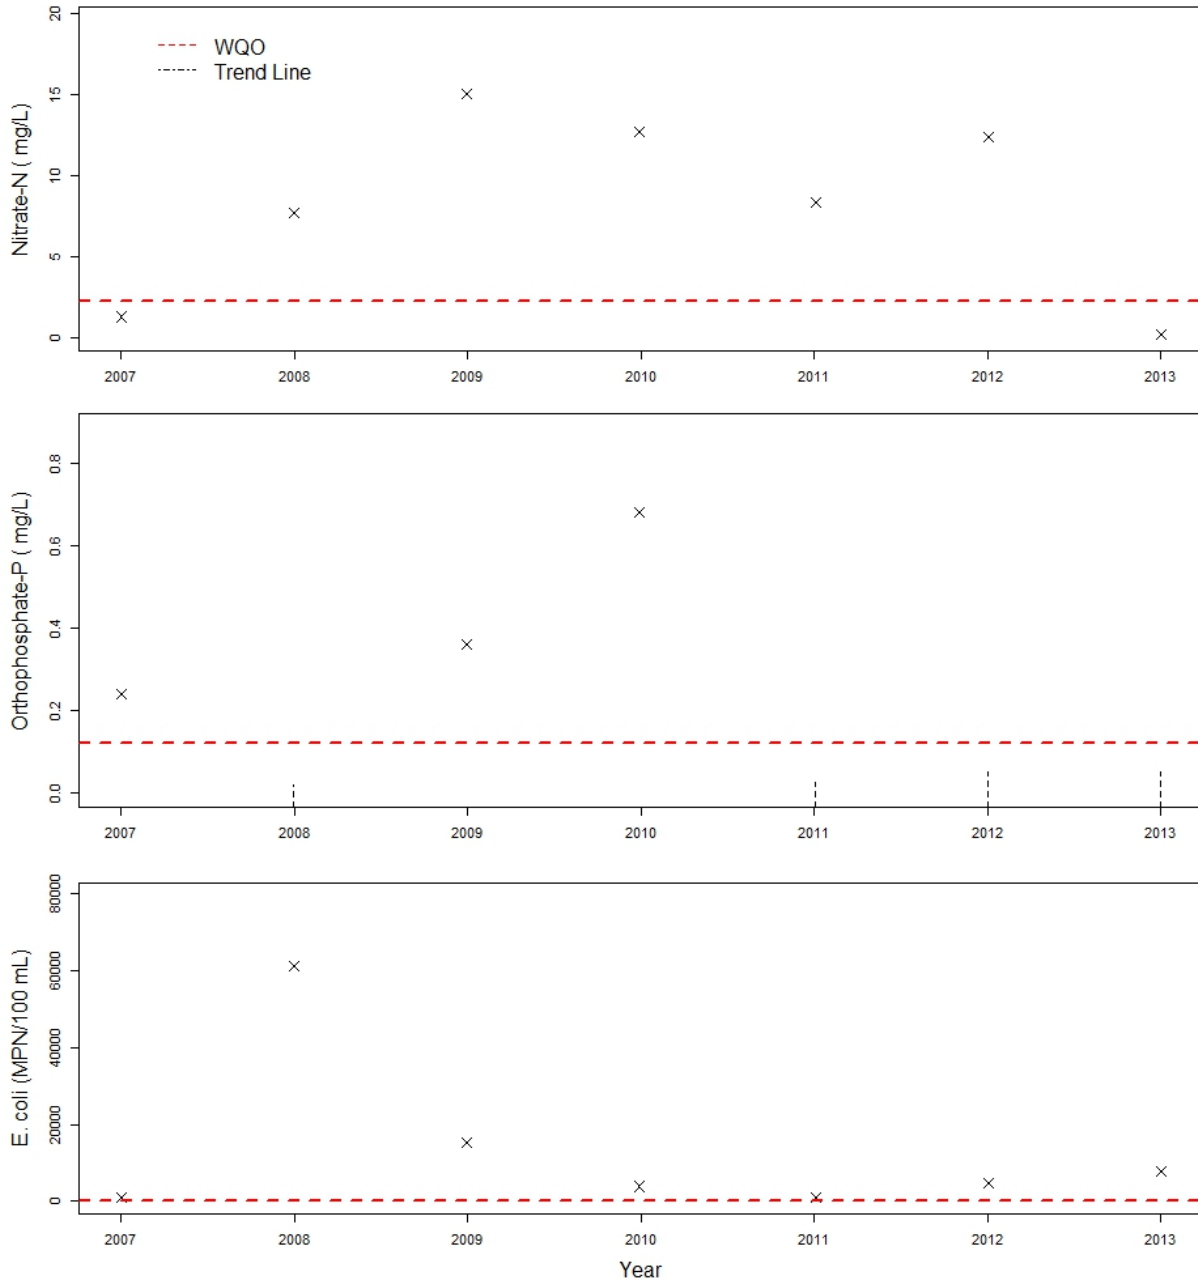
309-SRITA-32

Appendix A Figure 1 (cont'd): Plots of nitrate, orthophosphate and *E. coli* at sites that exceeded WQOs for three or more water quality parameters for at least 5 years.

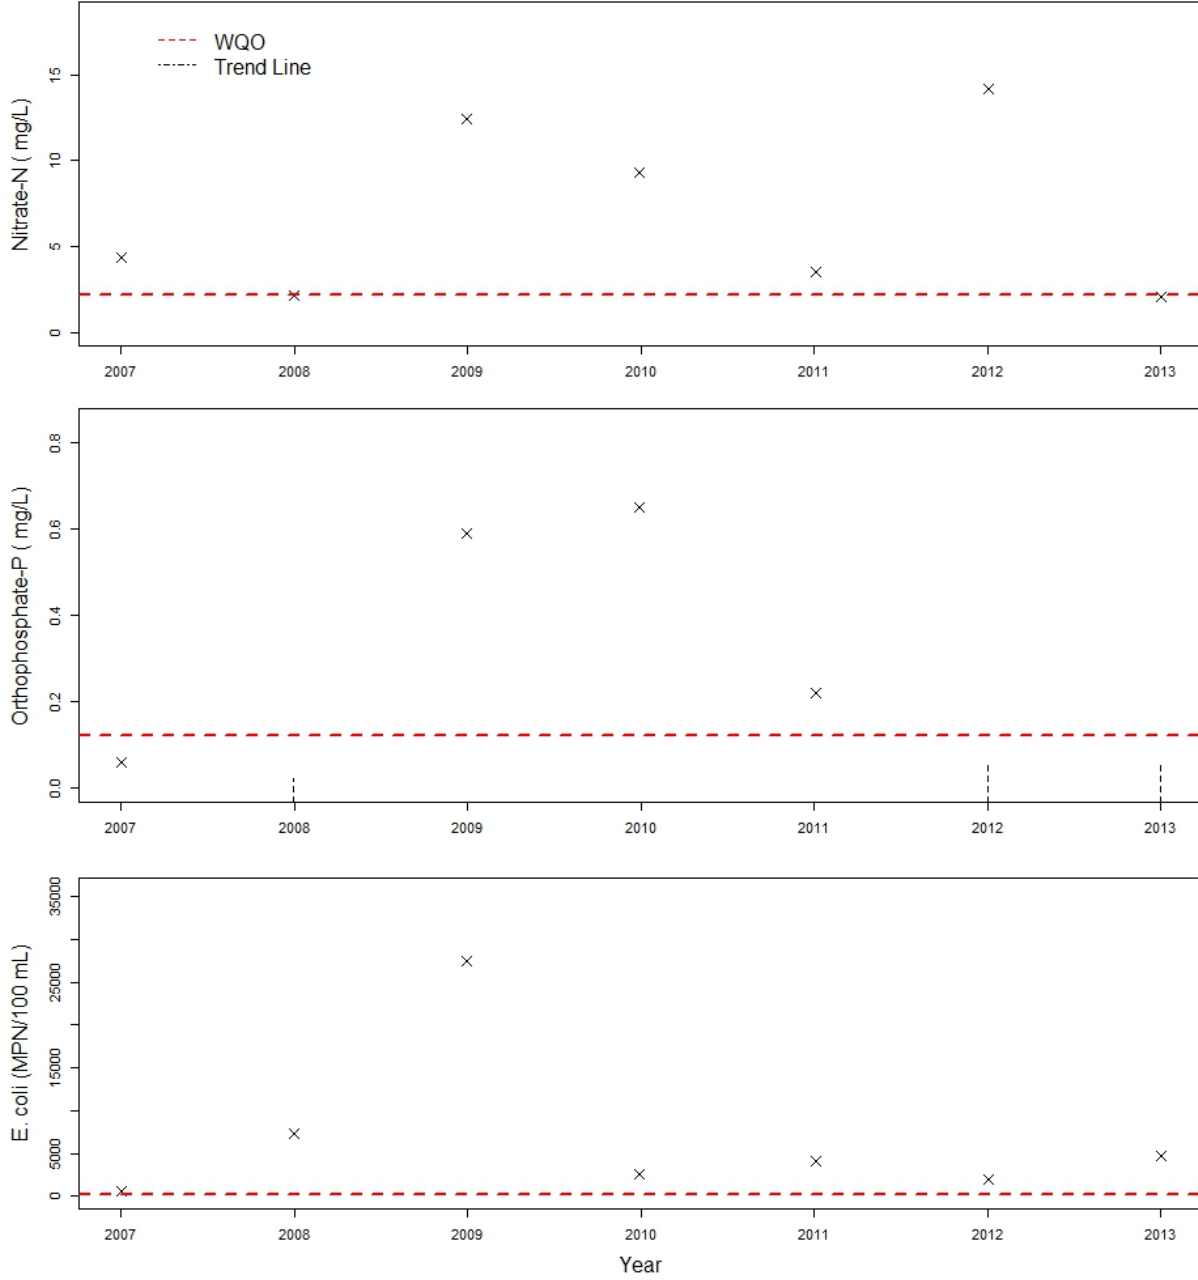
309-SRITA-34

Appendix A Figure 1 (cont'd): Plots of nitrate, orthophosphate and *E. coli* at sites that exceeded WQOs for three or more water quality parameters for at least 5 years.

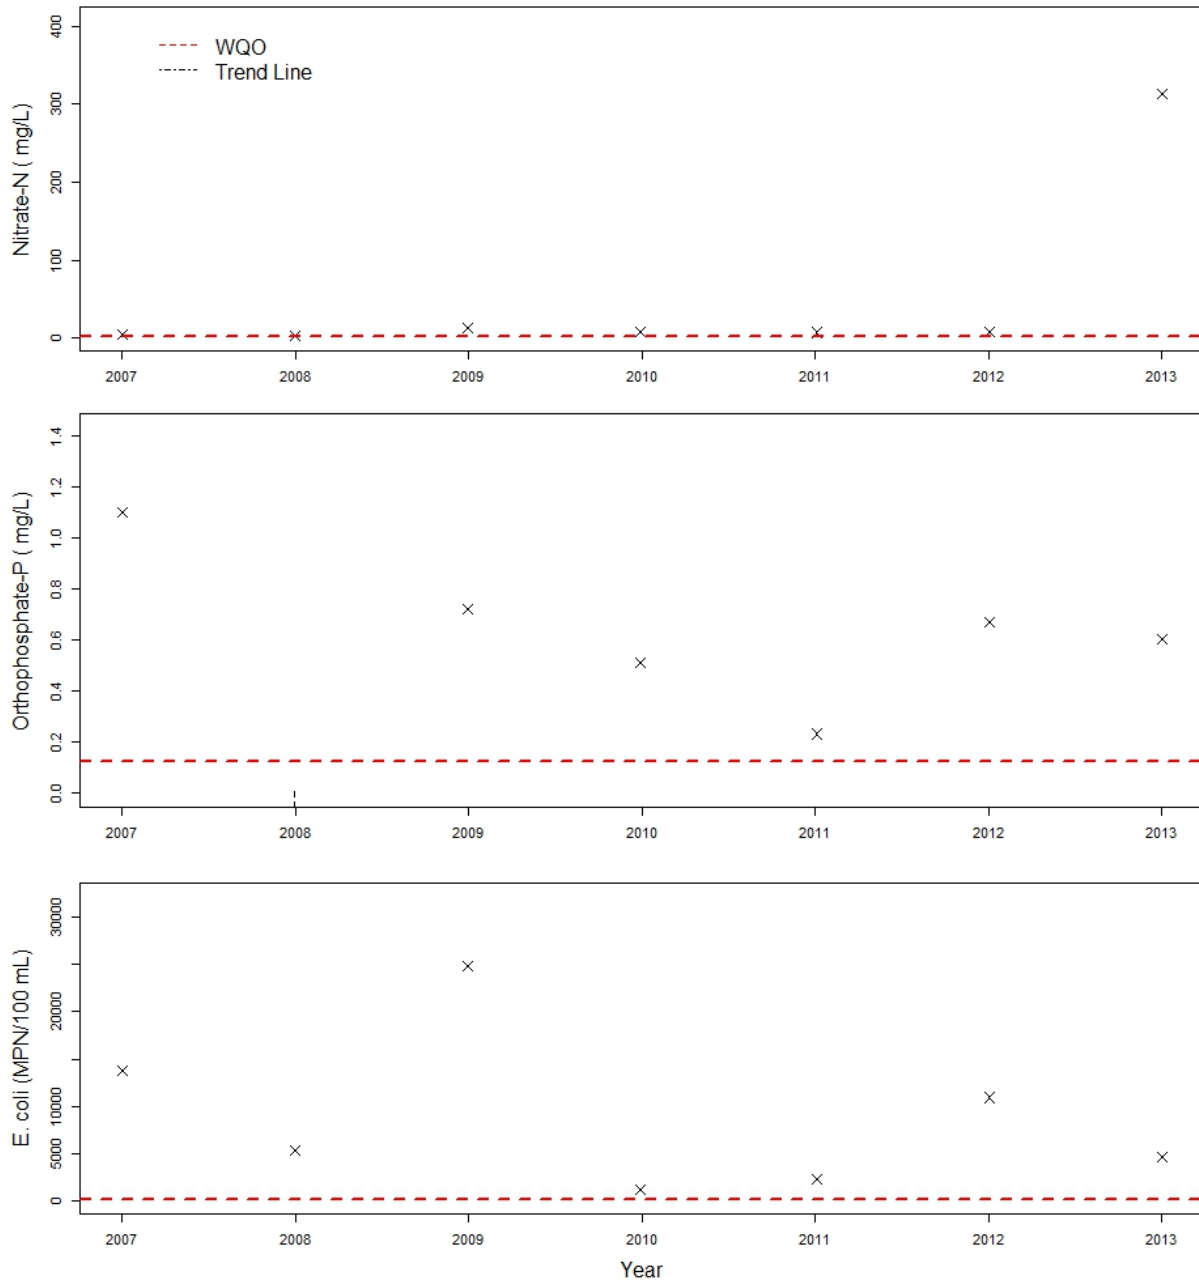
309-SRITA-35

Appendix A Figure 1 (cont'd): Plots of nitrate, orthophosphate and *E. coli* at sites that exceeded WQOs for three or more water quality parameters for at least 5 years.

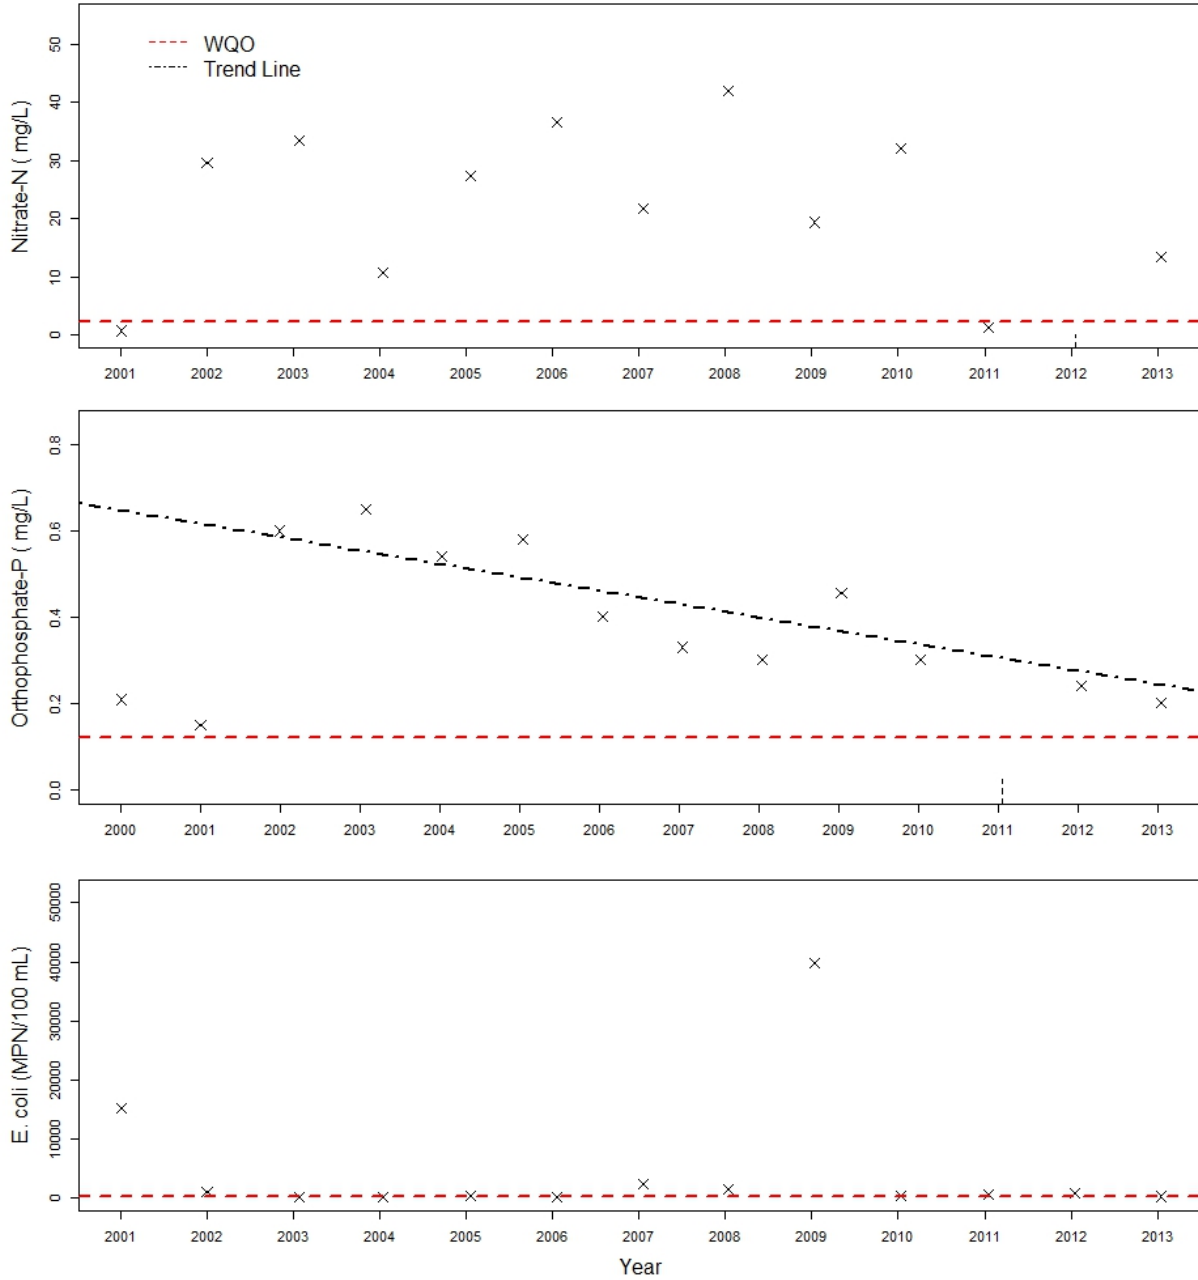
309-TEMBL-31

Appendix A Figure 1 (cont'd): Plots of nitrate, orthophosphate and *E. coli* at sites that exceeded WQOs for three or more water quality parameters for at least 5 years.

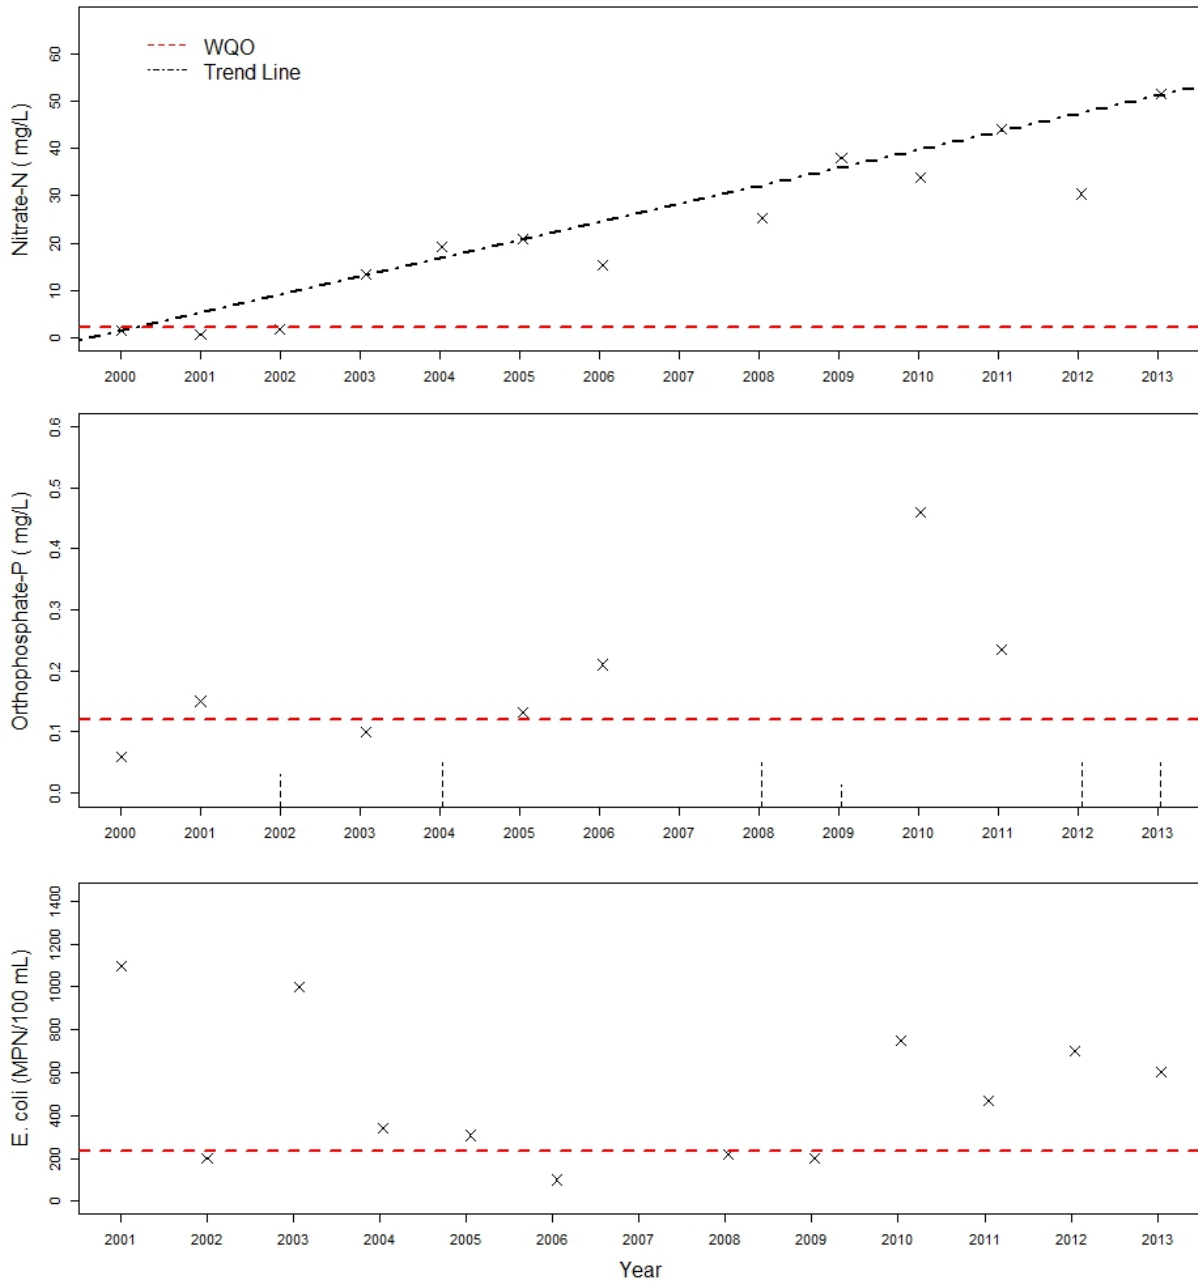
309-TEMBL-32

Appendix A Figure 1 (cont'd): Plots of nitrate, orthophosphate and *E. coli* at sites that exceeded WQOs for three or more water quality parameters for at least 5 years.
