FIGURES

Appendix A Figure 1: Plots of nitrate, orthophosphate and *E. coli* at sites that exceeded WQOs for three or more water quality parameters for at least 5 years.

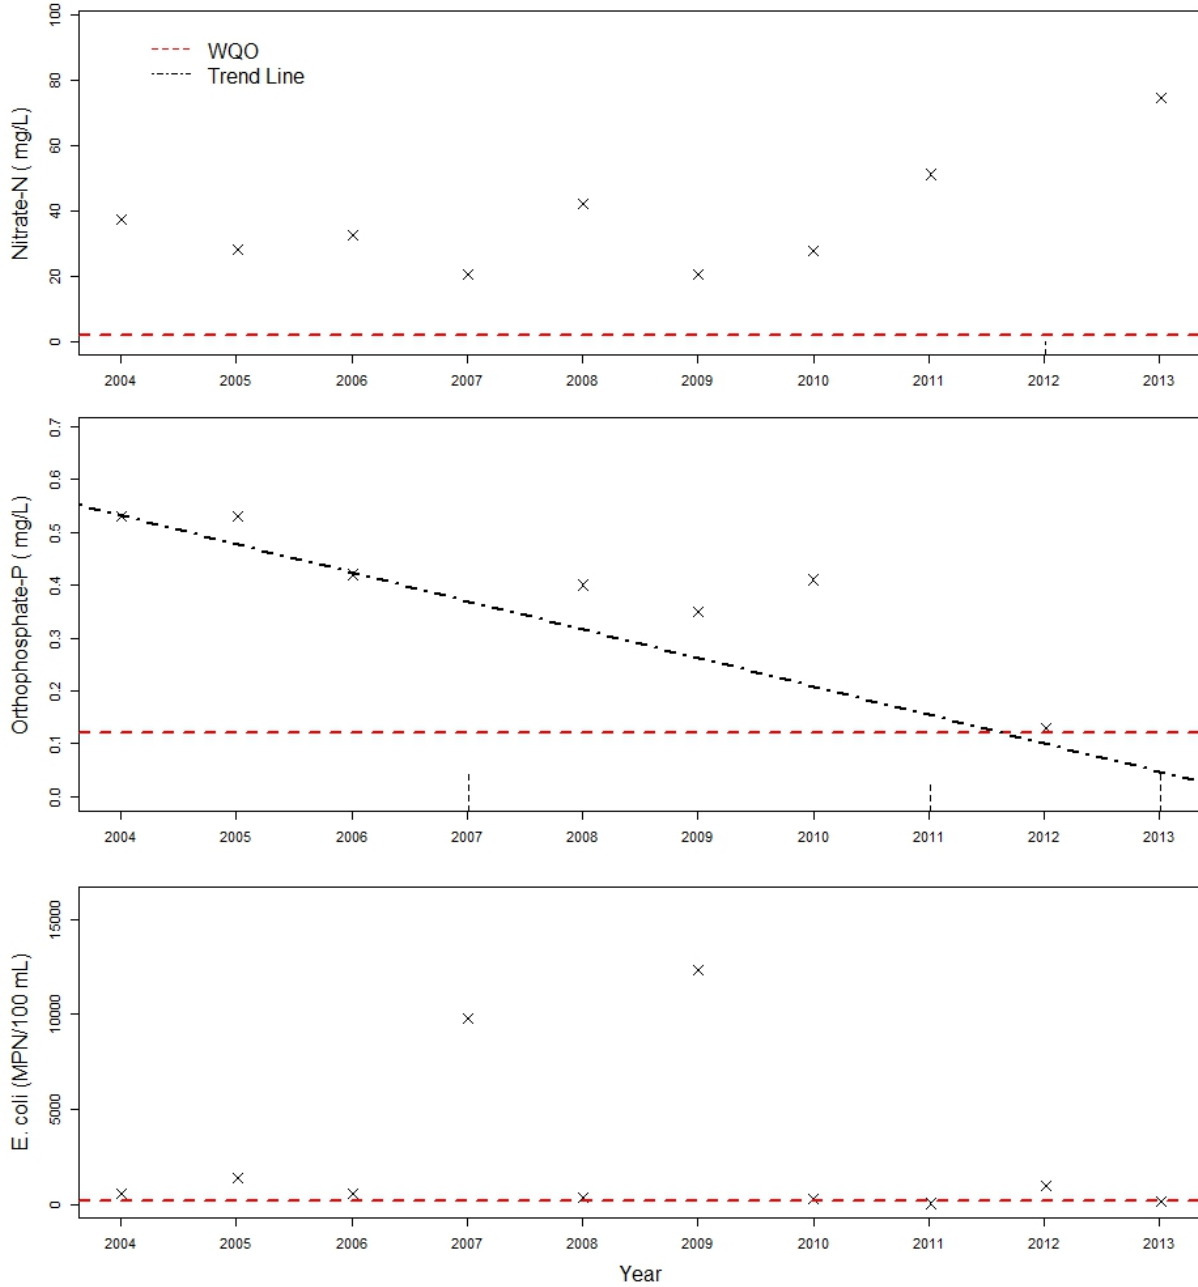
309-TEMBL-33

Appendix A Figure 1 (cont'd): Plots of nitrate, orthophosphate and *E. coli* at sites that exceeded WQOs for three or more water quality parameters for at least 5 years.

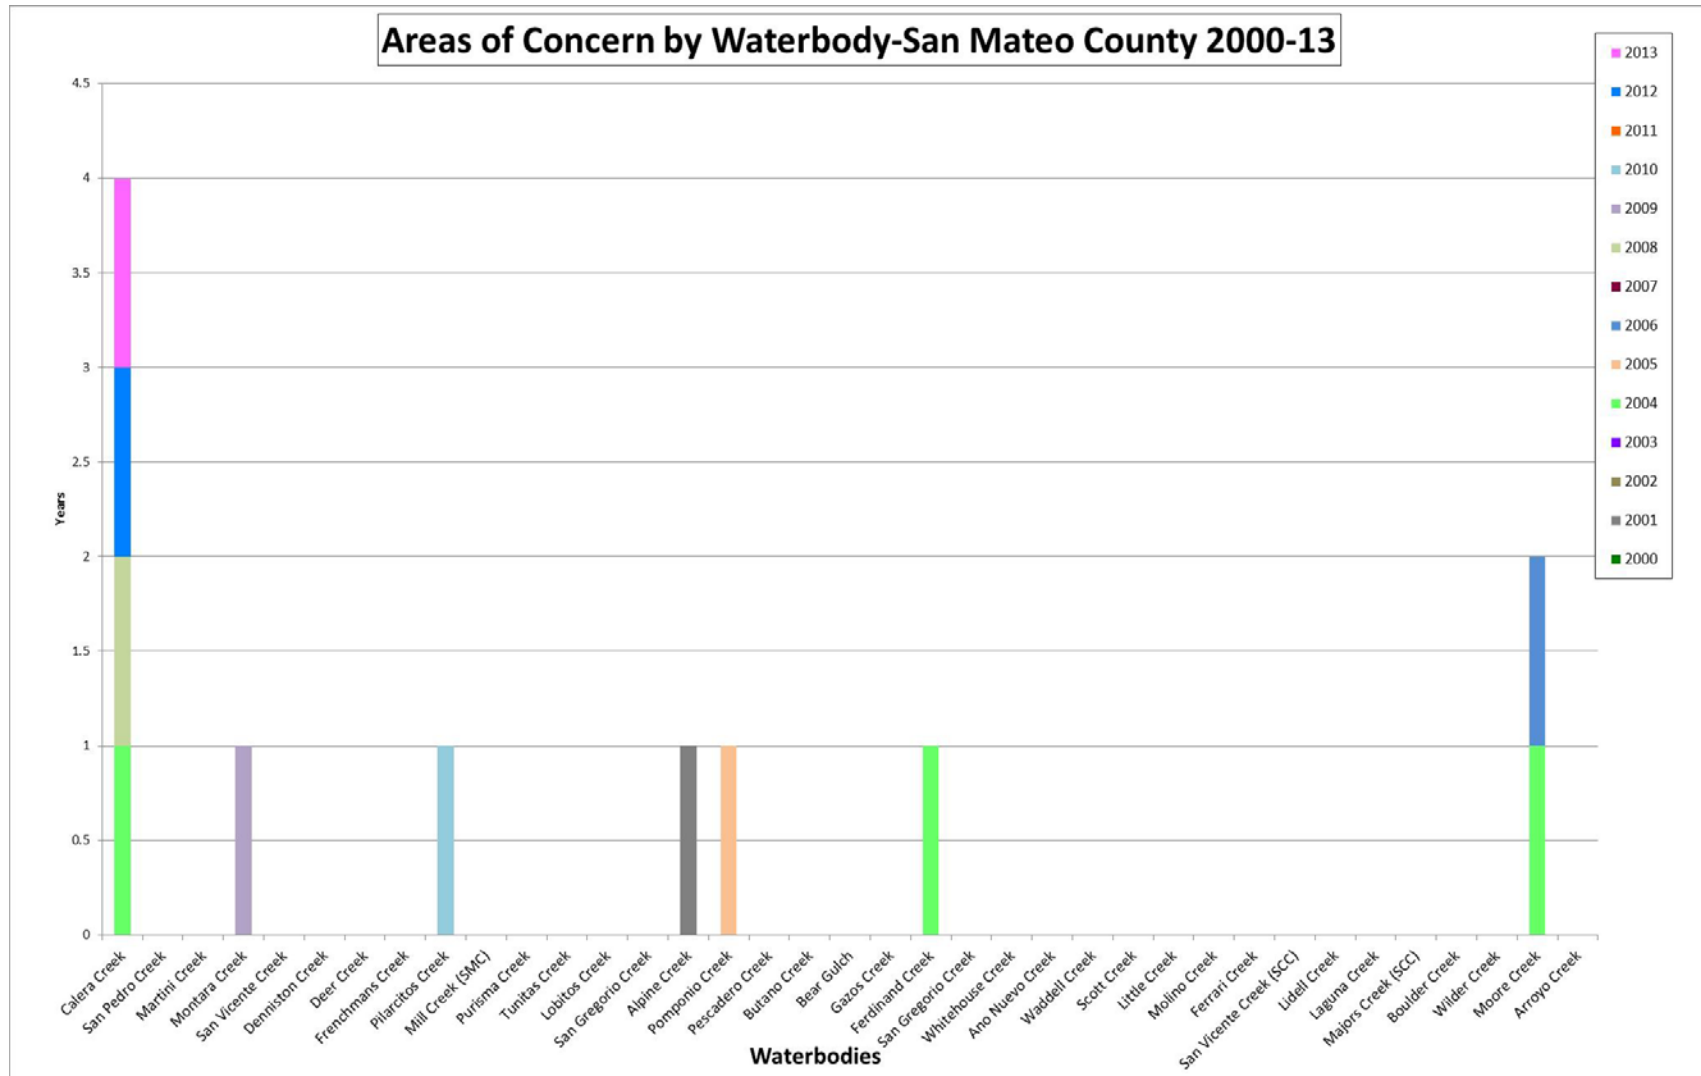
Appendix A Figure 2: Areas of Concern by waterbody for counties.

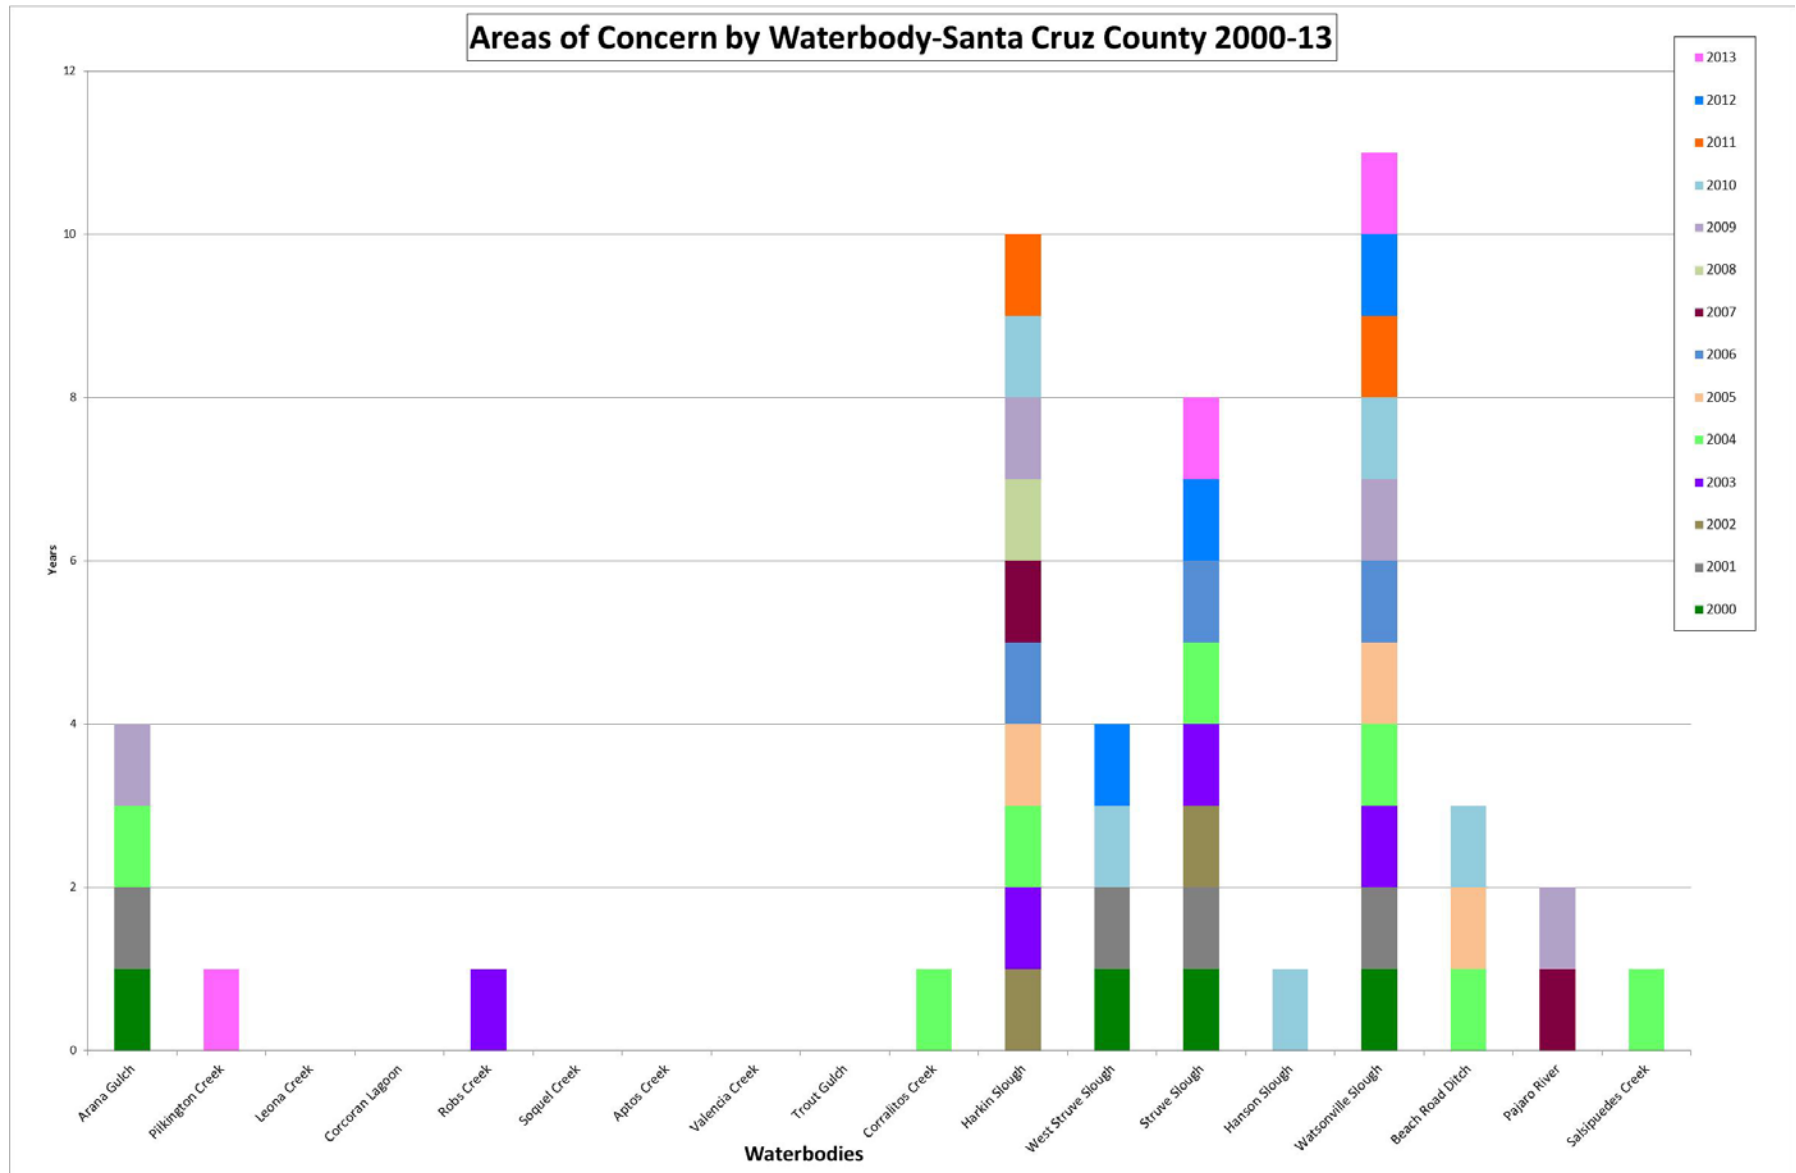
Appendix A Figure 2 (cont'd): Areas of Concern by waterbody for counties.

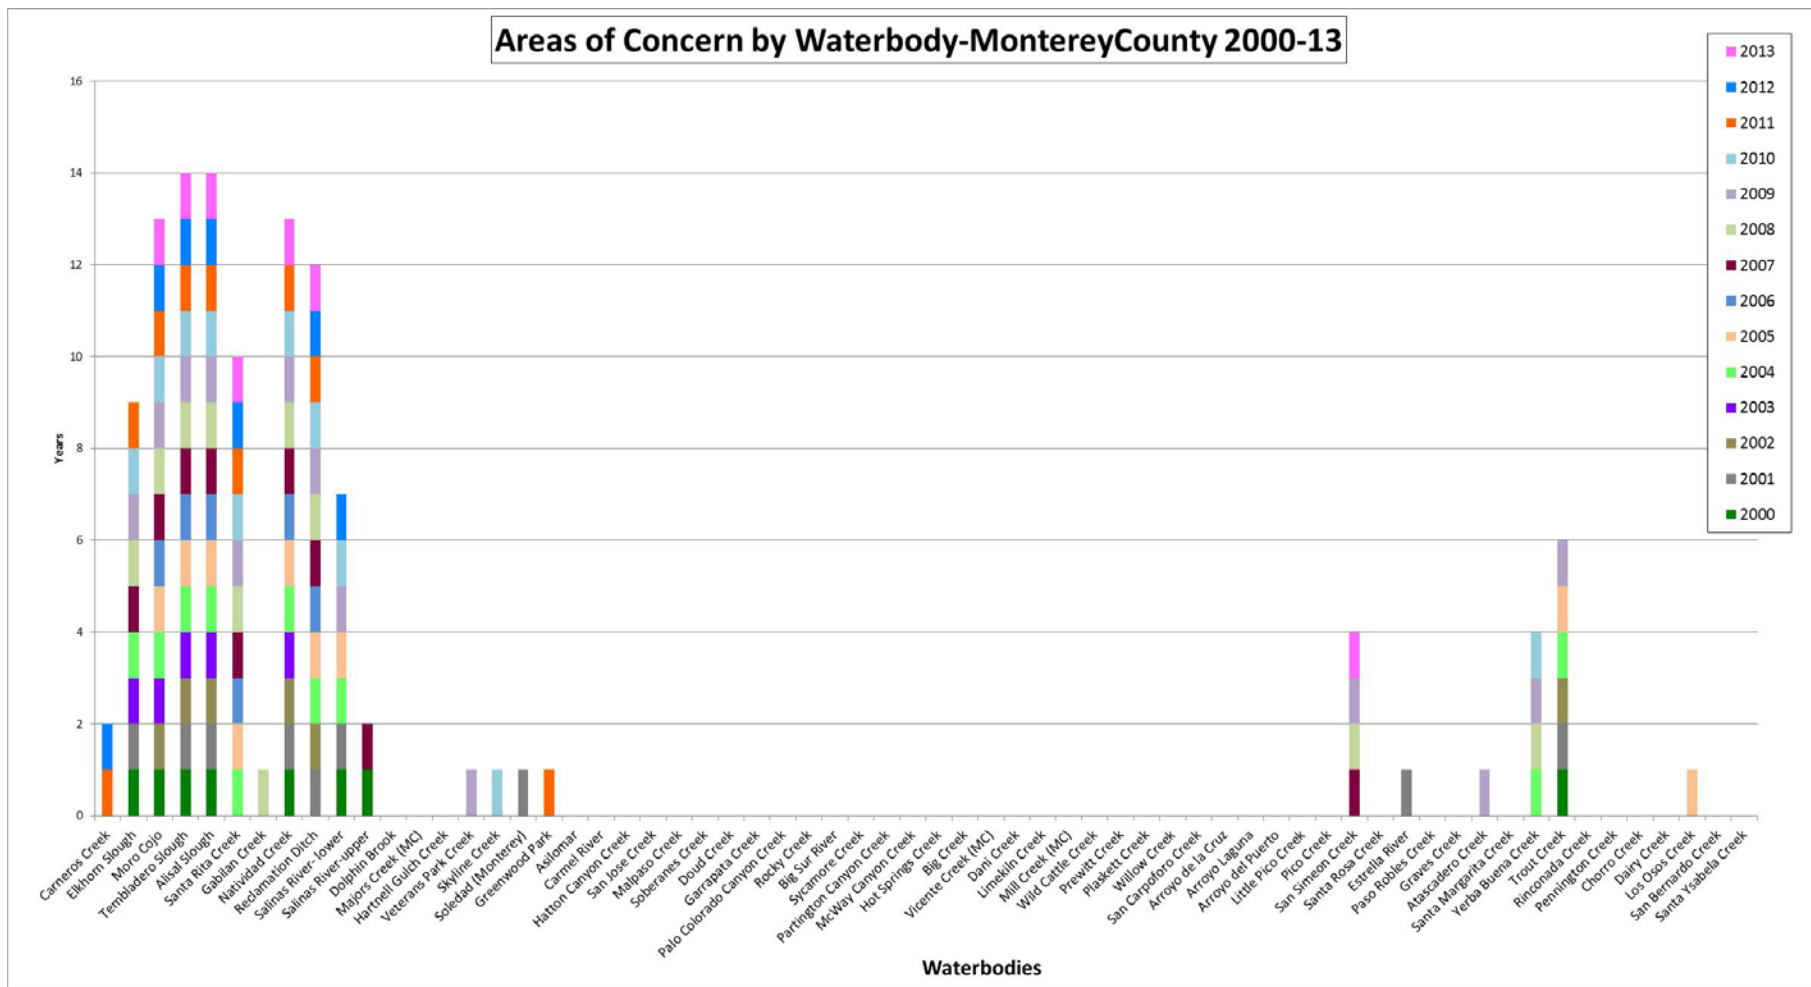
Appendix A Figure 2 (cont'd): Areas of Concern by waterbody for counties.
