PESCADERO-BUTANO WATERSHED ASSESSMENT

Final Report

March 5, 2004

Prepared for
Monterey Bay
National Marine Sanctuary Foundation
299 Foam Street
Monterey, CA 93940

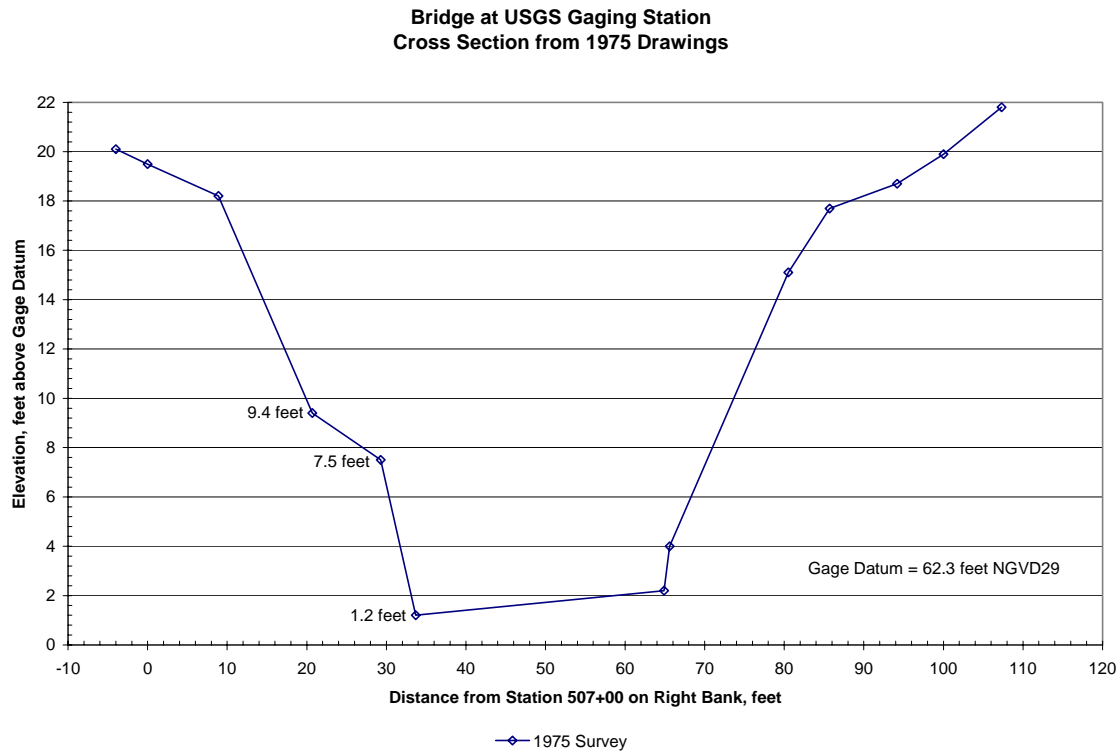
Figure 4-1: The above graph shows the channel cross section at the USGS gauge in 1975. The elevations shown on the graph have been converted into gauge heights. The elevation of the gauge datum is 62.3 feet.

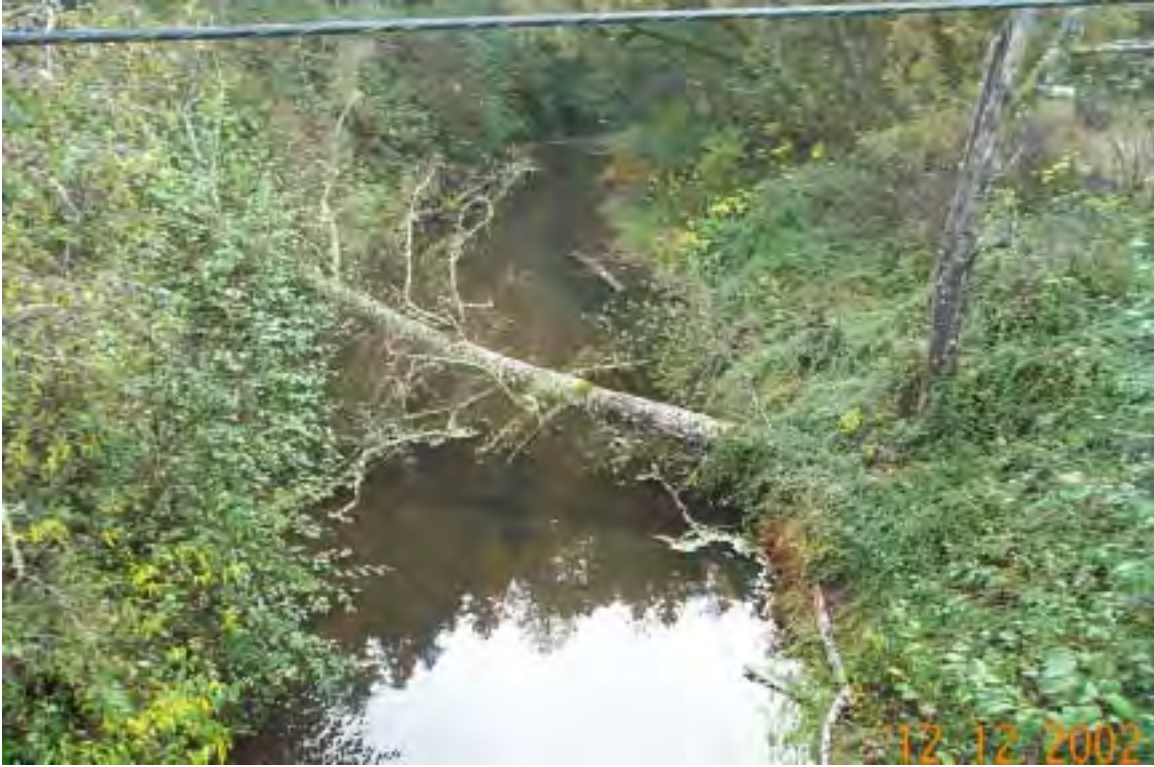
Figure 4-2: Photograph of Pescadero Creek just downstream of the USGS gauging station, taken from the Pescadero Road bridge.

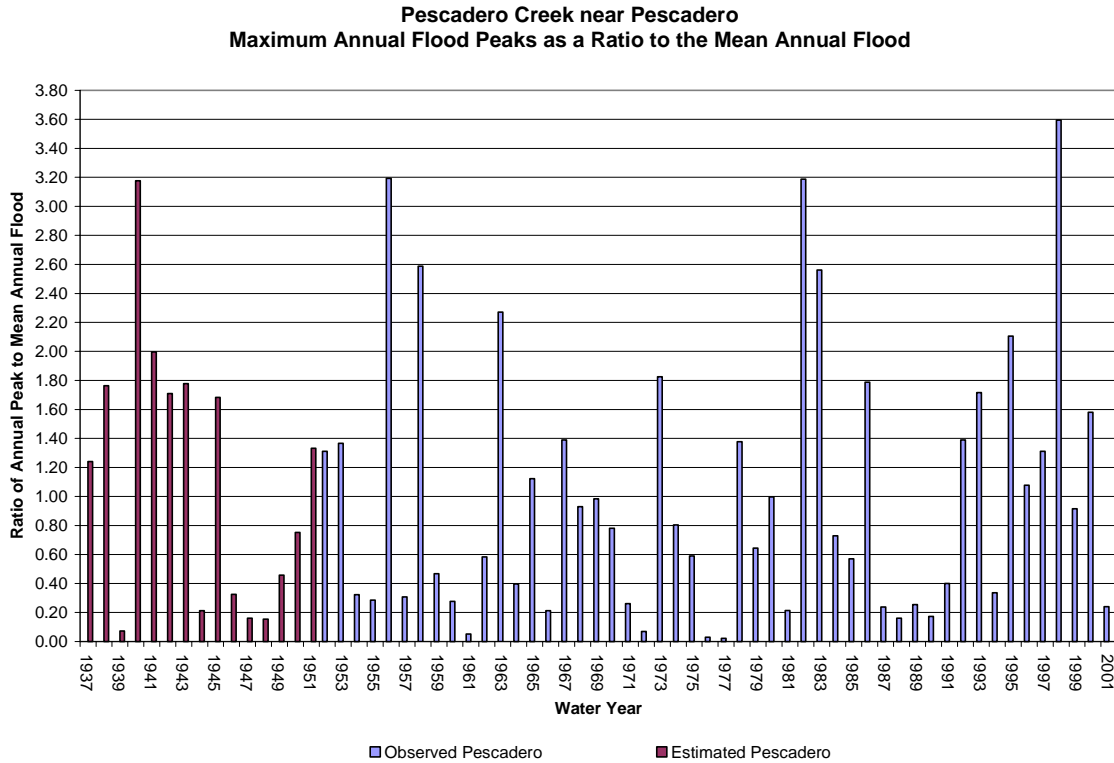
Figure 4-3: The annual maximum peak discharges for the USGS station, Pescadero Creek near Pescadero, are expressed as a ratio to the mean annual flood. Earlier peaks were estimated using the San Lorenzo River at Big Trees record.

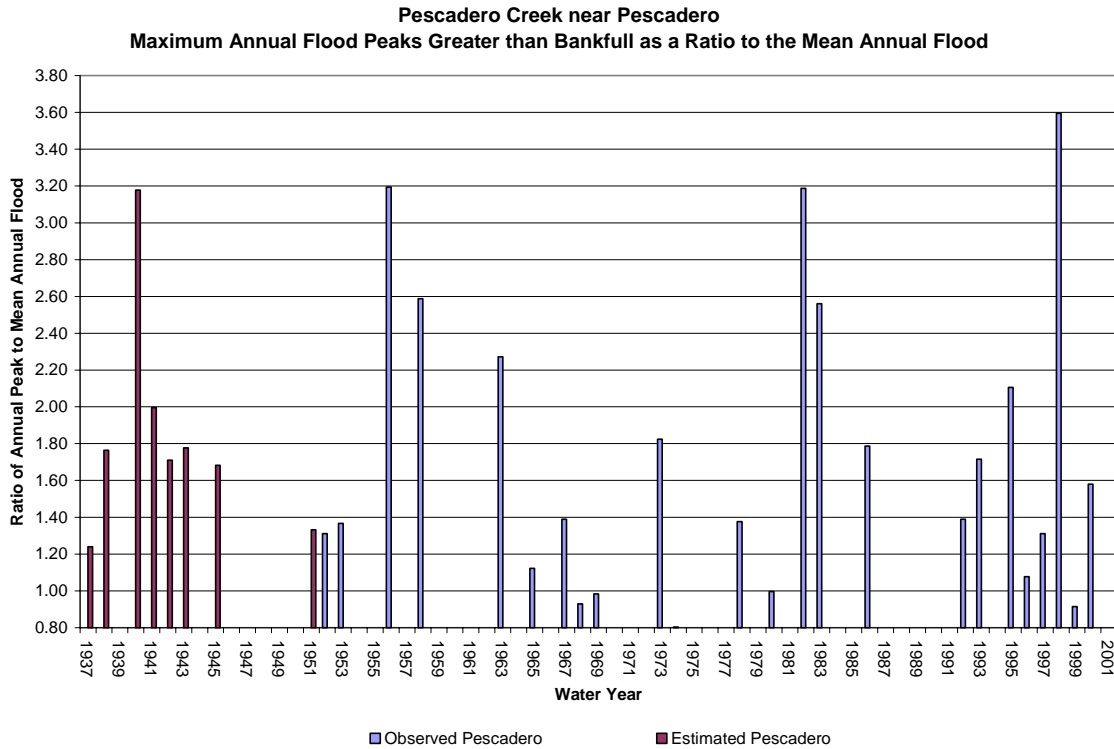
Figure 4-4: The annual flood series is shown with only the annual peaks larger than the estimated bankfull discharge of 0.8 times the mean annual flood.

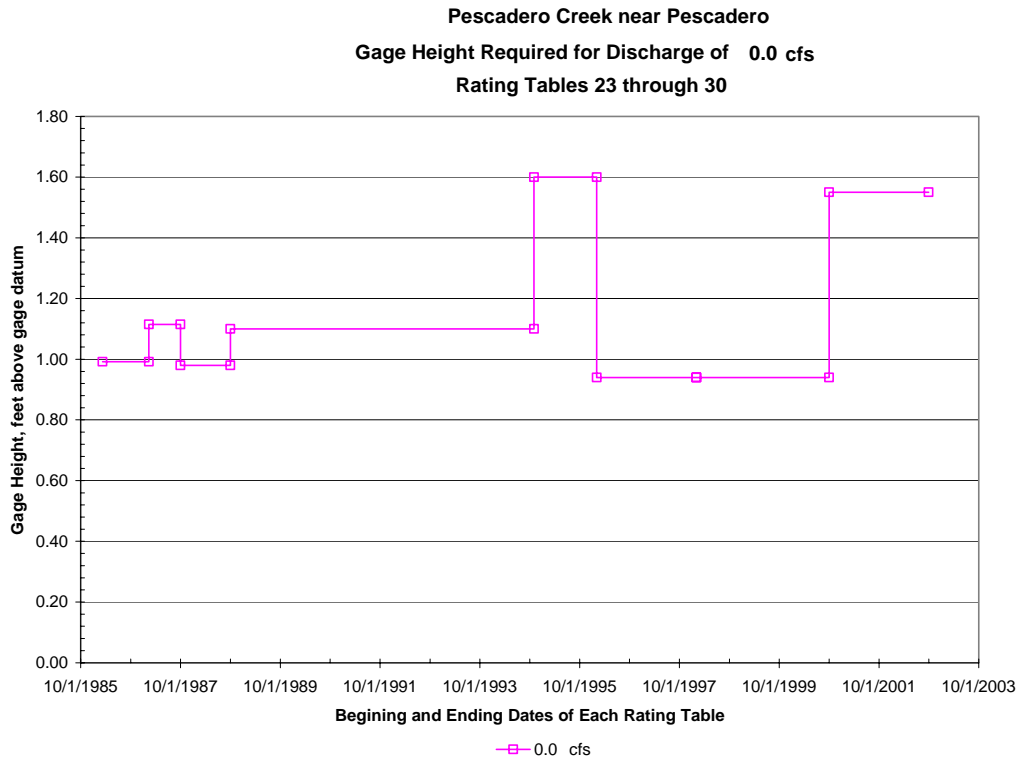
Figure 4-5: The above graph shows the gauge height for the flow cessation point for 1986 – 2002.

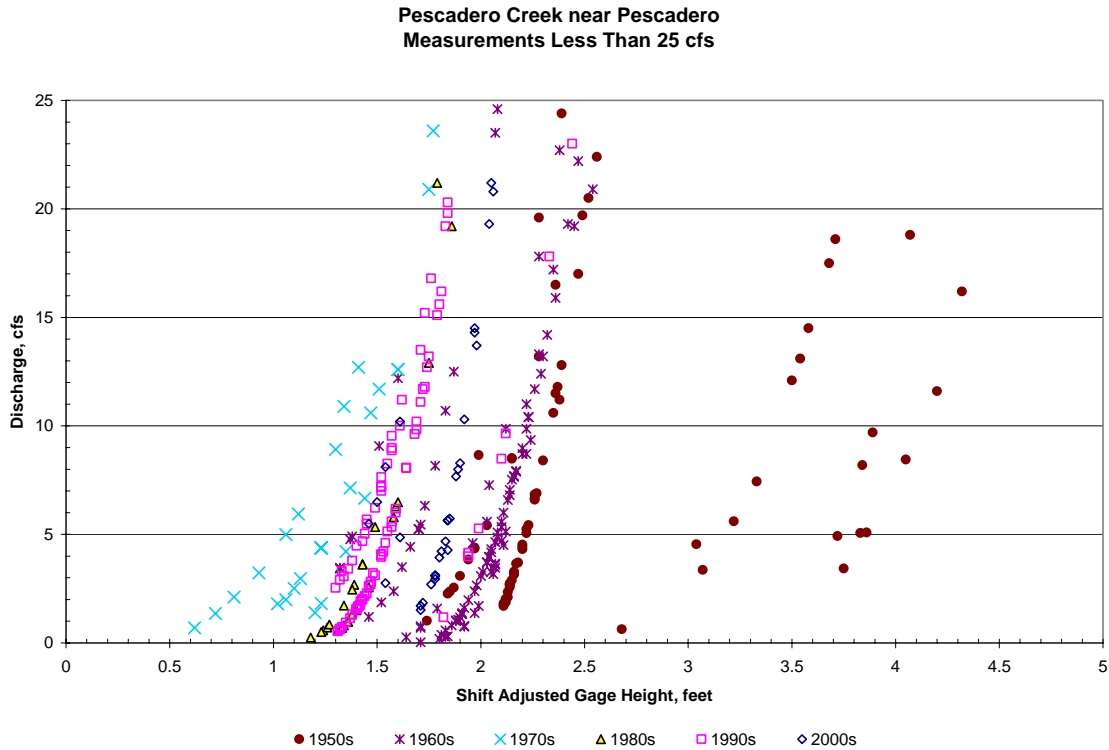
Figure 4-6: The discharge measurements less than 25 cfs for Pescadero Creek near Pescadero are shown above.

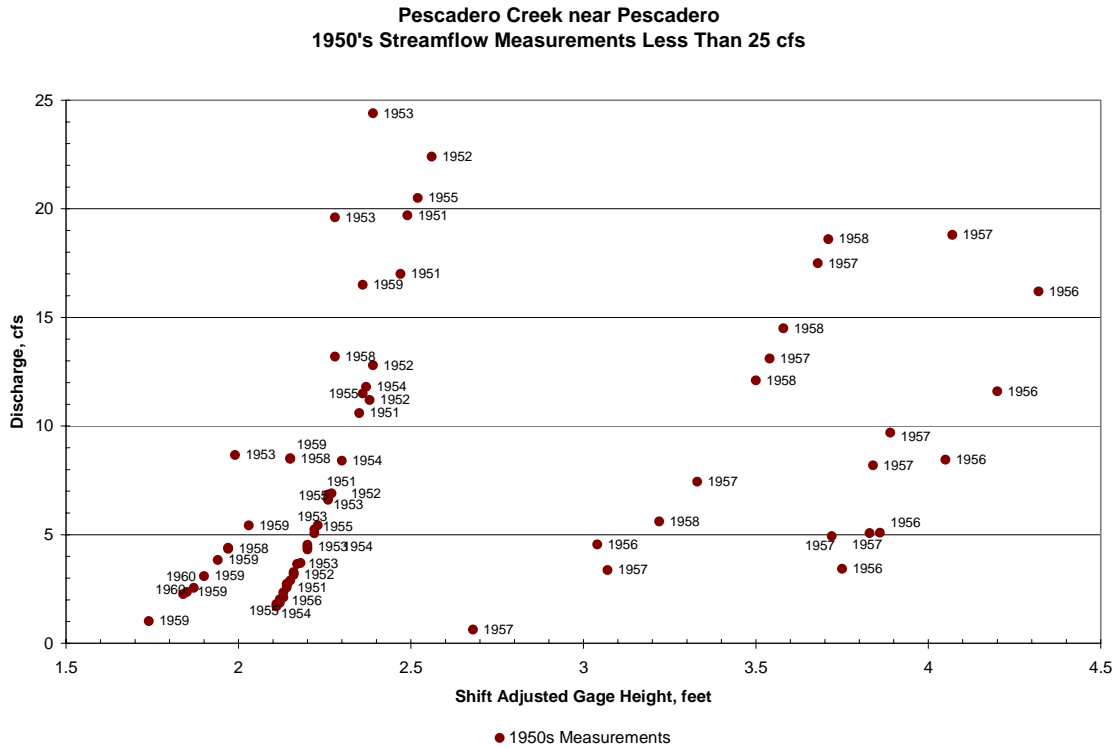
Figure 4-7: The discharge measurements less than 25 cfs for only the 1950s are shown above. The labels, adjacent to the data points, indicate the water-year of the measurement. Note that the gauge height scale begins at 1.5 and ends at 4.5 when comparing Figure 4-7 with Figure 4-6.

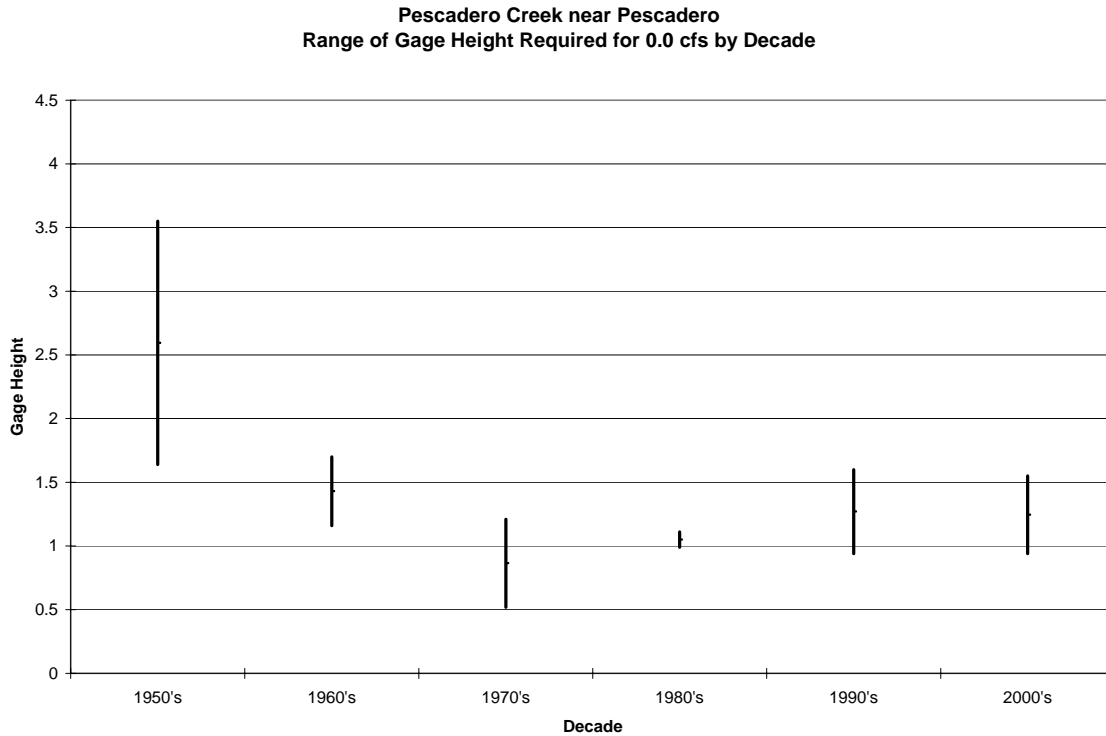
Figure 4-8: The range of the gauge height for the point of zero flow, by decade, is shown in the above graph.

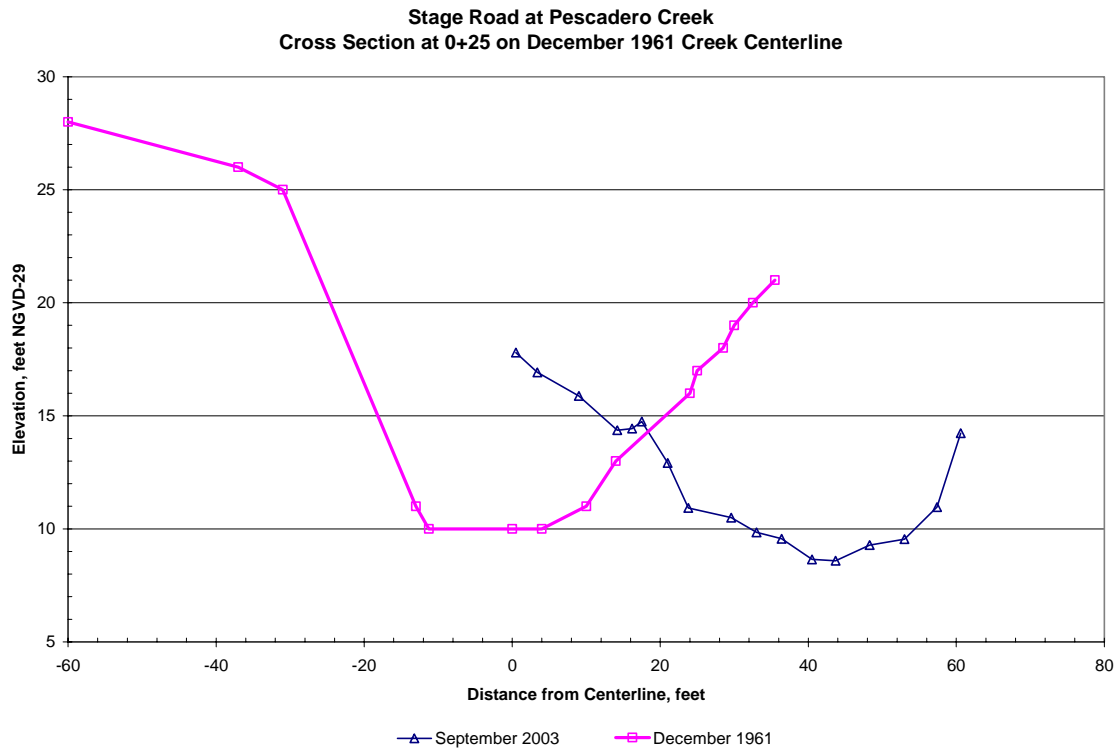
Figure 5-2: The graph of the cross section at Station 0+25 shows the apparent channel migration upstream of the Stage Road Bridge over Pescadero Creek.

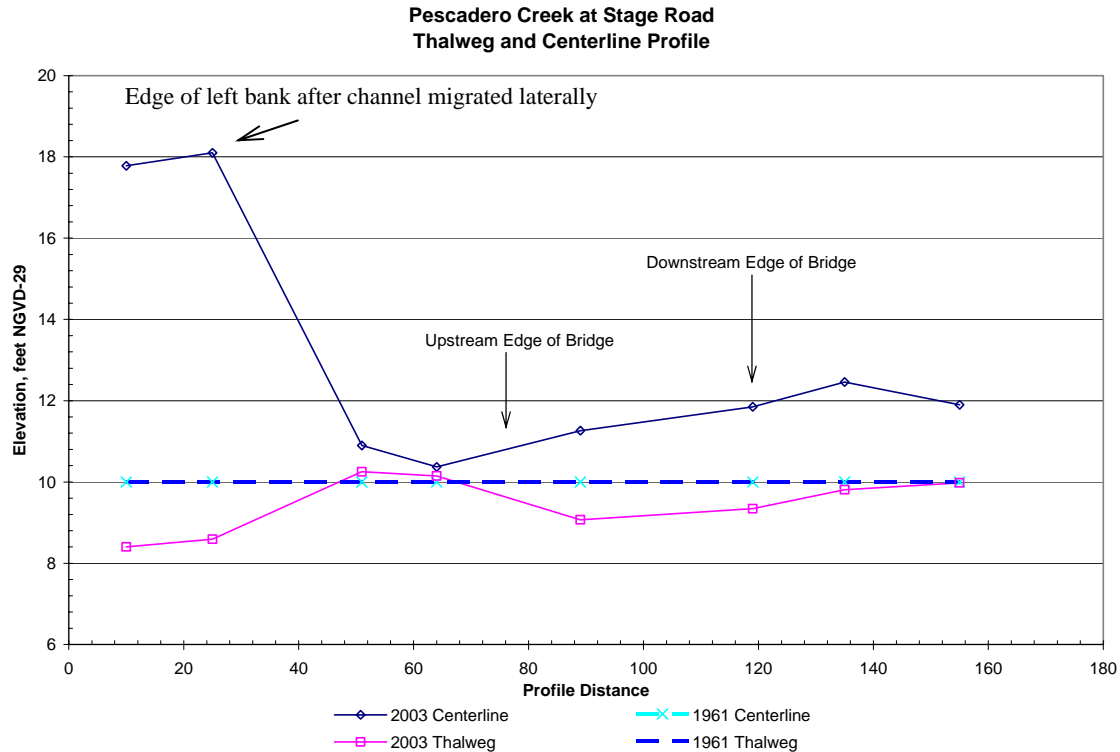
Figure 5-3: The graph shows the change in the centerline and thalweg profiles of Pescadero Creek under the Stage Road Bridge.

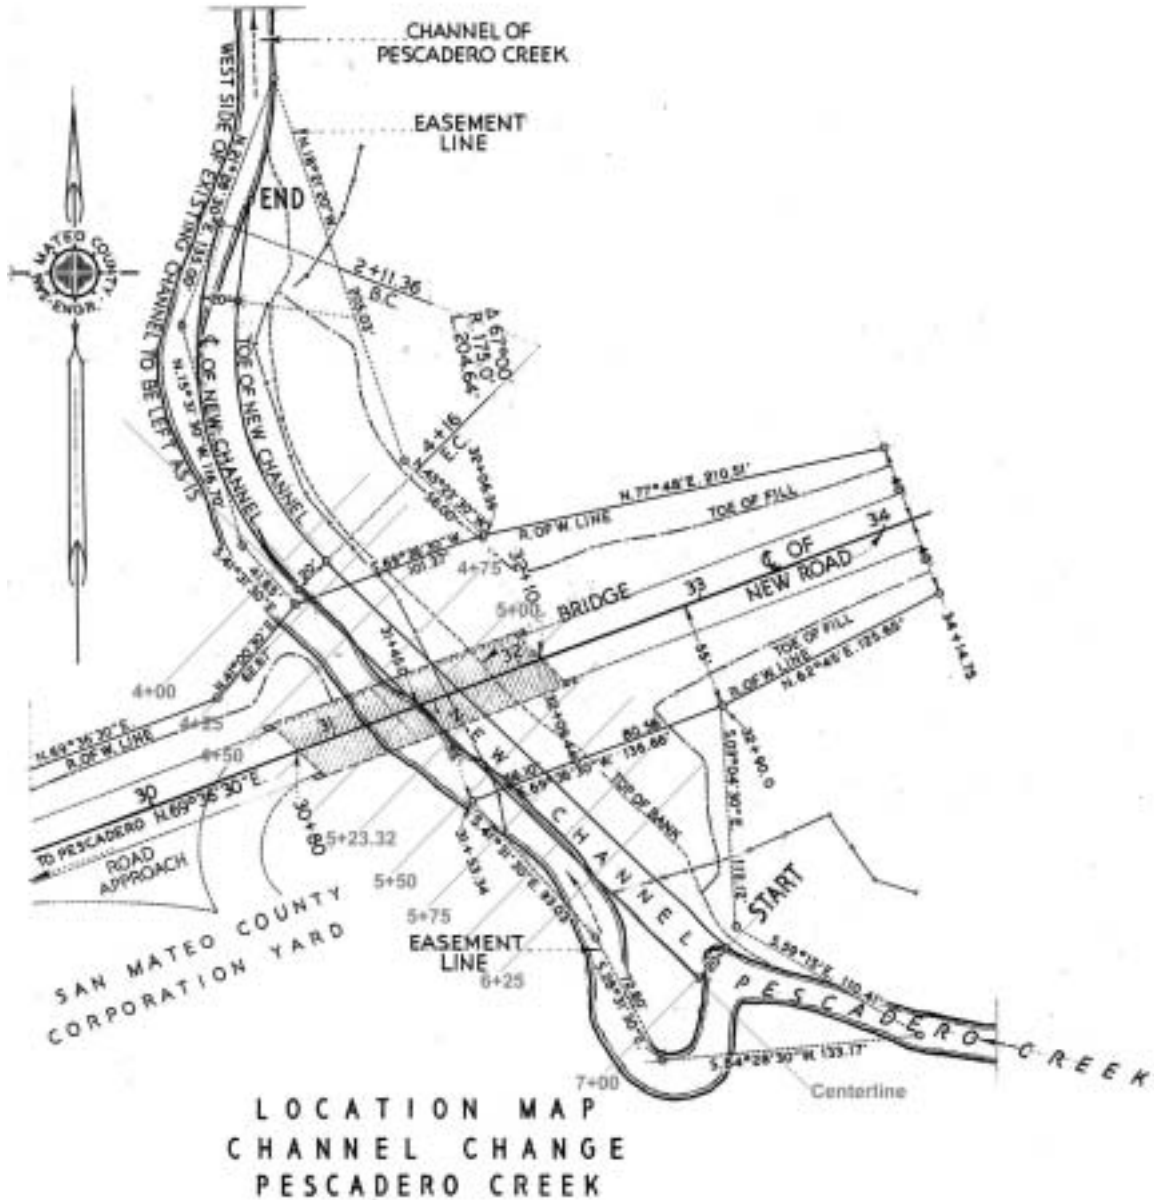
Figure 5-4: The channel change map for the Pescadero Cutoff Bridge is shown above. The flow is from the bottom of the page towards the top. The creek stationing and centerline were added by the author based on the stationing shown for the 175 foot radius turn north (downstream) of the bridge.

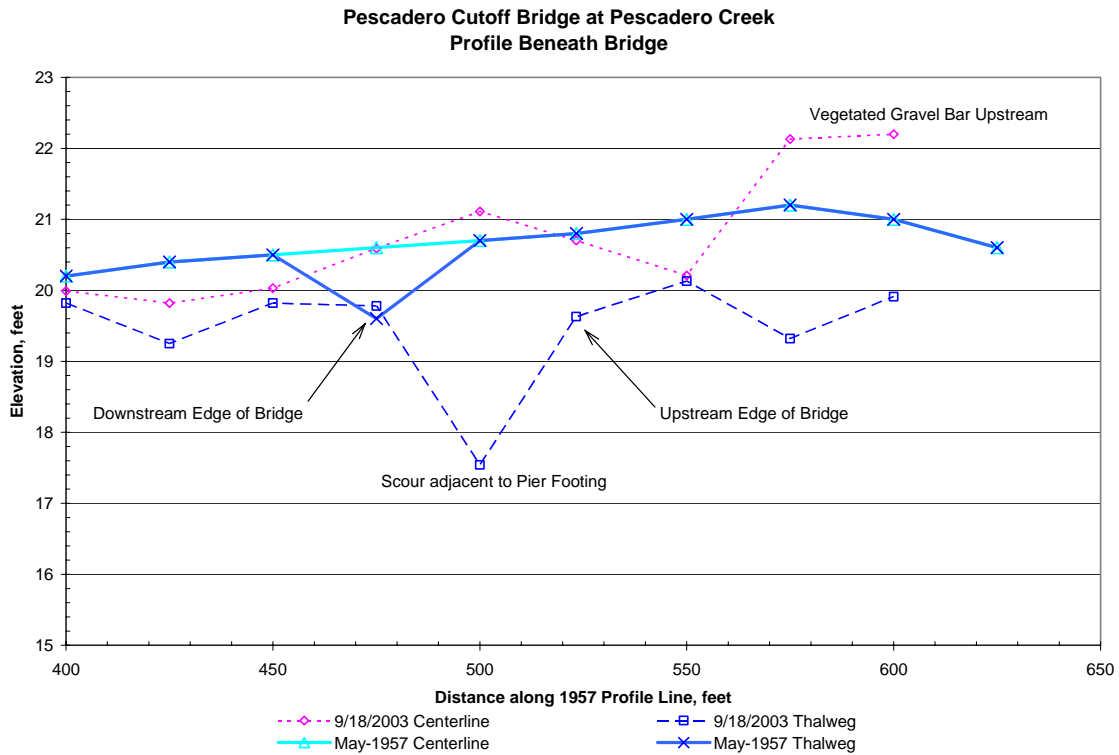
Figure 5-5: The comparison between the 1957 profile and the 2003 profile is shown.

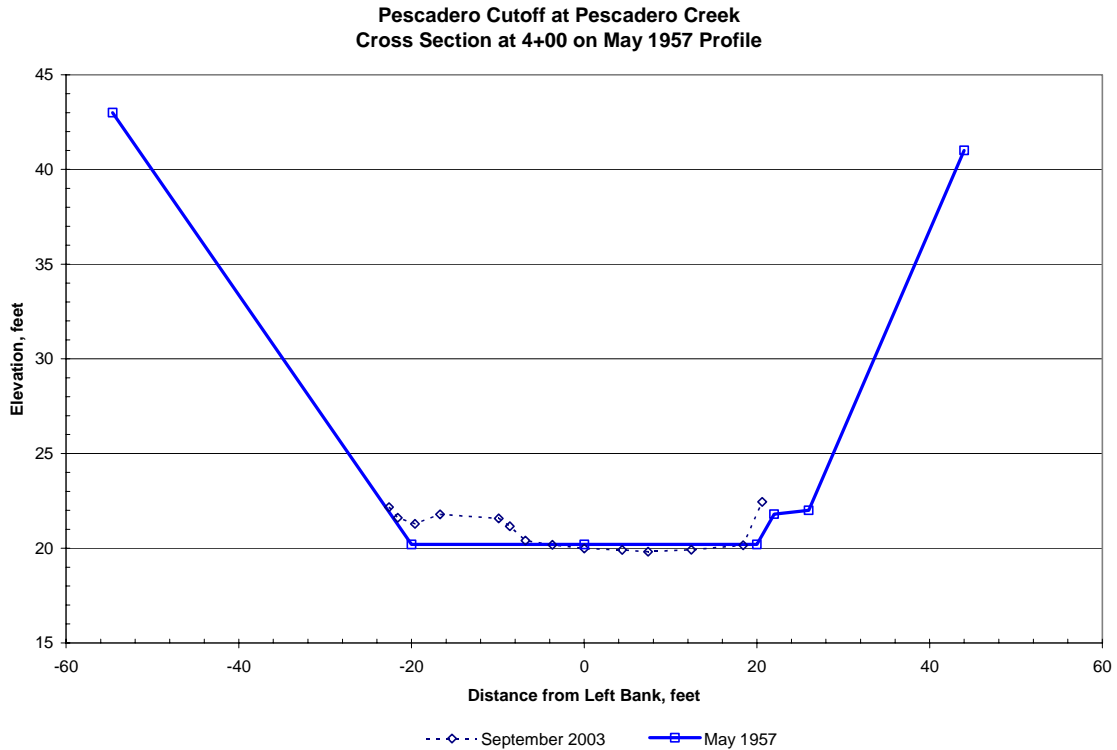
Figure 5-6: The comparison between the 1957 and 2003 surveys at station 4+00 is shown above.

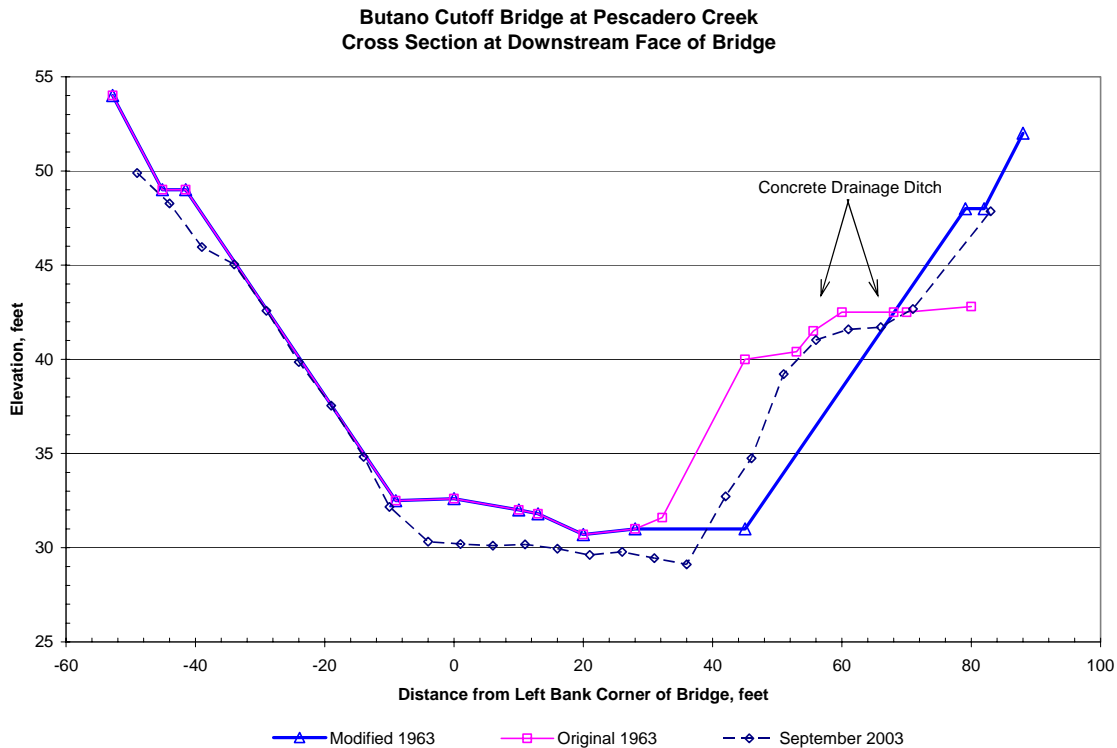
Figure 5-7: The comparison between the 1963 survey of the cross section at Station 2+20 and the 2003 survey alongside of the downstream bridge face at about Station 2+17 is shown. The 2003 cross section is about 3 feet upstream of the 1963 cross section. The original 1963 ground surface appears to be close to matching the top of the bench on the right bank suggesting that the right bank was not modified as much as suggested by the construction drawings.

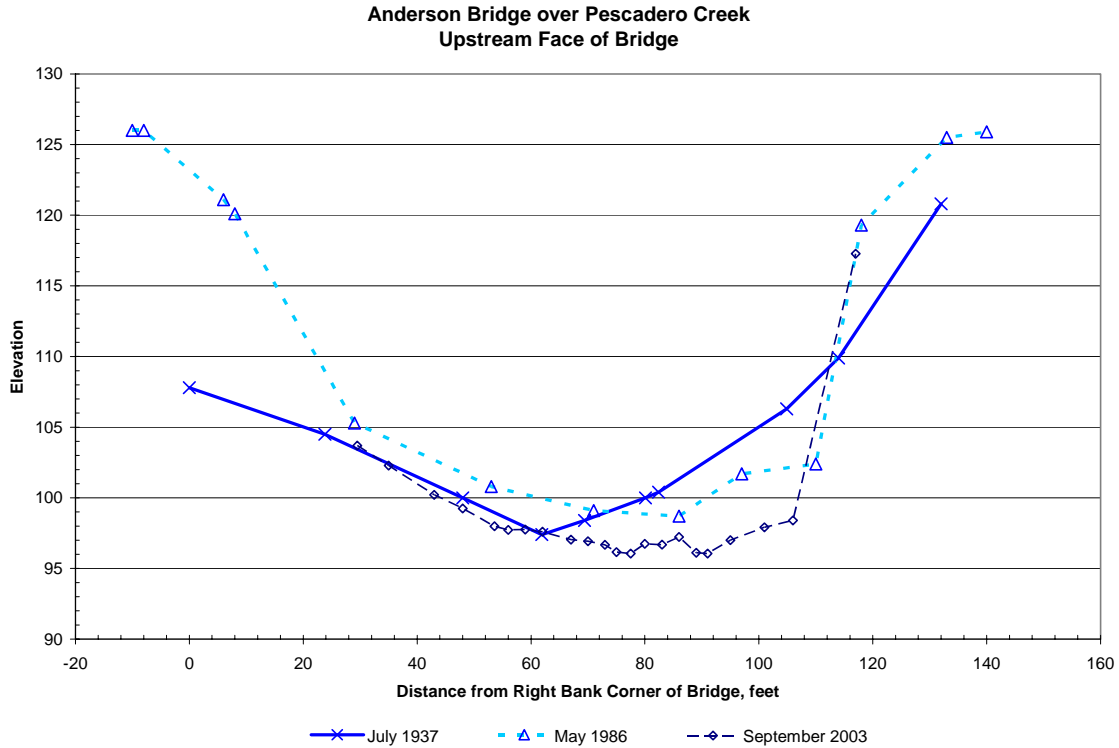
Figure 5-8: The comparison of the 1937, 1986 and 2003 cross section surveys for the upstream bridge face are shown above.

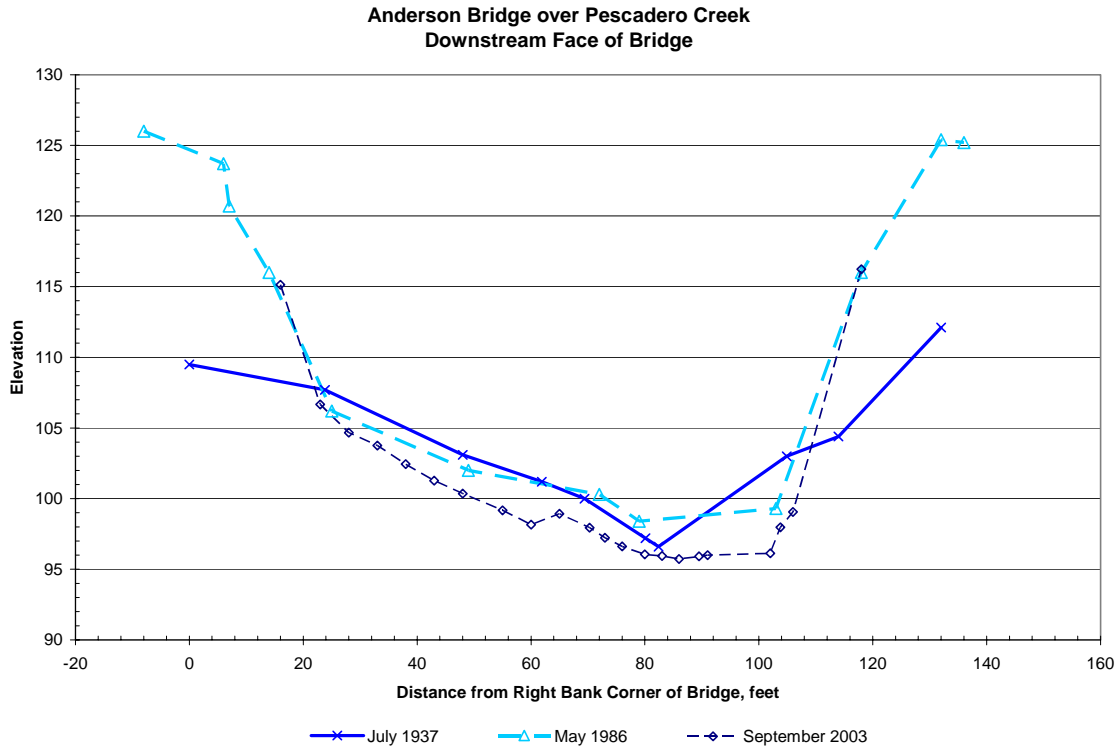
Figure 5-9: The comparison of the 1937, 1986 and 2003 cross section surveys for the downstream bridge face are shown above.

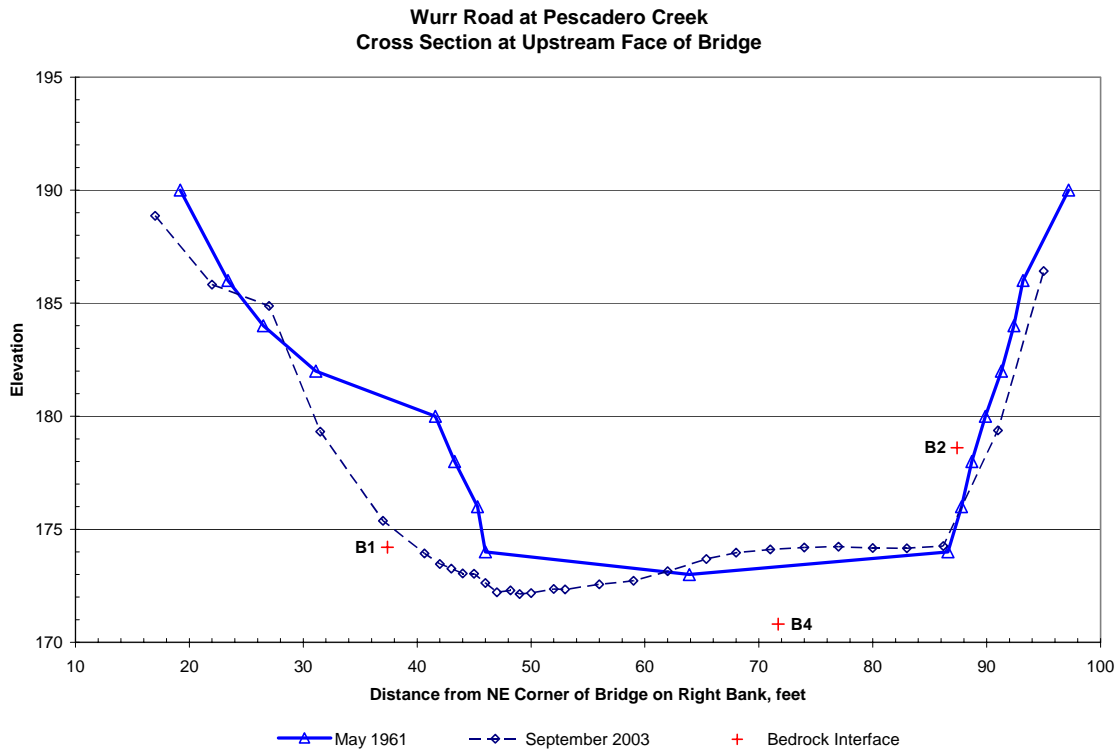
Figure 5-10: The comparison of the 1961 and 2003 channel cross sections for the upstream edge of the Wurr Road Bridge is shown above. The horizontal distance is from the right bank. The points labeled B1, B2, and B4 are the elevation of the top of bedrock shown on the boring logs. All the borings were done downstream of the cross section.

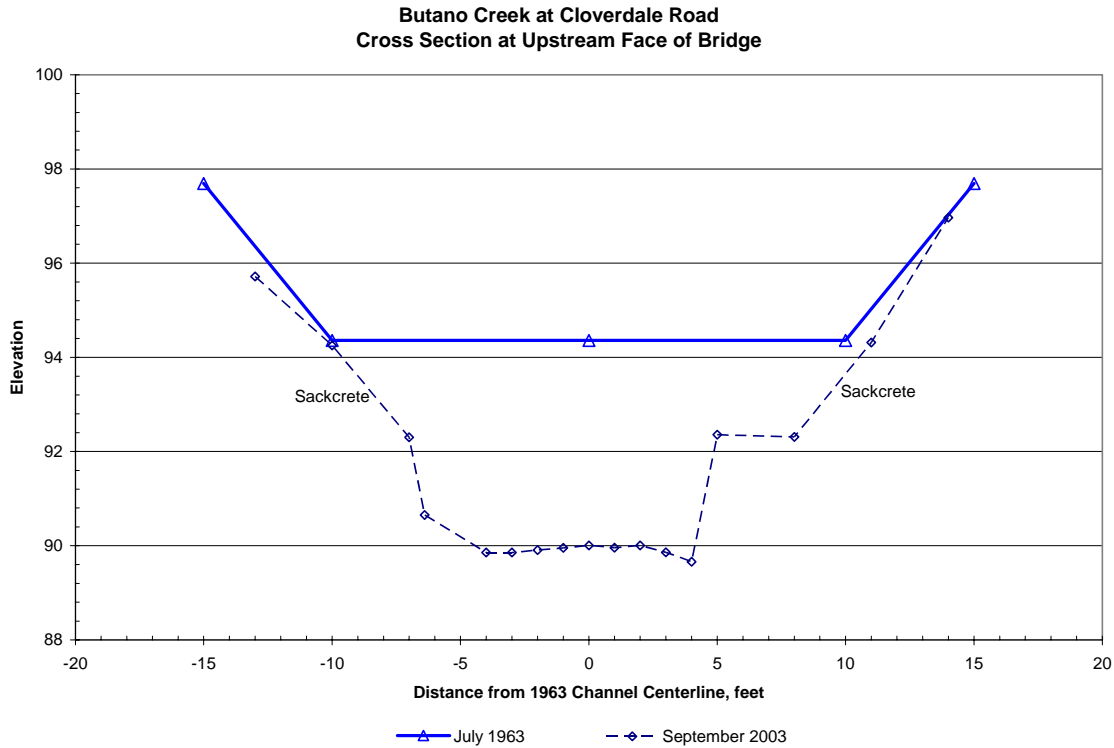
Figure 5-11: The above graph shows the channel degradation at the Cloverdale Road Bridge on Butano Creek that occurred between 1963 and 2003.

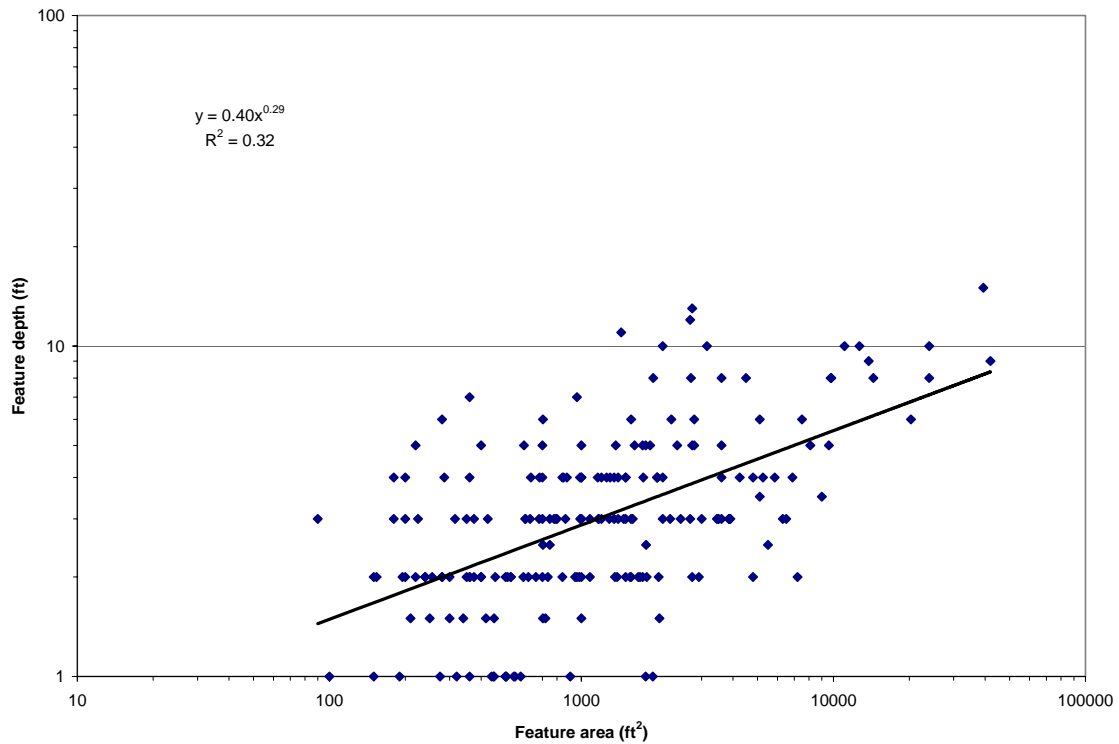
Figure 6-3: Area/depth regression for all field-inventoried debris slides

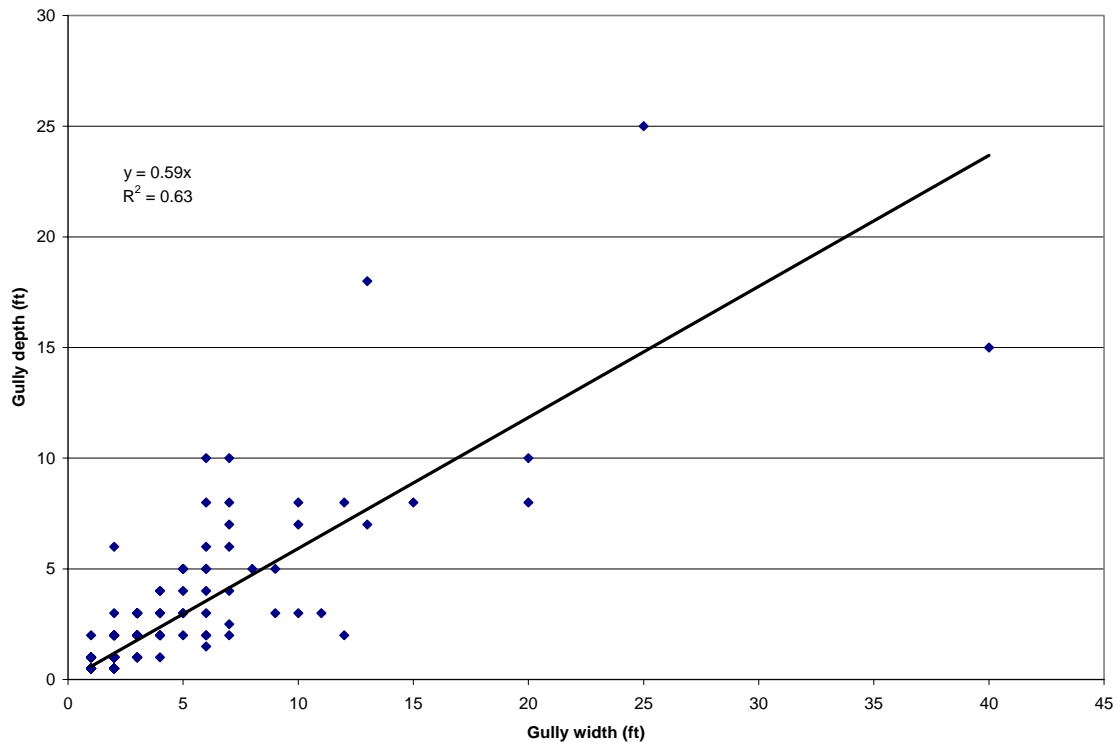
Figure 6-4: Width/depth regression for all field-inventoried gullies

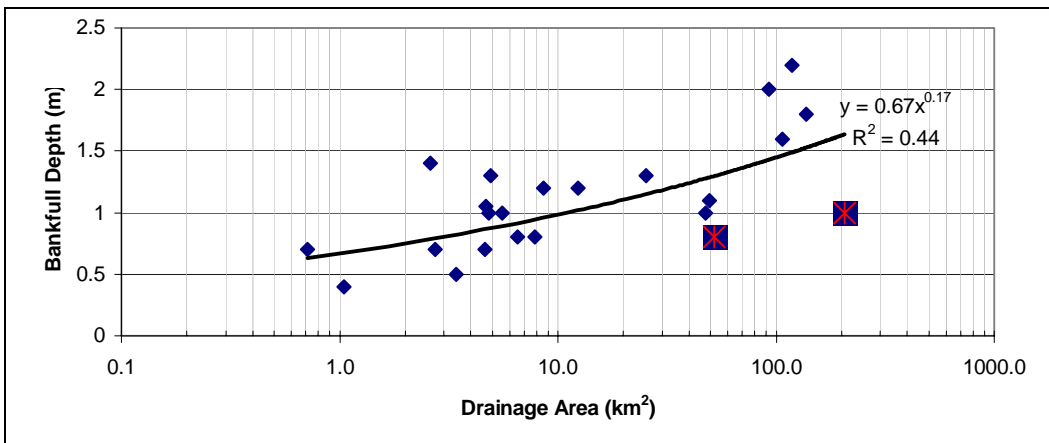
Figure 7-3: Bankfull depth as a function of drainage area. The highlighted points represent “marsh” sites in lower Pescadero and Butano Creeks where bankfull depth lies at the extreme low end of the observed distribution for larger drainage areas.

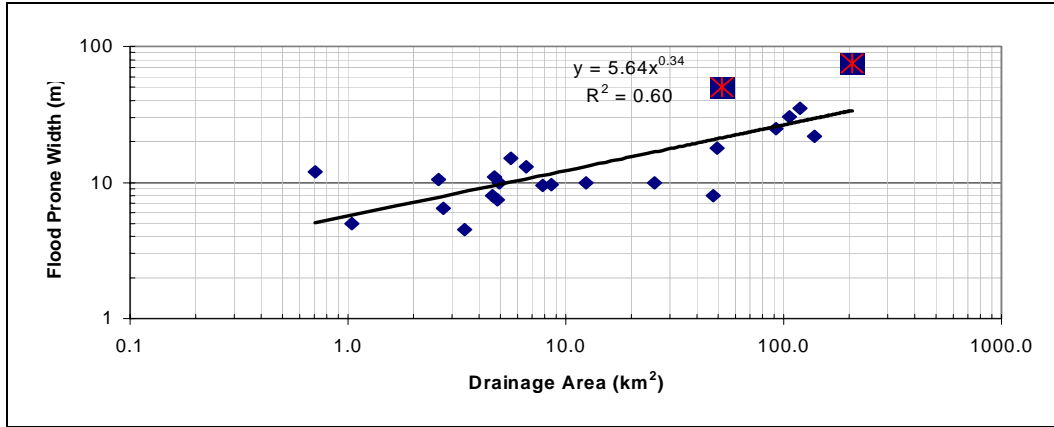
Figure 7-4: Flood prone width as a function of drainage area. The highlighted points represent “marsh” sites in lower Pescadero and Butano Creeks where bankfull depth lies at the extreme high end of the observed distribution for larger drainage areas.

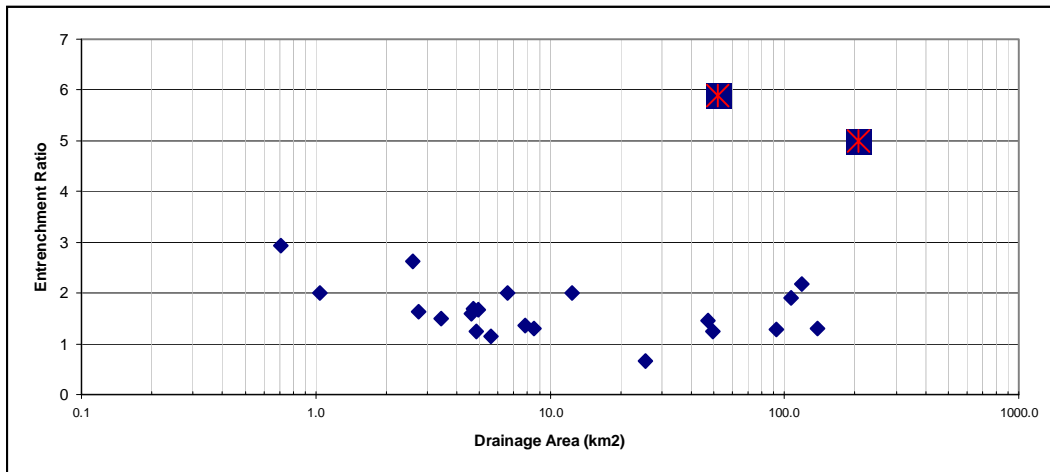
Figure 7-5: Entrenchment ratio as a function of drainage area. The highlighted points represent “marsh” sites in lower Pescadero and Butano Creeks where the entrenchment ratio lies at the extreme high end of the observed distribution for larger drainage areas.

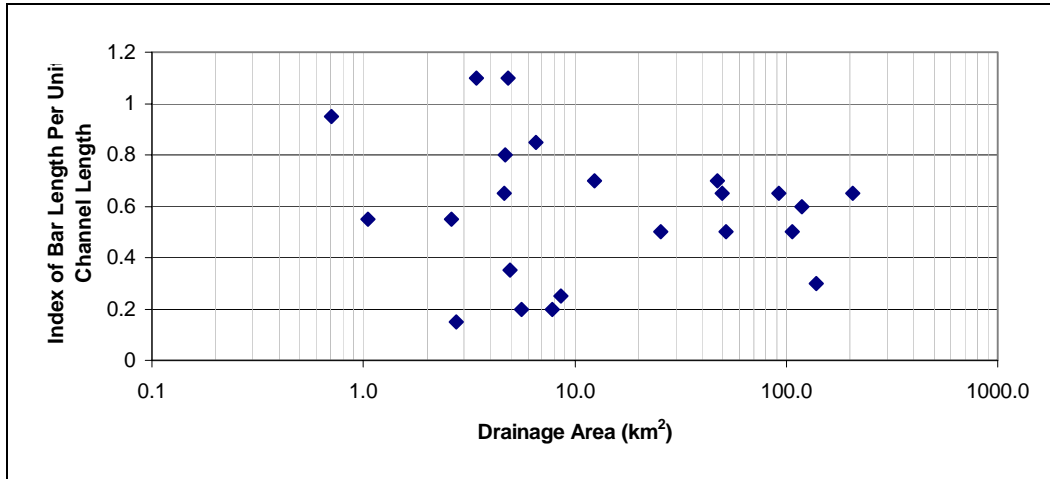
Figure 7-8: Gravel bar proportion per unit channel length.

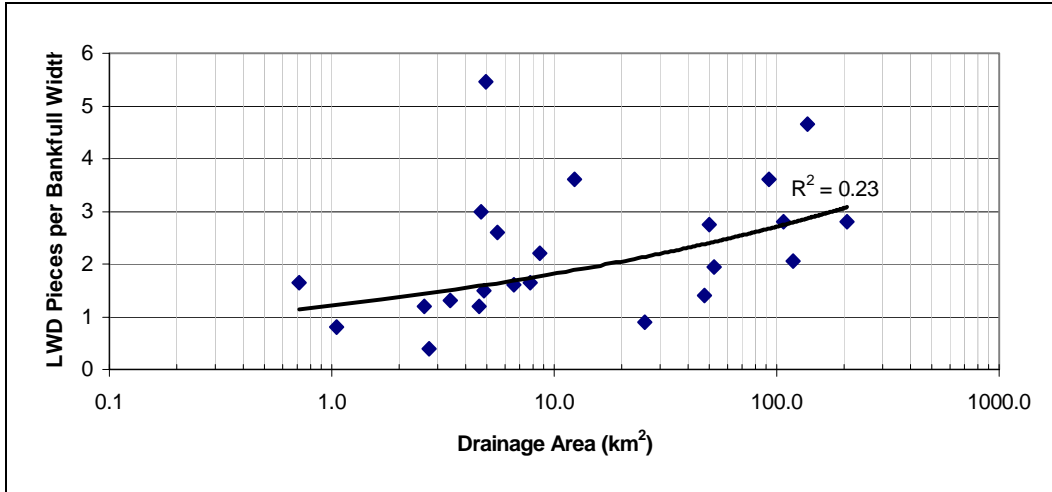
Figure 7-9: Large woody debris pieces per unit channel length as a function of drainage area. Channel length is expressed in units of bankfull width.

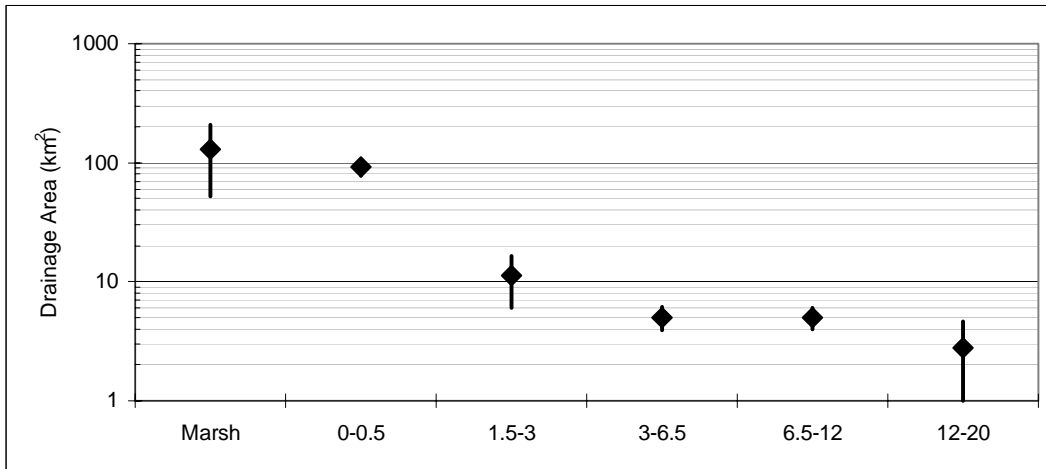
Figure 7-11: Drainage area as a function of channel slope class. The diamond indicates the mean value; the line represents the range of one standard error around the mean.

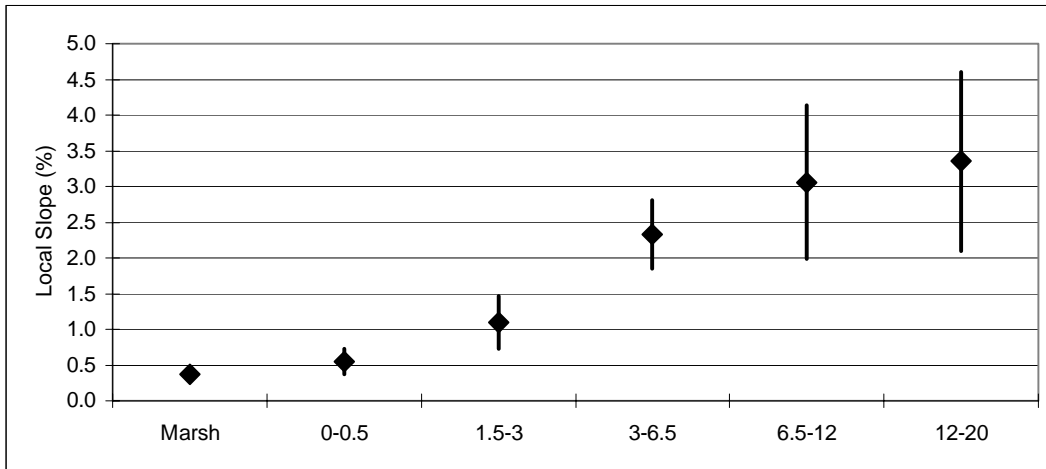
Figure 7-12: Local channel slope measured in the field as a function of channel slope class. The diamond indicates the mean value; the line represents the range of one standard error around the mean.

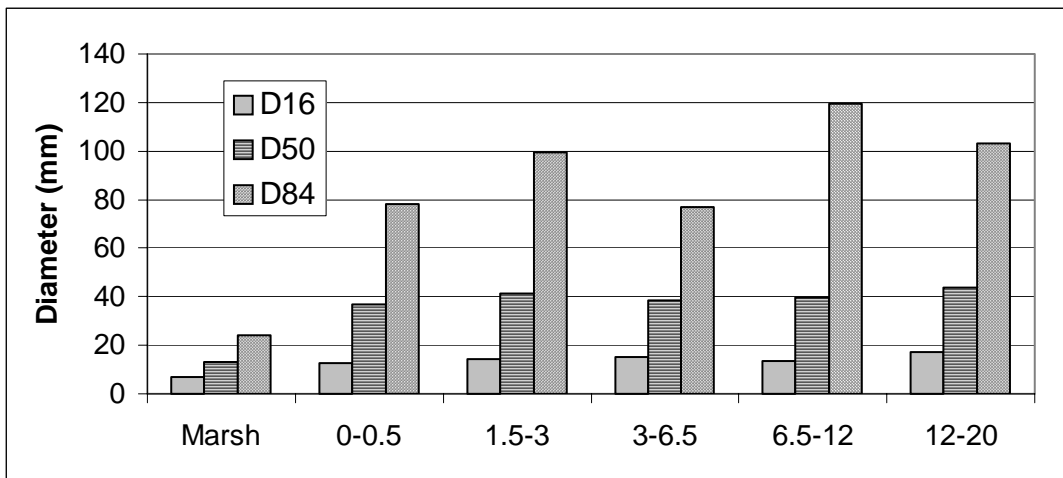
Figure 7-13: Mean values of D16, D50 and D84 as a function of channel slope class.

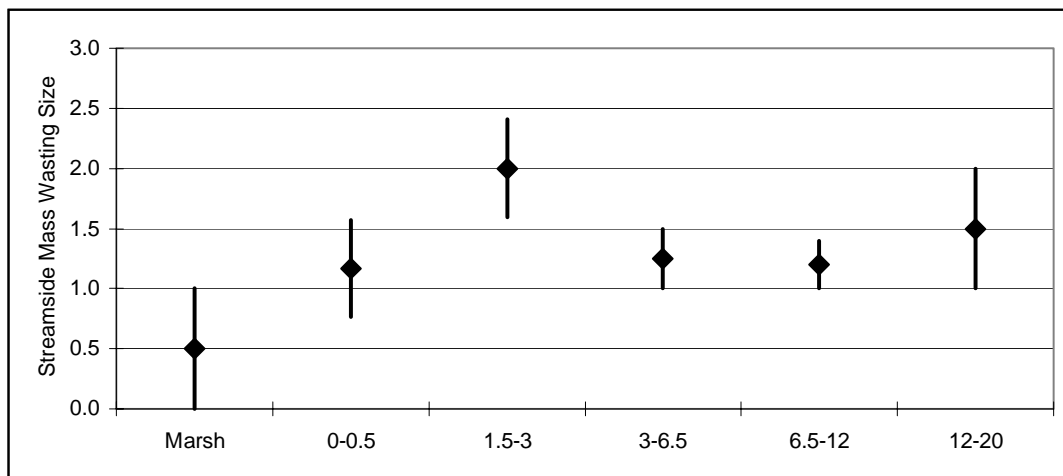
Figure 7-18: Size of streamside mass wasting (SSMW) features in stream channels as a function of channel slope class. A value of 1 indicates the scale of SSMW features are $< 5x$ bank height, a value of 2 indicates that SSMW features are $5-10x$ bank height. The diamond indicates the mean value; the line represents the range of one standard error around the mean.
