PESCADERO-BUTANO WATERSHED ASSESSMENT

Final Report

March 5, 2004

Prepared for
Monterey Bay
National Marine Sanctuary Foundation
299 Foam Street
Monterey, CA 93940

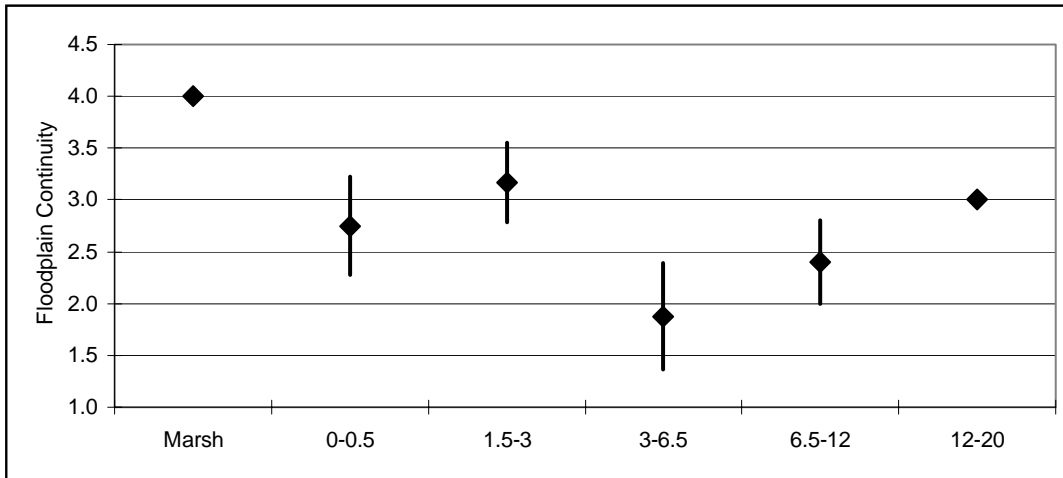
Figure 7-19: Floodplain continuity in stream channels as a function of channel slope class. A value of 4 indicates continuous floodplain in the reach, a value of 3 indicates discontinuous floodplain in the reach, and a value of 2 indicates terraces with no evidence of recent overbank flow. The diamond indicates the mean value; the line represents the range of one standard error around the mean.

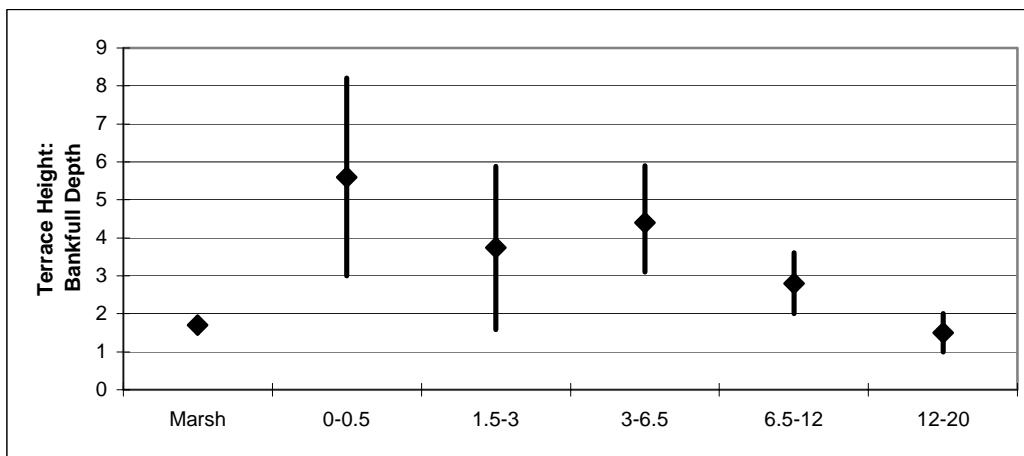
Figure 7-20. Ratio of terrace height to "bankfull" depth in stream channels as a function of channel slope class. This ratio quantifies the relative vertical distance between water elevation at "bankfull" (i.e. field estimated 2-yr recurrence interval flow) and the lowest floodplain surface (often classified in the field as a terrace). High values indicate deep channel entrenchment; low values indicate that the floodplain elevation is low relative to bankfull elevation, suggesting relatively high flooding potential. The diamond indicates the mean value; the line represents the range of one standard error around the mean.

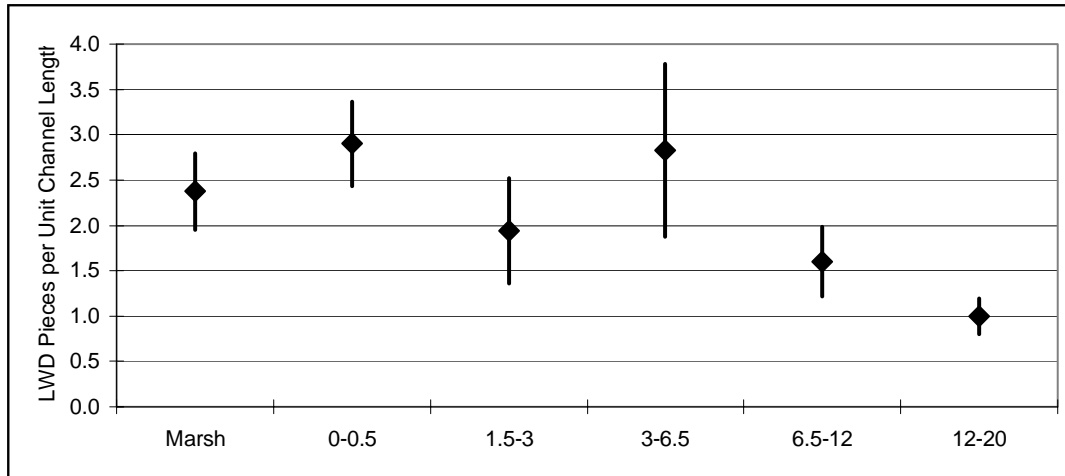
Figure 7-21: LWD per unit channel length (bankfull-width units) as a function of channel slope class. The diamond indicates the mean value; the line represents the range of one standard error around the mean.

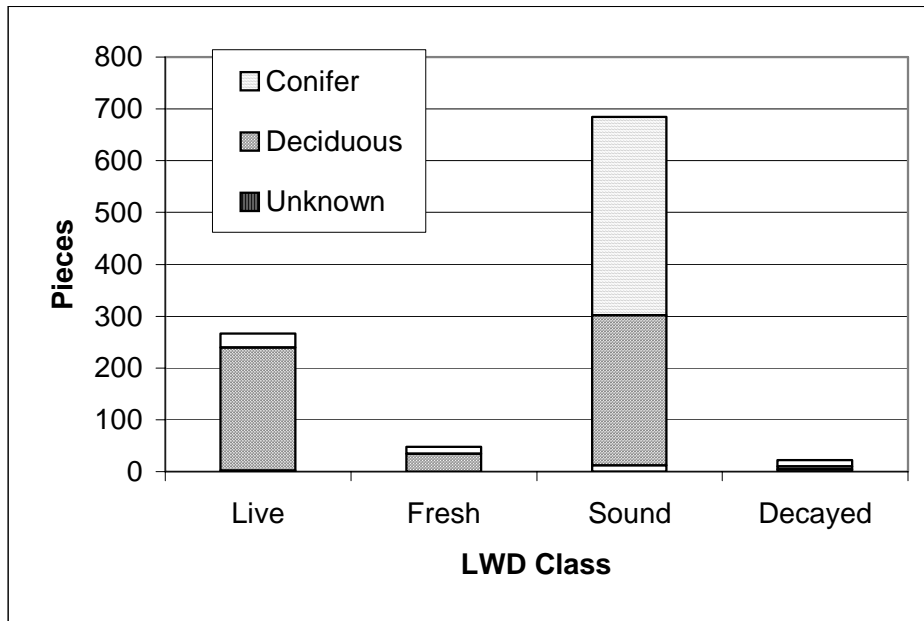
Figure 7-22: Total LWD pieces in each decay class and proportions contributed by coniferous and deciduous trees. The “unknown” type category is negligible. Note the high proportion of live trees that are deciduous.

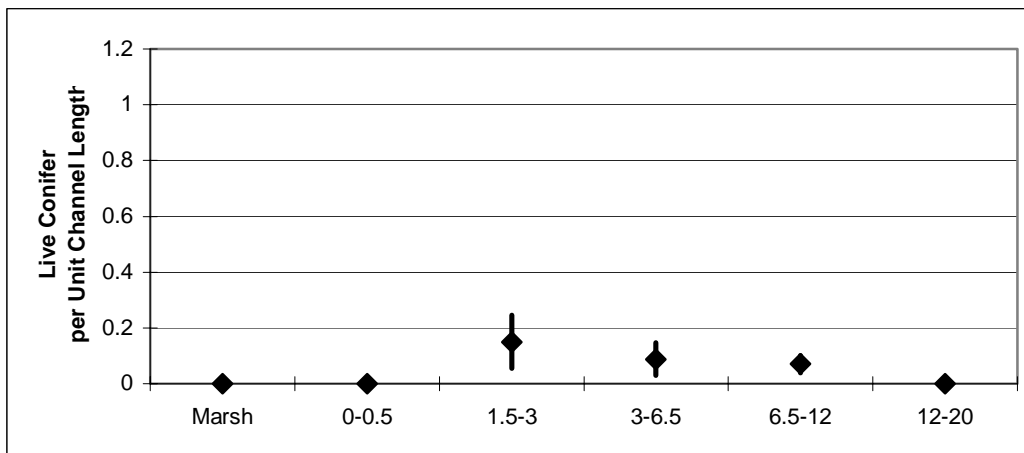
Figure 7-23: Live conifer per unit channel length (bankfull width units) as a function of channel slope class. The diamond indicates the mean value; the line represents the range of one standard error around the mean.

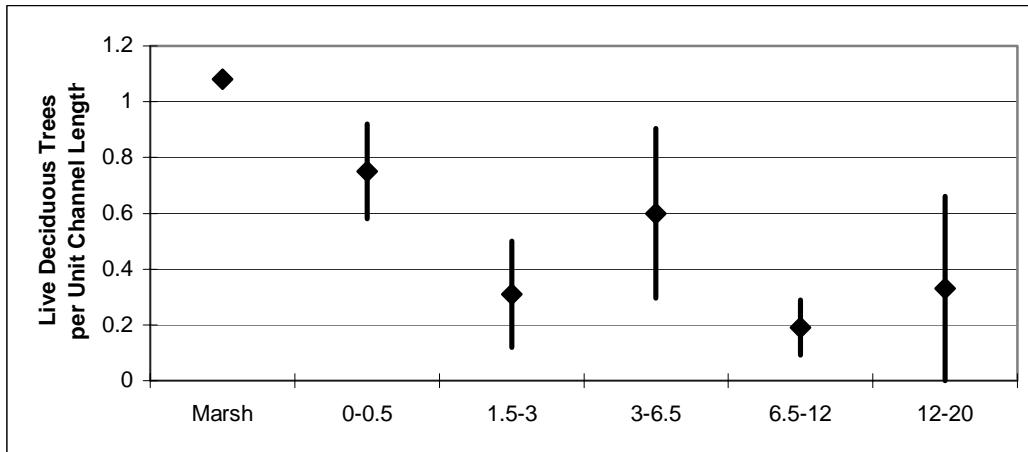
Figure 7-24: Live deciduous trees per unit channel length (bankfull width units) as a function of channel slope class. The diamond indicates the mean value; the line represents the range of one standard error around the mean.

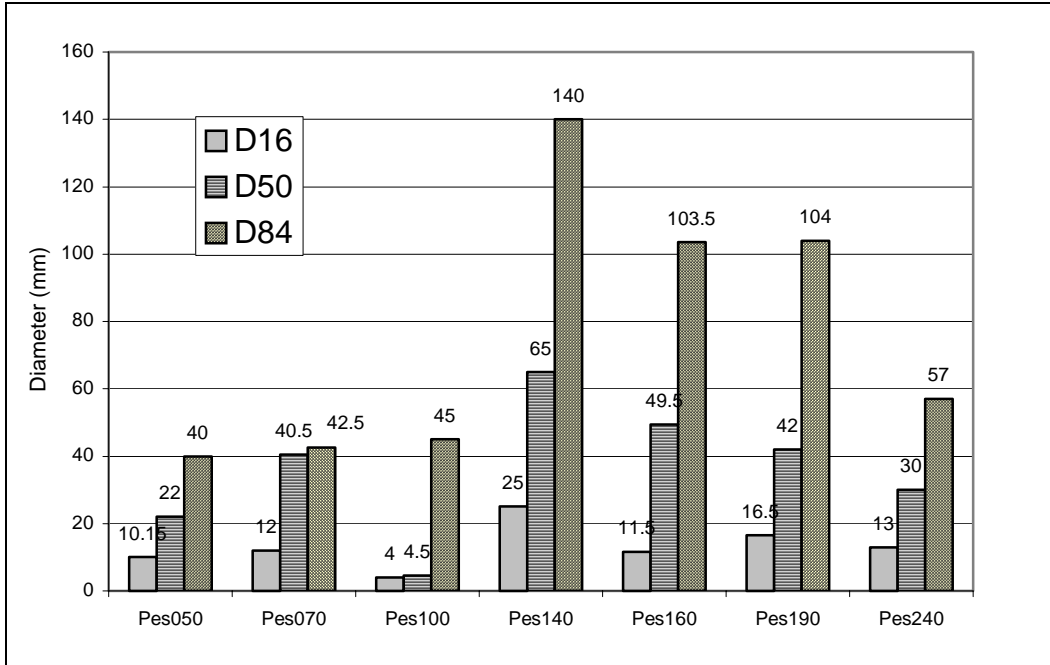
Figure 7-26: Diameters of D16, D50 and D84 for sample reaches ascending Pescadero Creek (from left to right).

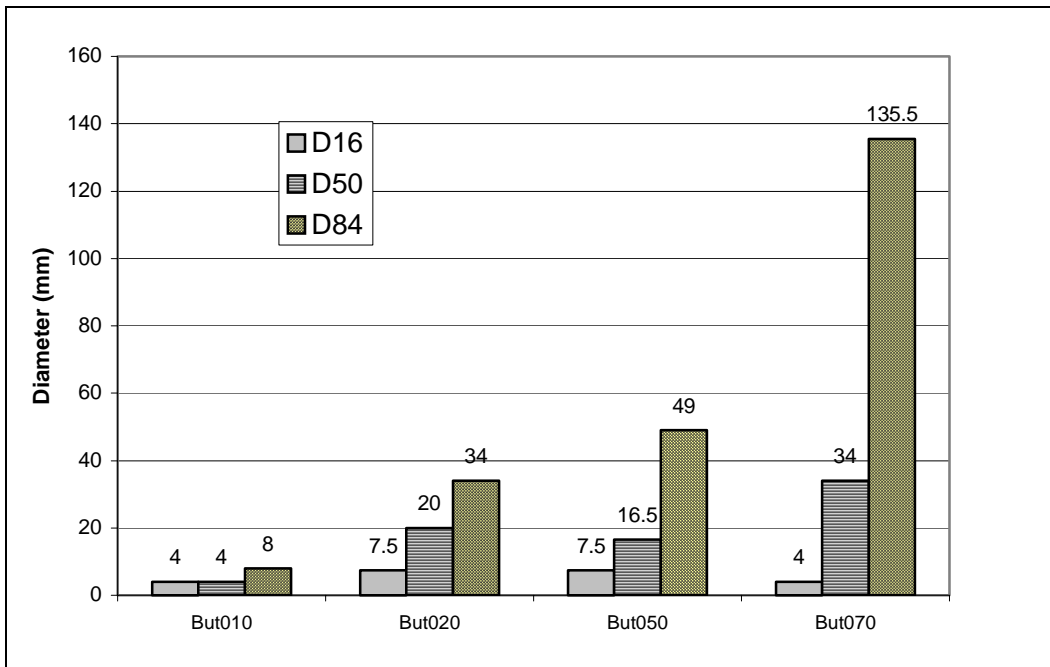
Figure 7-27: Diameters of D16, D50 and D84 for sample reaches ascending Butano Creek (from left to right).
