COASTAL EROSION AND ARMORING IN SOUTHERN MONTEREY BAY

A Technical Report in support of the
Monterey Bay National Marine Sanctuary
Coastal Armoring Action Plan

Version 1.1

June 2005

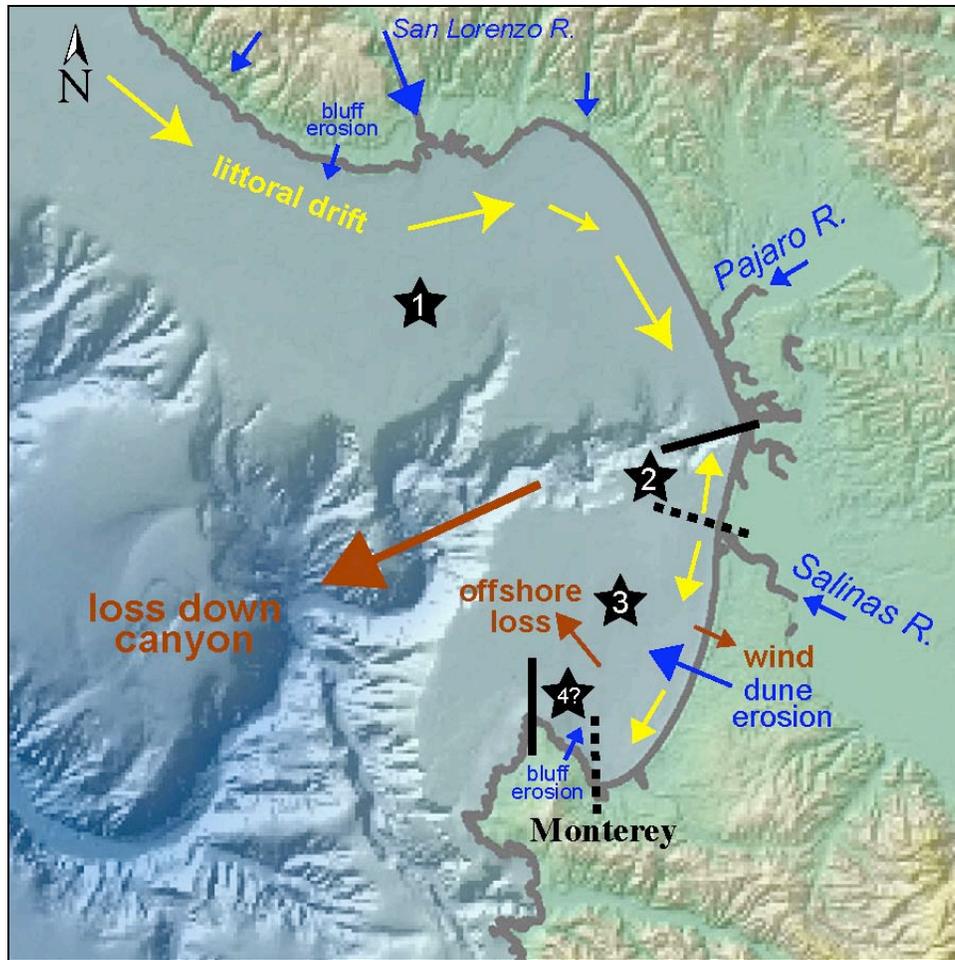
Figure 1.3: Schematic map of Monterey Bay littoral cells. Black bars represent divisions between littoral cells, which are highlighted with stars. Dashed divisions are not as fully constrained as solid divisions. Blue arrows represent major inputs of sand to the system, brown arrows represent significant losses of sand from the system, and yellow arrows represent the approximate path of littoral drift. Arrows are not to scale.

Monterey Canyon effectively bisects the bay, dividing the region into two major littoral cells (Figure 1.3). A littoral cell is a self-contained compartment of the coast, which includes all sources and sinks for littoral, or beach-sized, sand. In Monterey Bay, sources of beach sand include discharge from coastal rivers and erosion of coastal bluffs; natural sinks or losses can occur where submarine canyons intersect the nearshore zone, where wind transports sand from beaches into coastal dunes, or where sand gets dispersed offshore onto the continental shelf. Littoral drift is driven by longshore currents, which

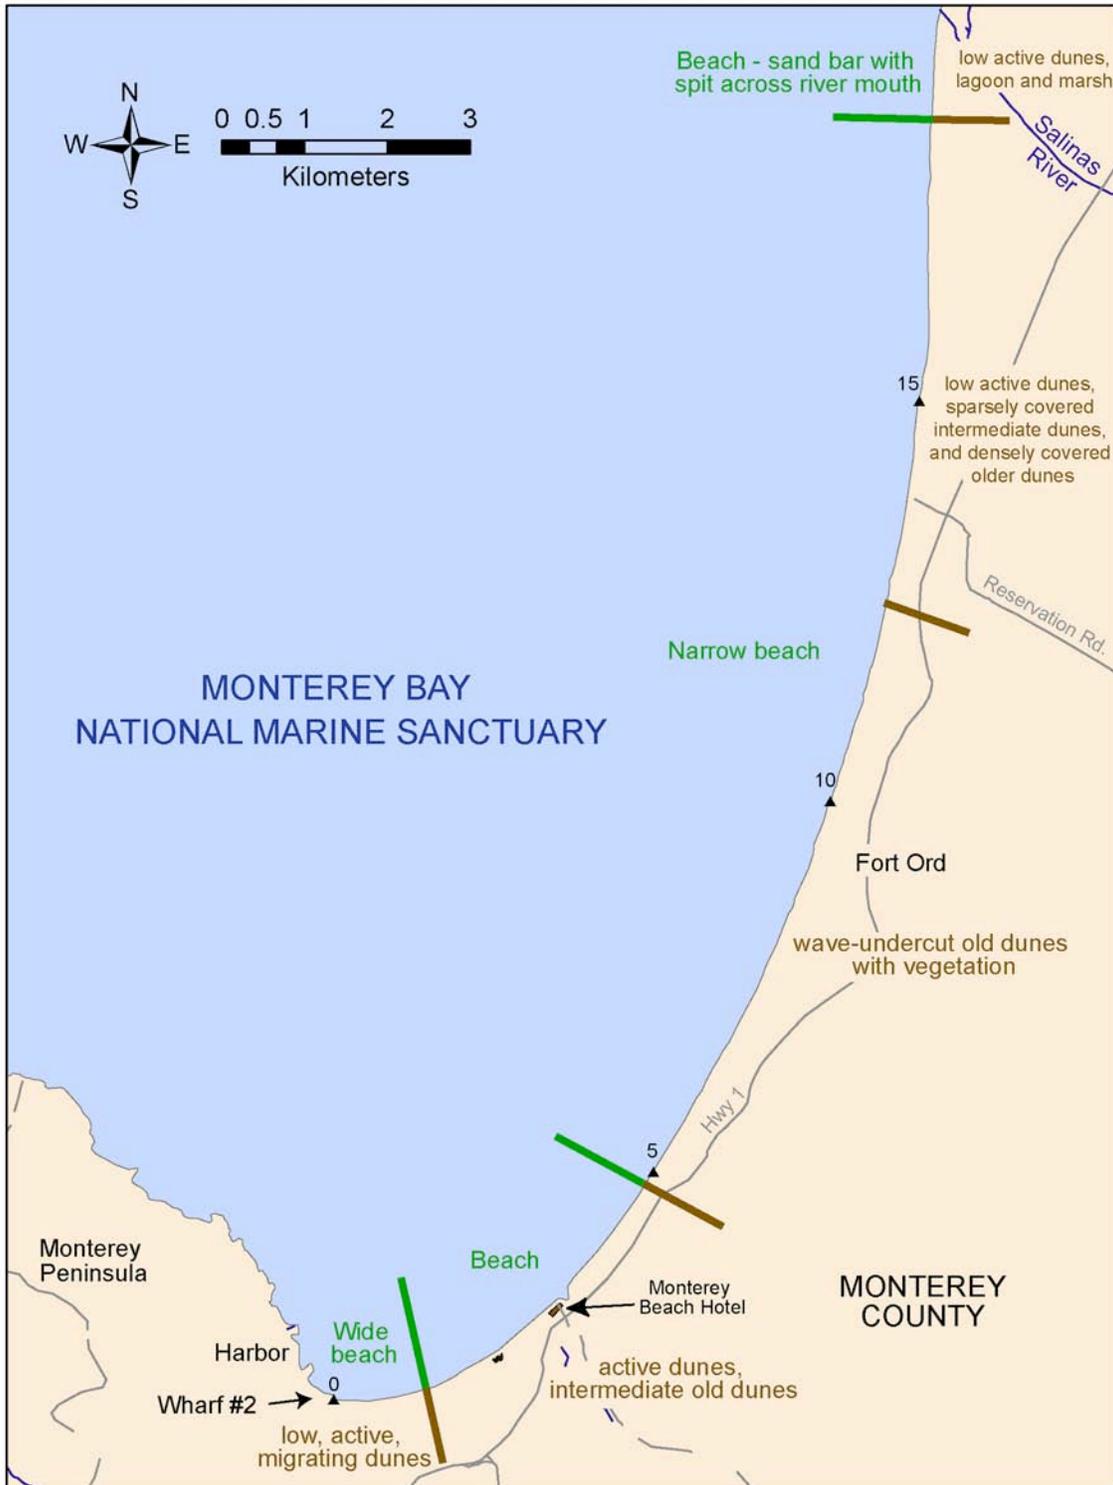
Figure 1.4: Relative beach width (green text) and adjacent dune morphology (brown text) in southern Monterey Bay. Distances from Wharf #2 in Monterey are shown in kilometers (black triangles). Coastline descriptions from Coyne (2001).

The shoreline of SMB is an 18 km stretch of continuous sandy beach, being wider at the southern end than at the northern end (Figure 1.4). The morphology of beaches in this region varies from season to season, but they are generally wider and gently sloping in summer and narrower and steeper in winter. The dunes at the back edge of the beach have an average height of 10.3 m, but can be as high as 46 m (Thornton et al. in press)

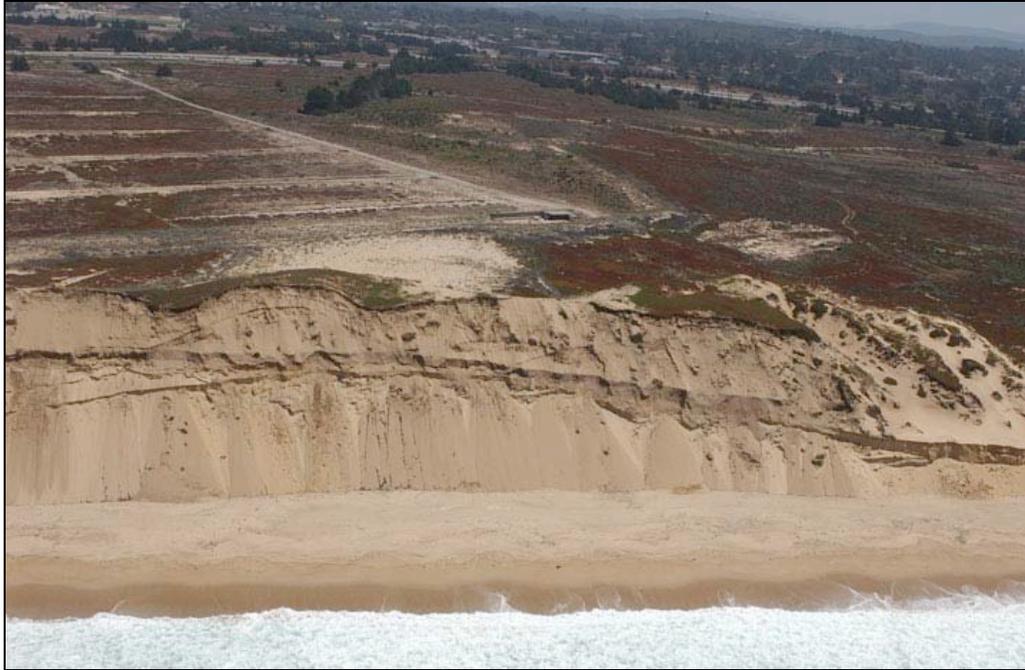
Figure 1.5: Aerial photograph of wave-cut dunes near the relatively undeveloped area of Fort Ord, California. This type of erosion provides much of the sand for the southern Monterey Bay littoral system. Despite the fact that this photograph was taken in summer, the beach is relatively narrow. During storms and/or high tides, waves wash up the beach and undercut the dunes. See Figure 1.4 for location of Fort Ord. Photograph copyright © 2002 Kenneth & Gabrielle Adelman (<http://www.californiacoastline.org/>).

(Figure 1.5). Most of the dune surfaces that are not directly exposed to wave energy are vegetated, indicating that the dunes are stabilized in some areas. Yet, drifting sand across Highway 1 is evidence of some inland dune migration because of prevailing onshore winds (Figure 1.6). Erosion of these dunes, which has been occurring since sea level began to rise at the end of the last glacial period, is the dominant sand supply to the SMB littoral cell (Figure 1.3).

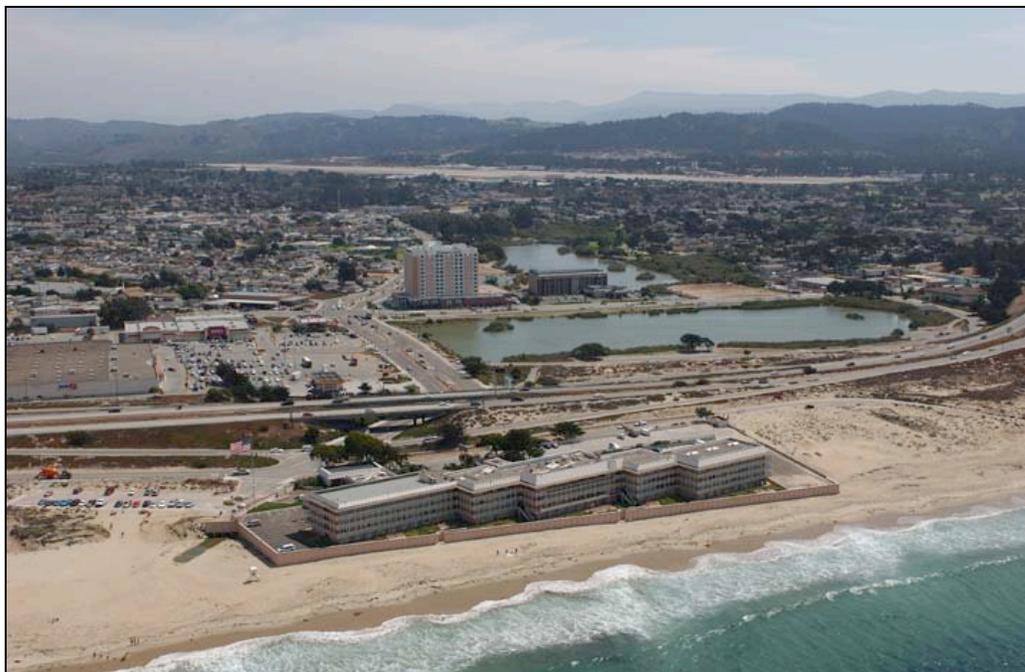
Figure 1.6: Aerial photograph of the Monterey Beach Hotel (Seaside, CA) in summer, showing a wide beach, low back-beach area, and migrating dunes. In contrast to Figure 1.5, there is significant development along this stretch of southern Monterey Bay. See map Figure 1.4 for location of the hotel. Photograph copyright © 2002 Kenneth & Gabrielle Adelman (<http://www.californiacoastline.org/>).

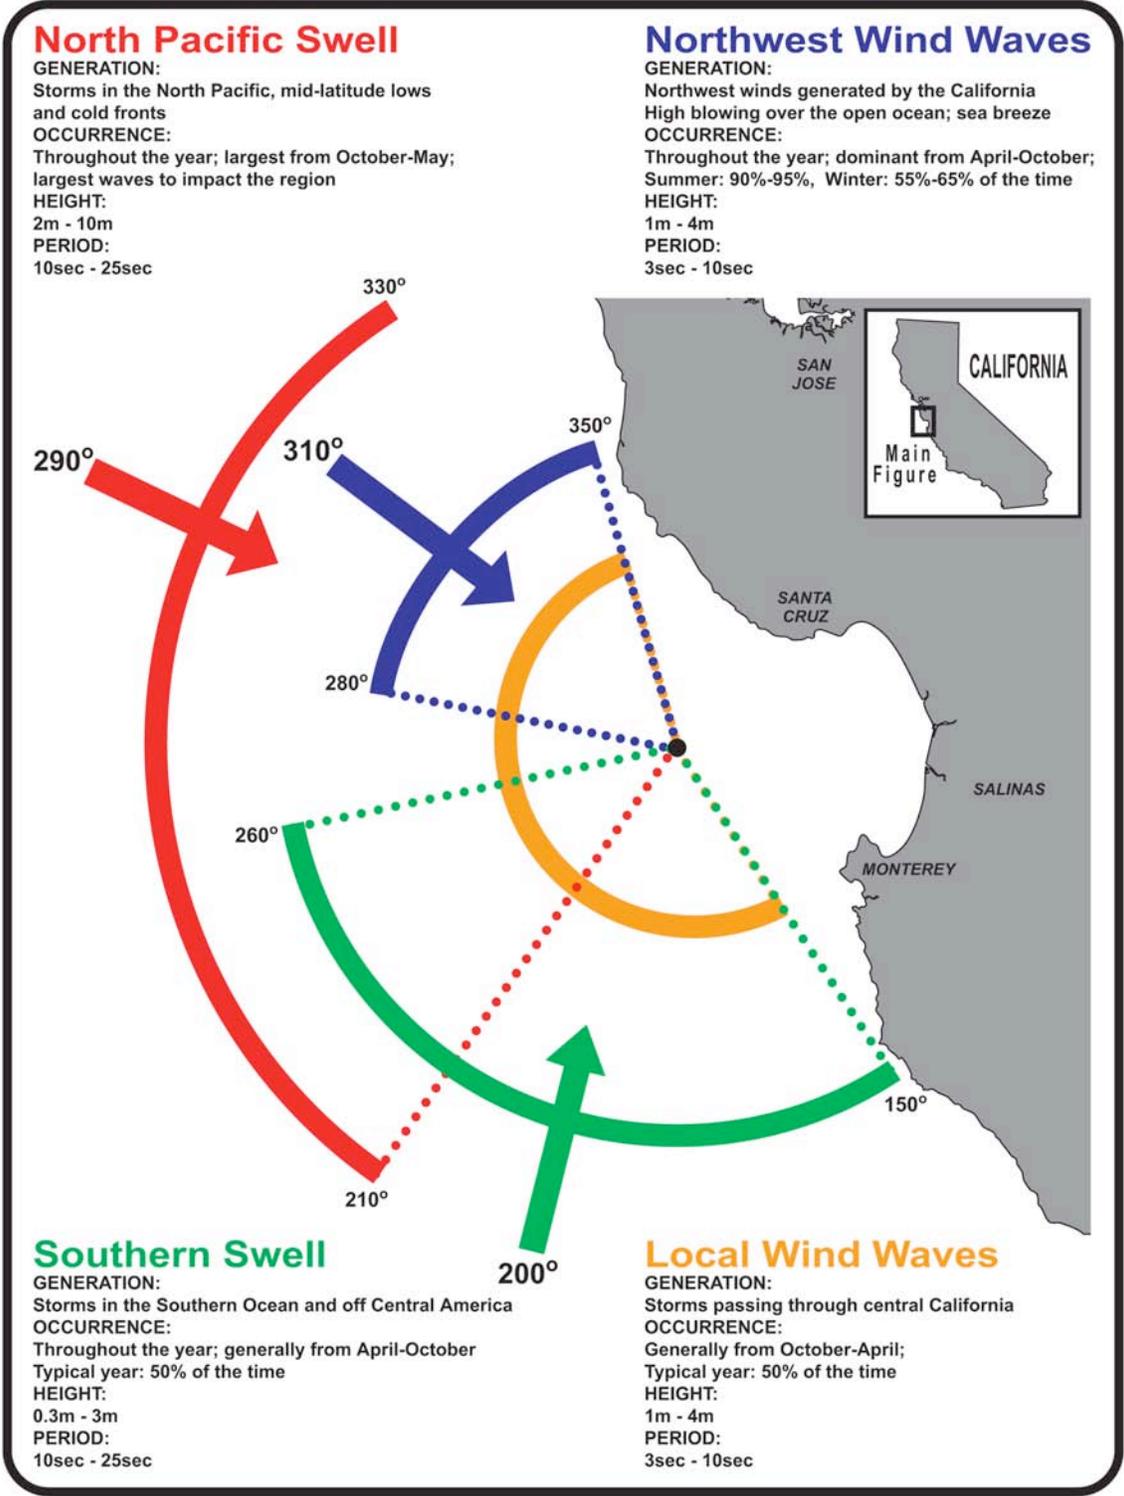
Figure 1.7: Major wave patterns impacting the Monterey Bay. This compilation was generated by analyzing almost ten years of hourly buoy data on wave height, period and direction, as well as wind speed and direction (Storlazzi and Wingfield 2005).

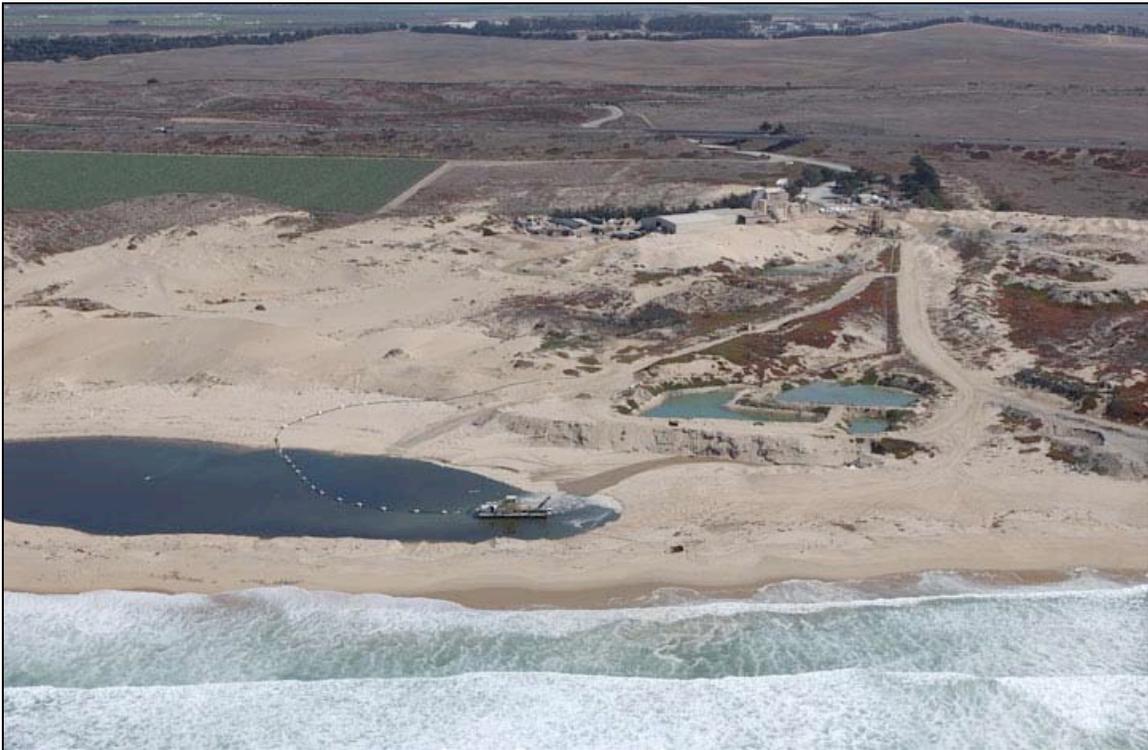
Figure 1.8: Sand mining operations in northern Marina, California. The company has dredged a lagoon from which they extract sand. Some argue that the lagoon actually traps beach material in addition to dune sand. See Figure 1.9 for location of mine. Aerial photograph taken in October 2004; copyright © 2002 Kenneth & Gabrielle Adelman (<http://www.californiacoastline.org/>).

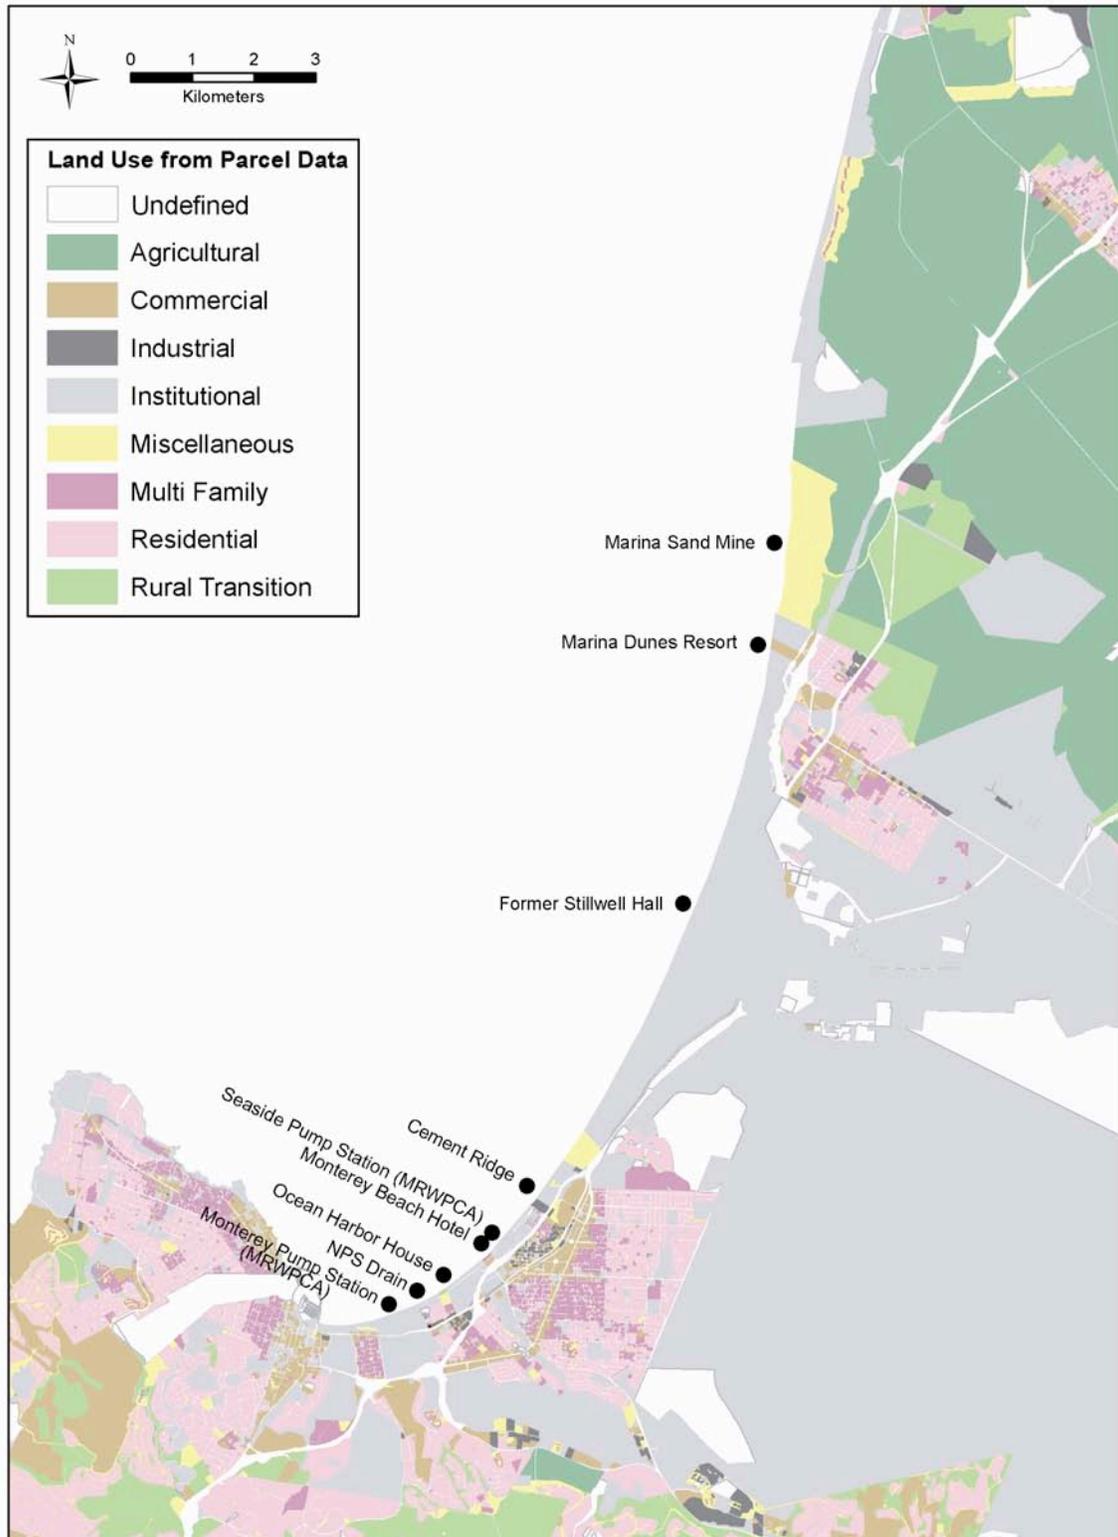
Figure 1.9: Generalized land use in southern Monterey Bay, adapted from Monterey County parcel data. Coastal development features, discussed in later in this report, are also highlighted.

The coastal zone in SMB is relatively undeveloped, which is consistent with the inherent hazards of building in dynamic beach and dune environments (Figure 1.9). Many kilometers of the sandy shoreline and back-beach area are protected as state parks, including Marina State Beach, the new Fort Ord Dunes State Park, and Monterey State Beach. These long stretches are used primarily for recreation, including hiking, hang-gliding and picnicking; strong rip currents make swimming and surfing hazardous.

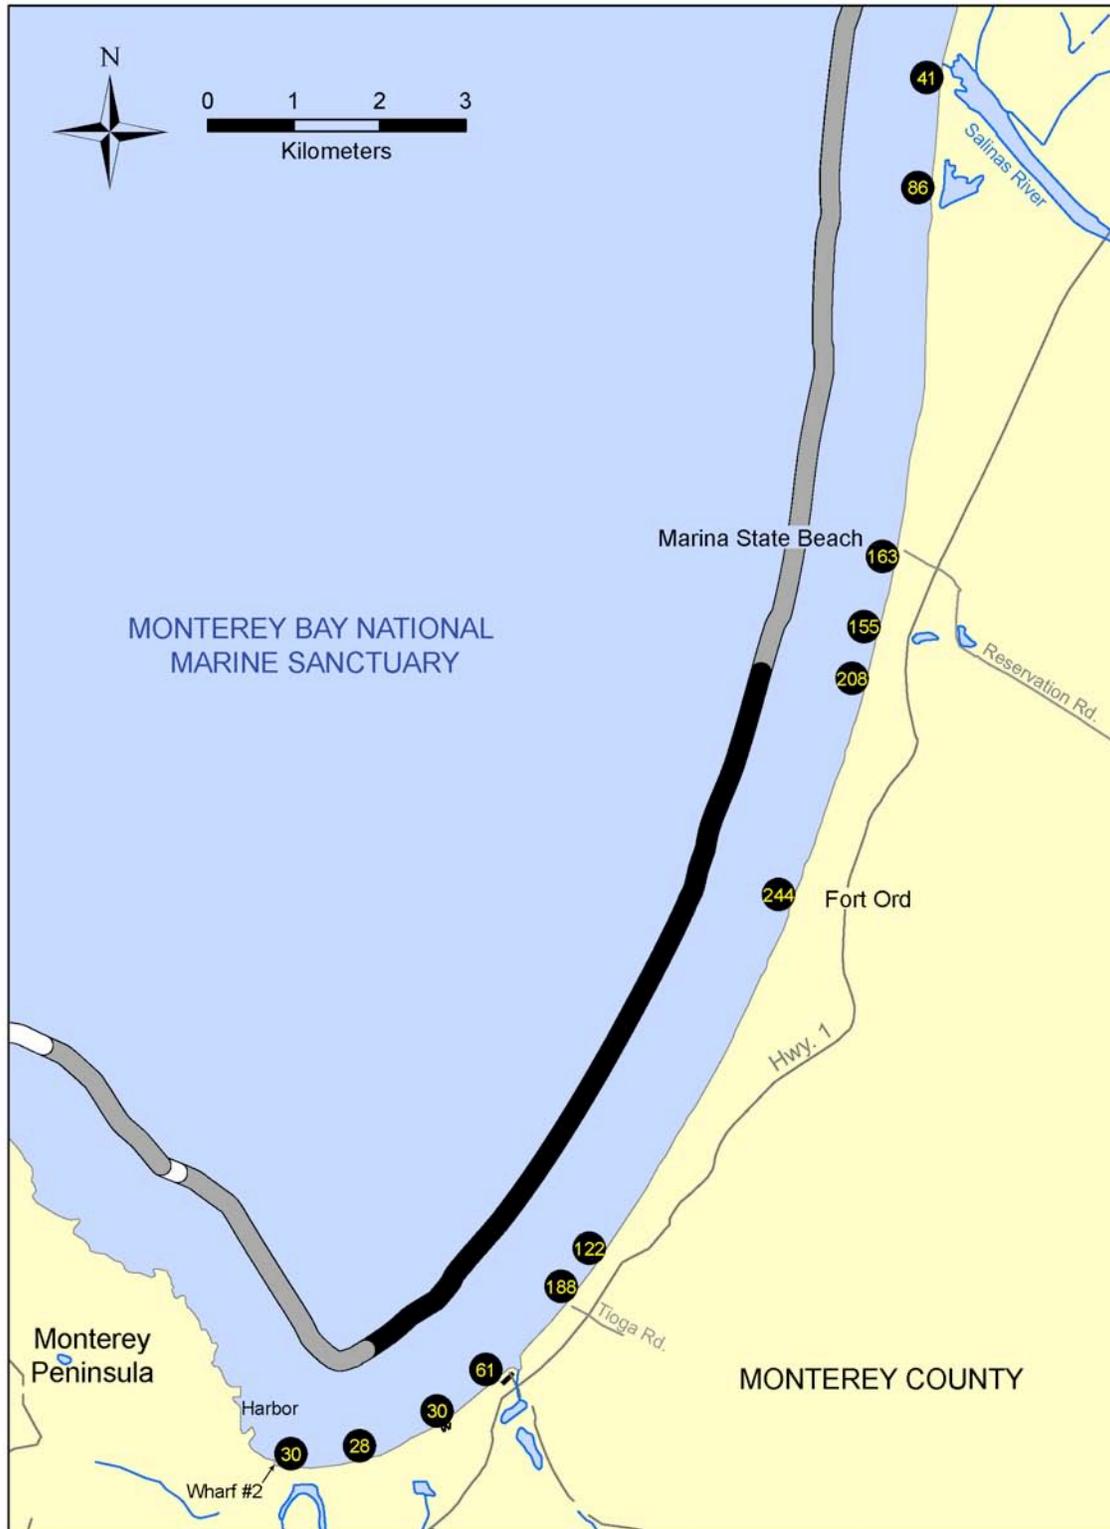
Figure 2.1: Coastal erosion rates, reported in centimeters per year (black circles), and relative hazard zones (black=high risk, grey=moderate risk, white=low risk) as documented in *Living with the Changing California Coast* (Griggs et al. in press). For reference, 100 cm = 3.28 ft.

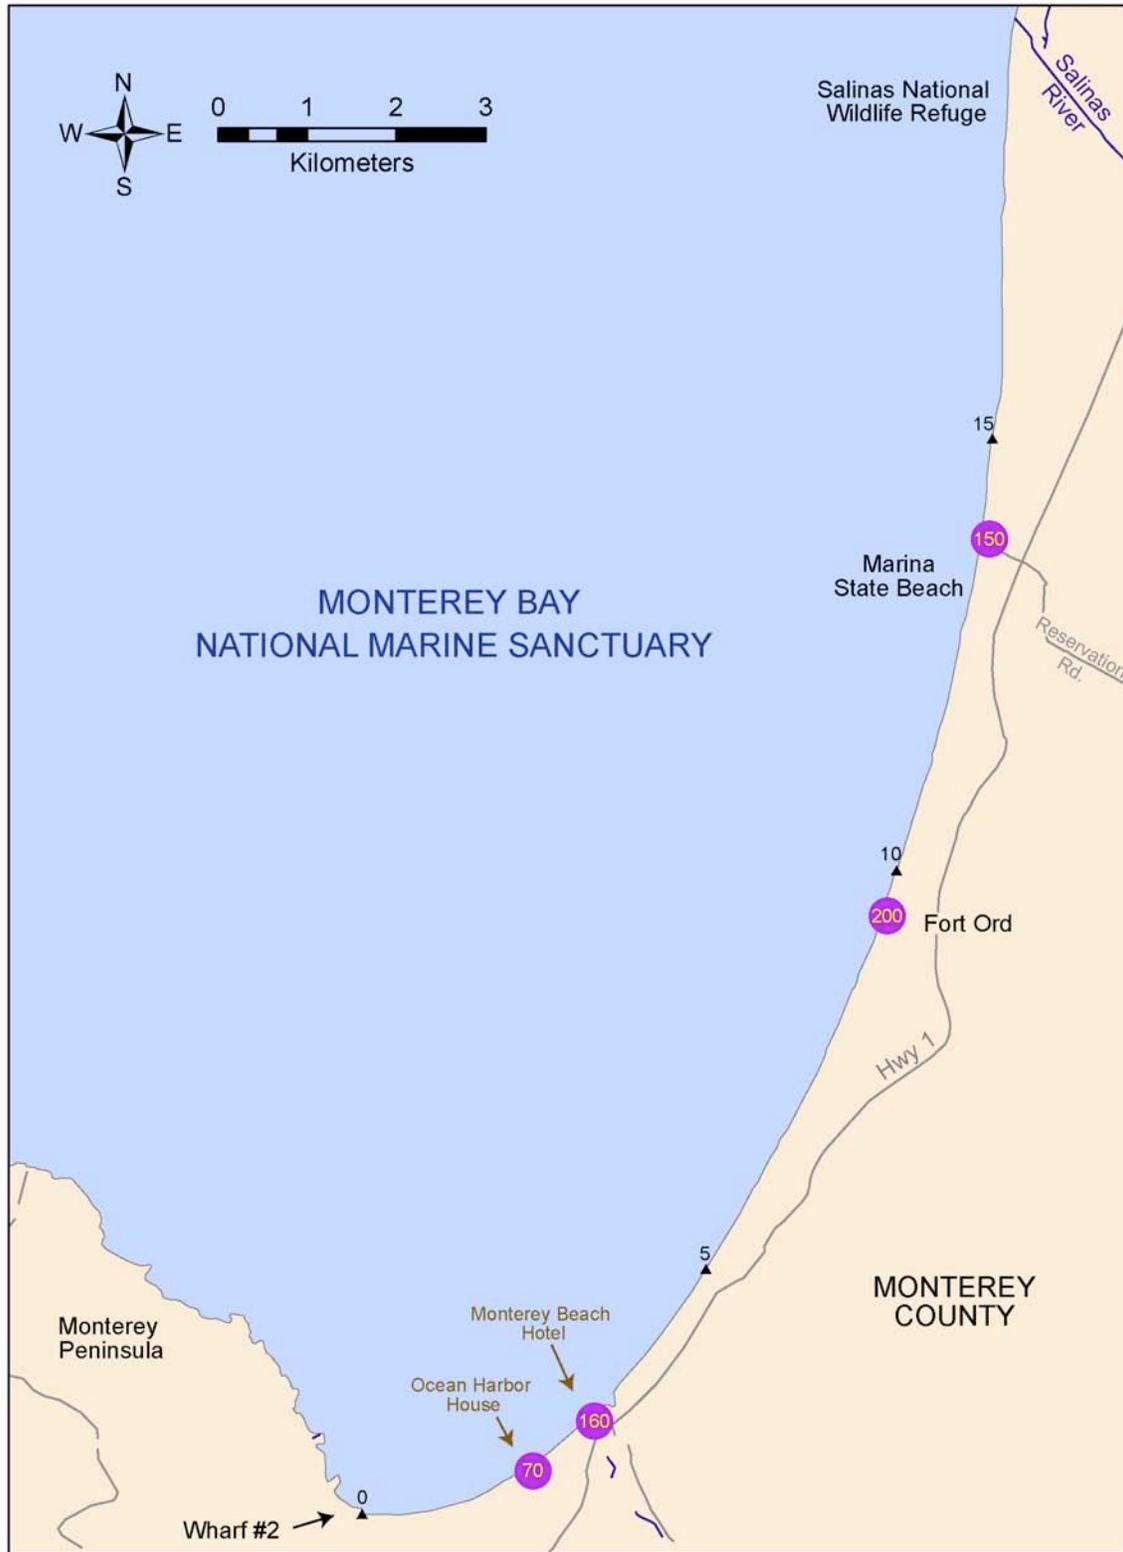
Figure 2.2: Coastal erosion rates reported in centimeters per year (purple circles), as determined by Gref (2004) of CSUMB. Rates were calculated over the years 1976-2004. Distances from Wharf #2 in Monterey are in kilometers (black triangles). For reference, 100 cm=3.28 ft.

For Marina State Beach, at the end of Reservation Road, Gref calculated rates along 10 shore-normal transects and found a total retreat rate of 150 cm/yr (4.9 ft/yr) (Figure 2.2). Near the former Stilwell Hall site, on Fort Ord coastal property, 14 transects were averaged to yield an erosion rate of 200 cm/yr (6.6 ft/yr). Erosion across 14 transects for the 4 years of measurements was 160 cm/yr (5.2 ft/yr) near the Monterey Beach Hotel in Seaside. Rates were calculated for the areas adjacent to, not in front of, the hotel's seawall, because the seawall has fixed the coastline since 1968. Finally, Gref determined

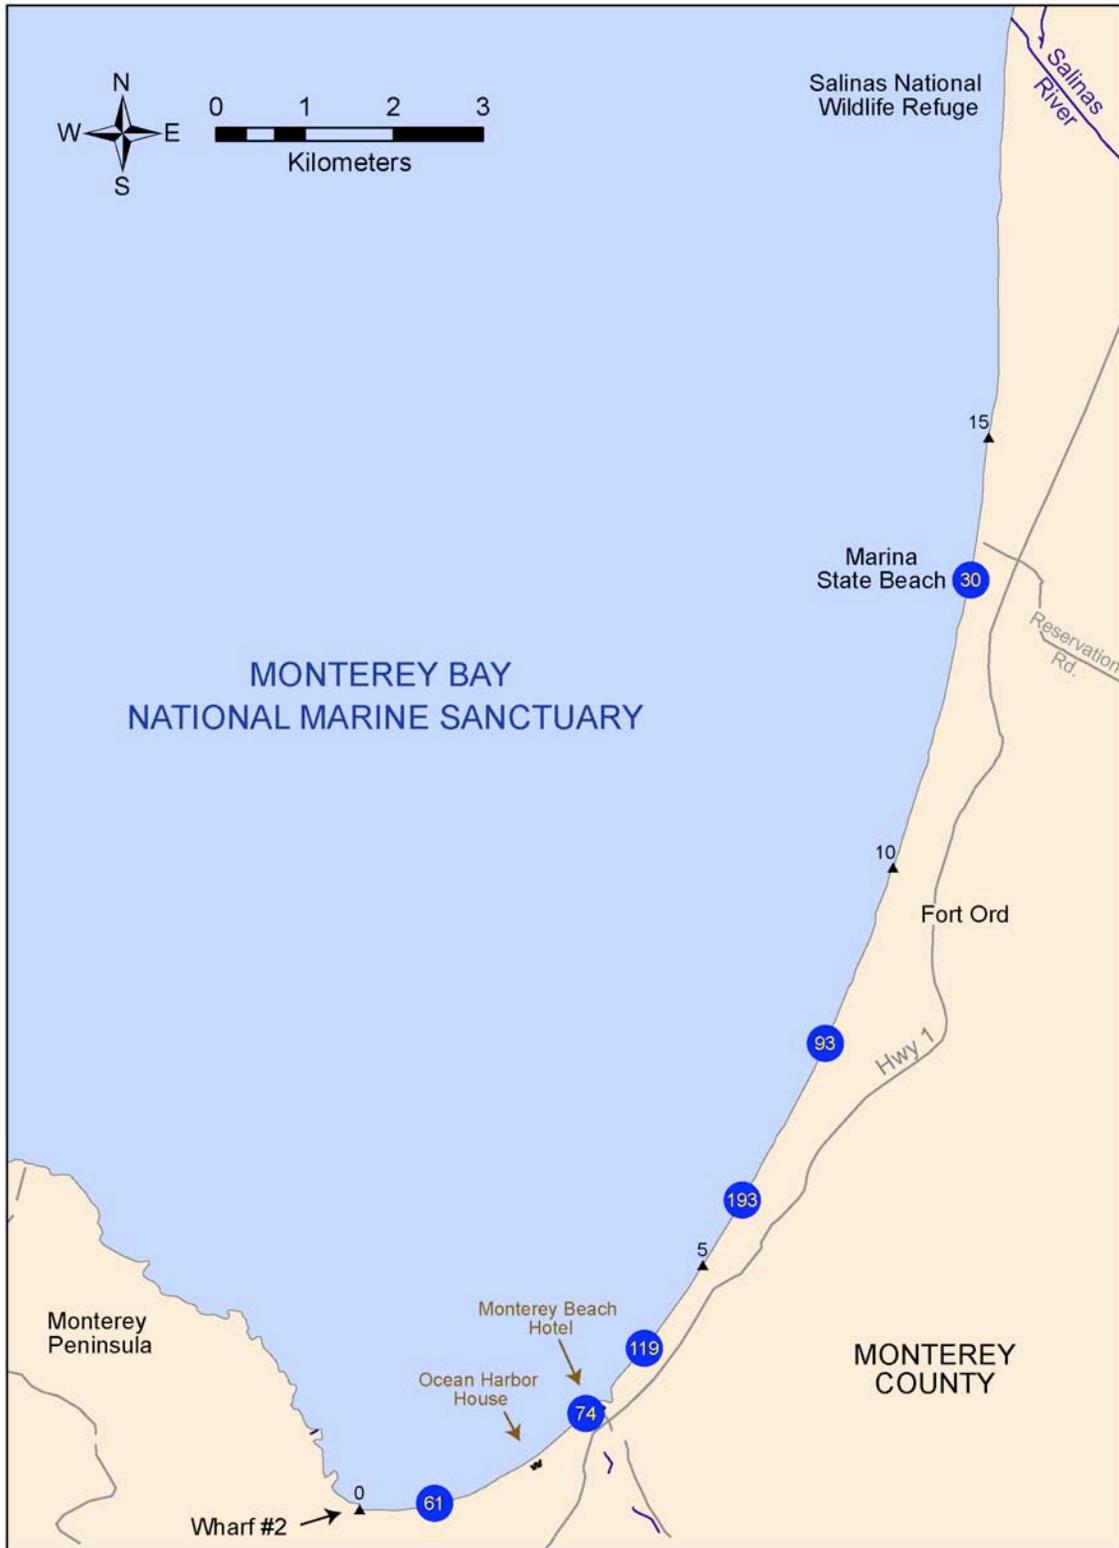
Figure 2.3: Coastal erosion rates in centimeters per year (blue circles) for the time period 1940-1984, as documented by Thornton et al. (in press). Distances from Wharf #2 in Monterey are in kilometers (black triangles). For reference, 100 cm=3.28 ft.

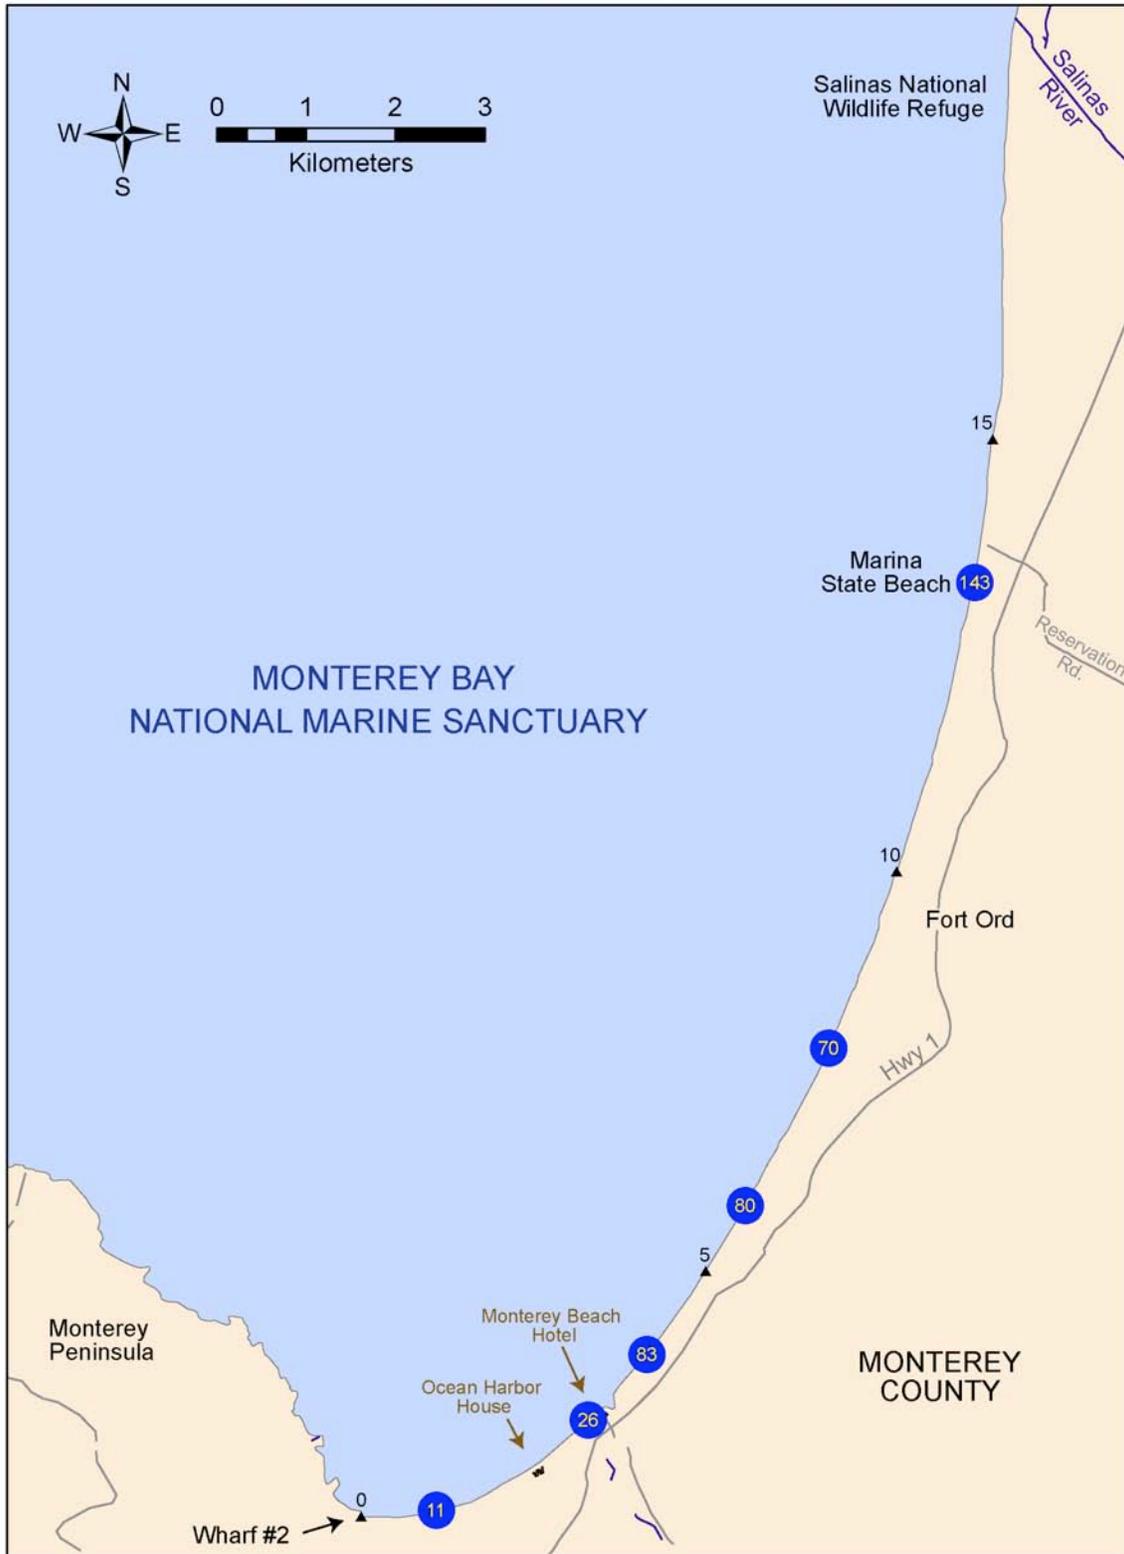
Figure 2.4: Coastal erosion rates in centimeters per year (blue circles) for the time period 1984-2004, as documented by Thornton et al. (in press). Distances from Wharf #2 in Monterey are in kilometers (black triangles). For reference, 100 cm=3.28 ft.

Despite intense erosion documented during the 1997-98 El Niño winter, when 1,820,000 m³ of dune sand was lost, erosion rates for the 1984 to 2004 time period were lower than those reported from 1940 to 1984. From 1984 to 2004, coastal retreat was highest (143 cm/yr or 4.7 ft/yr) just south of Reservation Road, at Marina State Beach. Three erosion measurements in the middle of the study region, from a site approximately 1.5 km south of the former Stillwell Hall locale to Sand City Beach, ranged from 70 to 83 cm/yr (2.3 to 2.7 ft/yr). Two relatively low erosion rates were documented in the southern end of the study area: 26 cm/yr (0.85 ft/yr) near the Monterey Beach Hotel and 11 cm/yr (0.46 ft/yr) 0.9 km east of Wharf #2 (Figure 2.4).

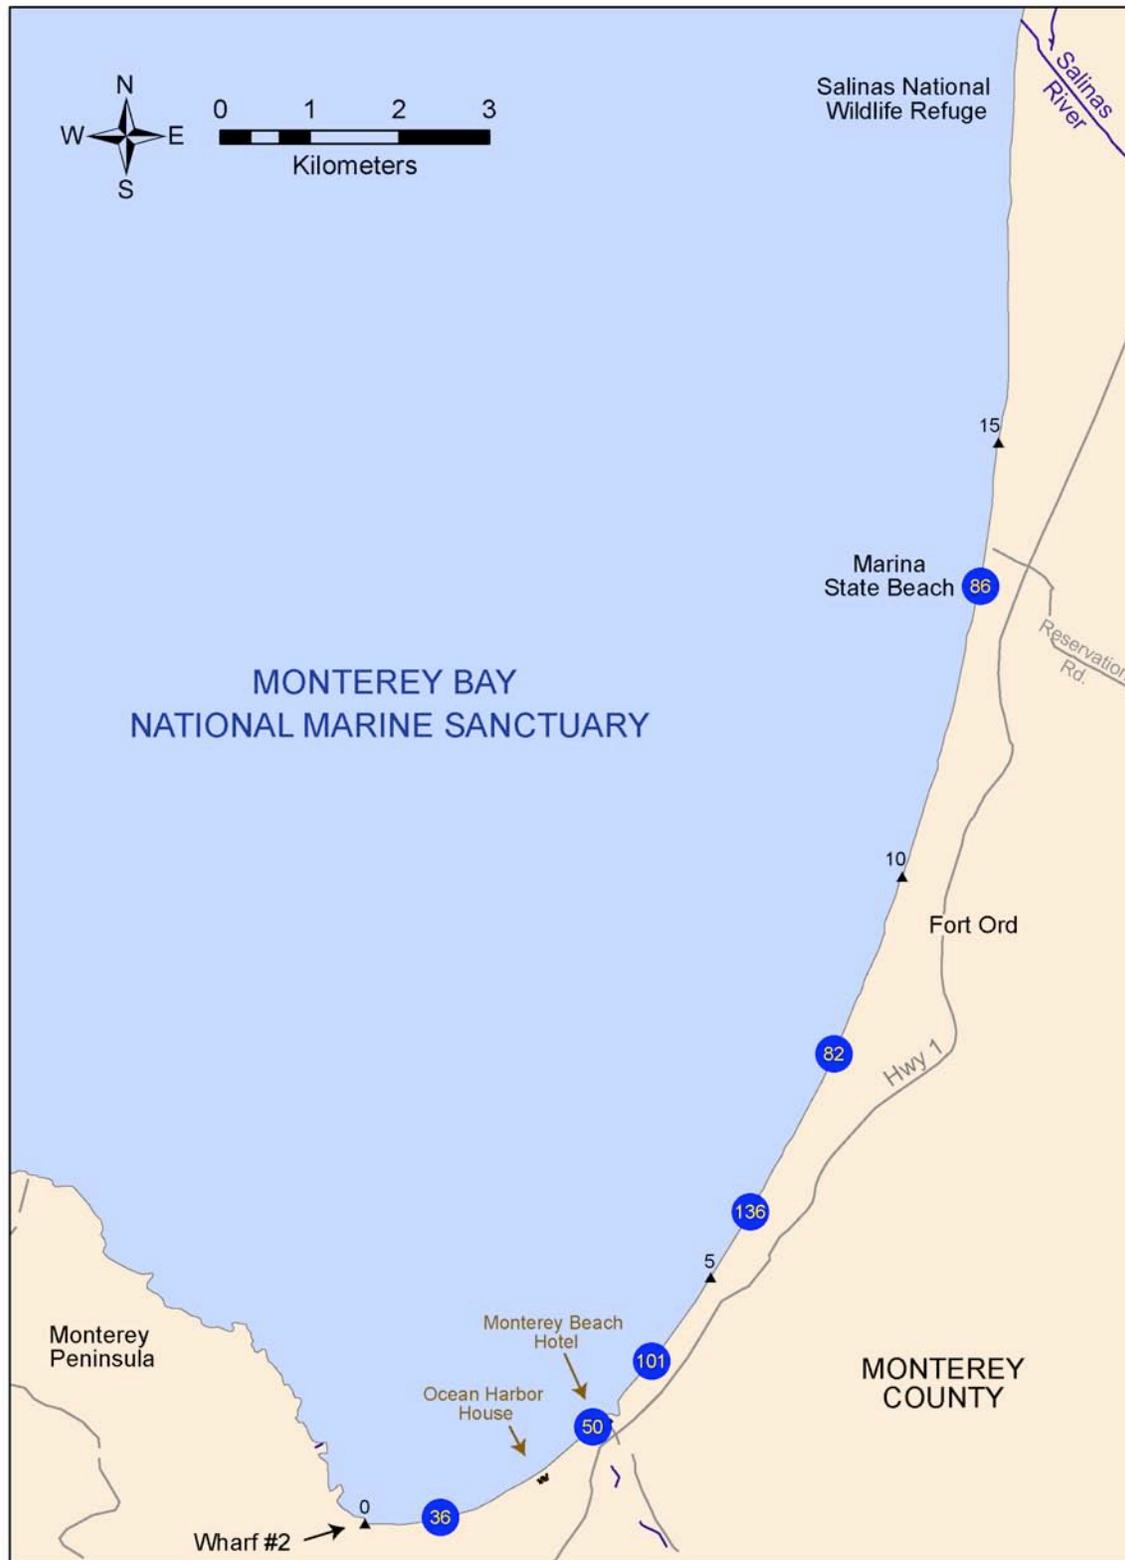
Figure 2.5: Coastal erosion rates in centimeters per year (blue circles) for the time period 1940-2004, averaged from Thornton et al. (in press). Distances from Wharf #2 in Monterey are in kilometers (black triangles). For reference, 100 cm=3.28 ft.

Planners will have to decide what their goal is when using the data presented by Thornton et al: if they want to compare this study with other studies that go back prior to 1984, it appears that an averaged (1940-2004) rate would be the most appropriate; if they want to get an idea of what current coastal retreat rates are, the 1984-2004 rates may be relevant. Yet Thornton et al. stress that caution should be taken when relying upon just the 1984-2004 rates because only 4 data sets were used in the calculation. Given the episodic nature of dune erosion in this region, a more conservative estimate of erosion would come from more robust, longer-term data (e.g., 1940-2004), despite the cessation of sand mining (Figure 2.5).

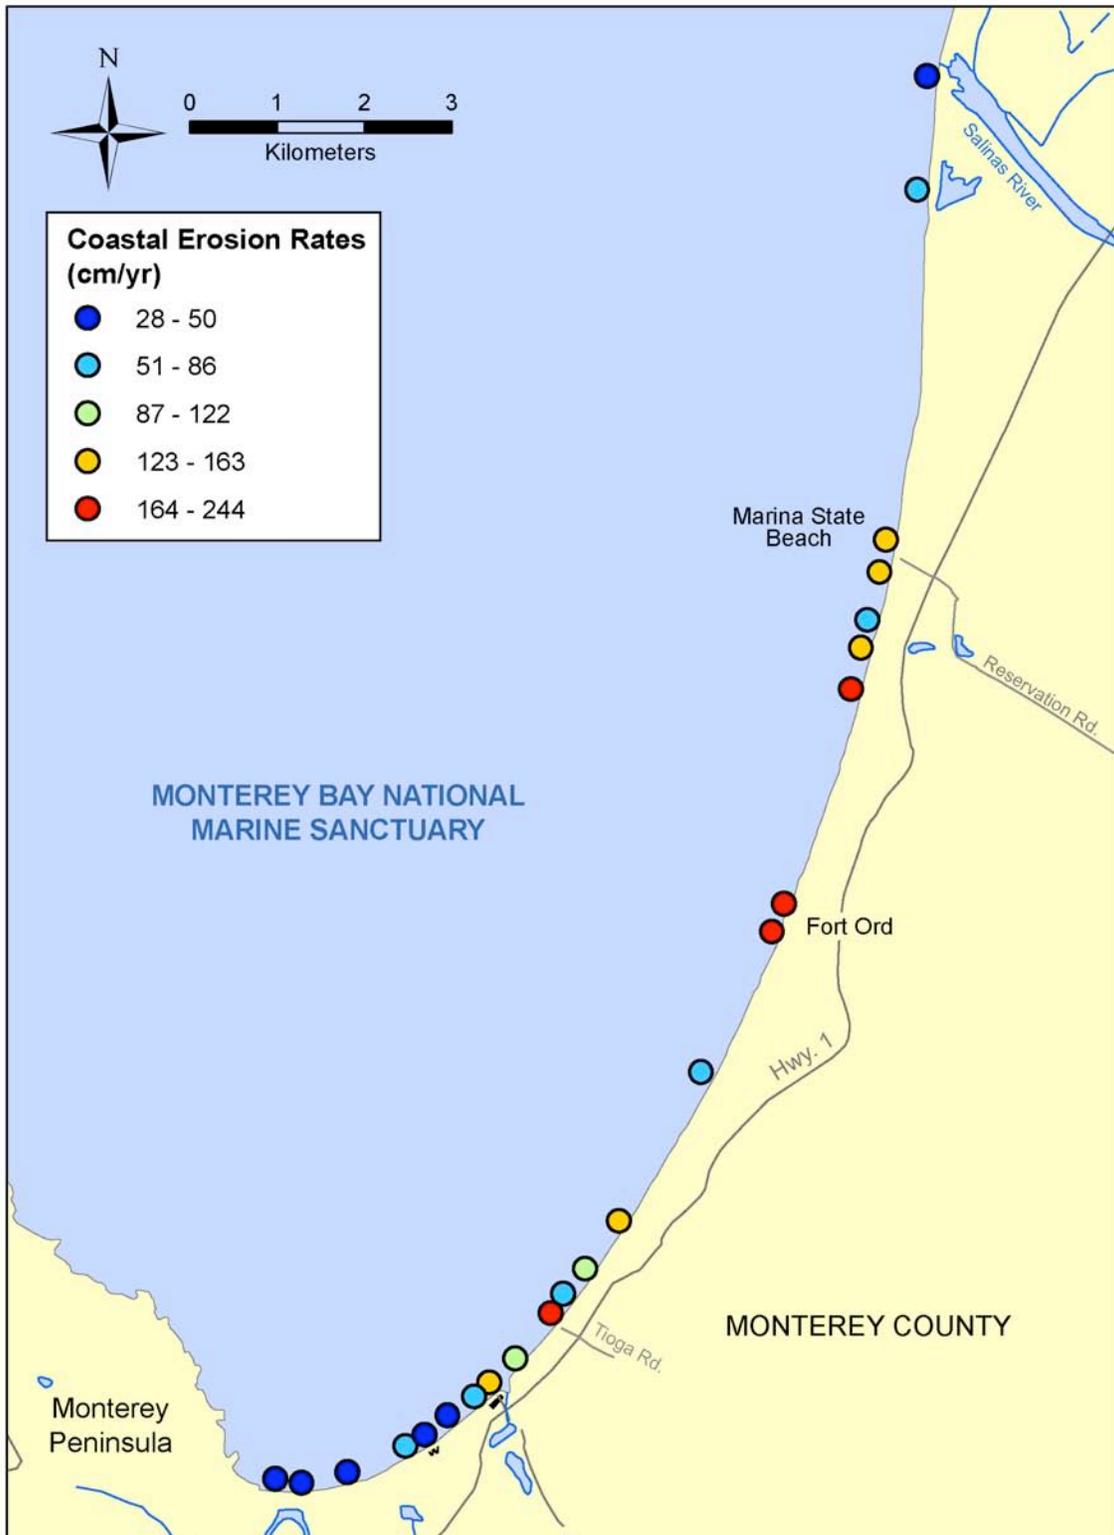
Figure 2.6: Coastal erosion rates for the study area, combining all available data (HKA 2003a; Gref 2005; Griggs et al. in press; Thornton et al. in press). Warm colors indicate more intense erosion than cool colors. For reference, 100 cm = 3.28 feet. See Appendix 2 for erosion rate data.

Combining all available erosion rates described above serves to highlight the general erosion trends in this area (Figure 2.6). Rates are highest near Fort Ord and generally dissipate to the north and south. This is in agreement with the overall oceanographic patterns, which focus wave energy in the Fort Ord region, and with the extreme erosion witnessed around the former Stillwell Hall (see Figure 4.1). This trend is also consistent with preliminary results of the USGS *National Assessment of Shoreline Change* project (Reid 2005). It is important to note that, because of the diversity of time scales and methods by which erosion rates were measured in these various studies, Figure 2.6 should be used only to highlight general erosion patterns and as a guide to focus future erosion hotspot analyses.

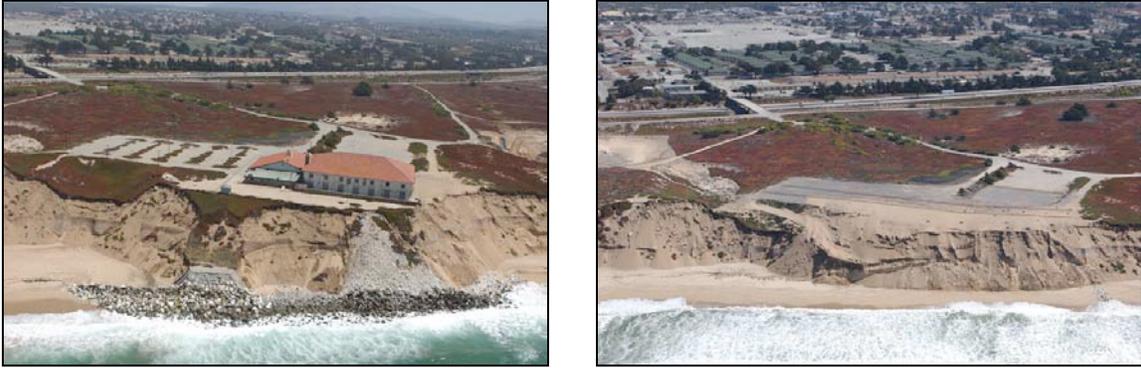
Figure 4.1: The former Fort Ord soldier's club, Stillwell Hall, was demolished in 2004 because attempts to save the structure from collapsing into the ocean by emplacing riprap in front of the dunes proved to be too costly and ineffective. Left photo taken August 2003, prior to demolition. Right photo taken October 2004 after removal of structure and all riprap. Photographs copyright © 2002 Kenneth & Gabrielle Adelman (<http://www.californiacoastline.org/>). See Figure 5.1 for location.

the Fort Ord soldier's club in Seaside, California, was torn down in March 2004 because the cost of both coastal armoring and relocating were too high (Figure 4.1).
