COASTAL EROSION AND ARMORING IN SOUTHERN MONTEREY BAY

A Technical Report in support of the
Monterey Bay National Marine Sanctuary
Coastal Armoring Action Plan

Version 1.1

June 2005

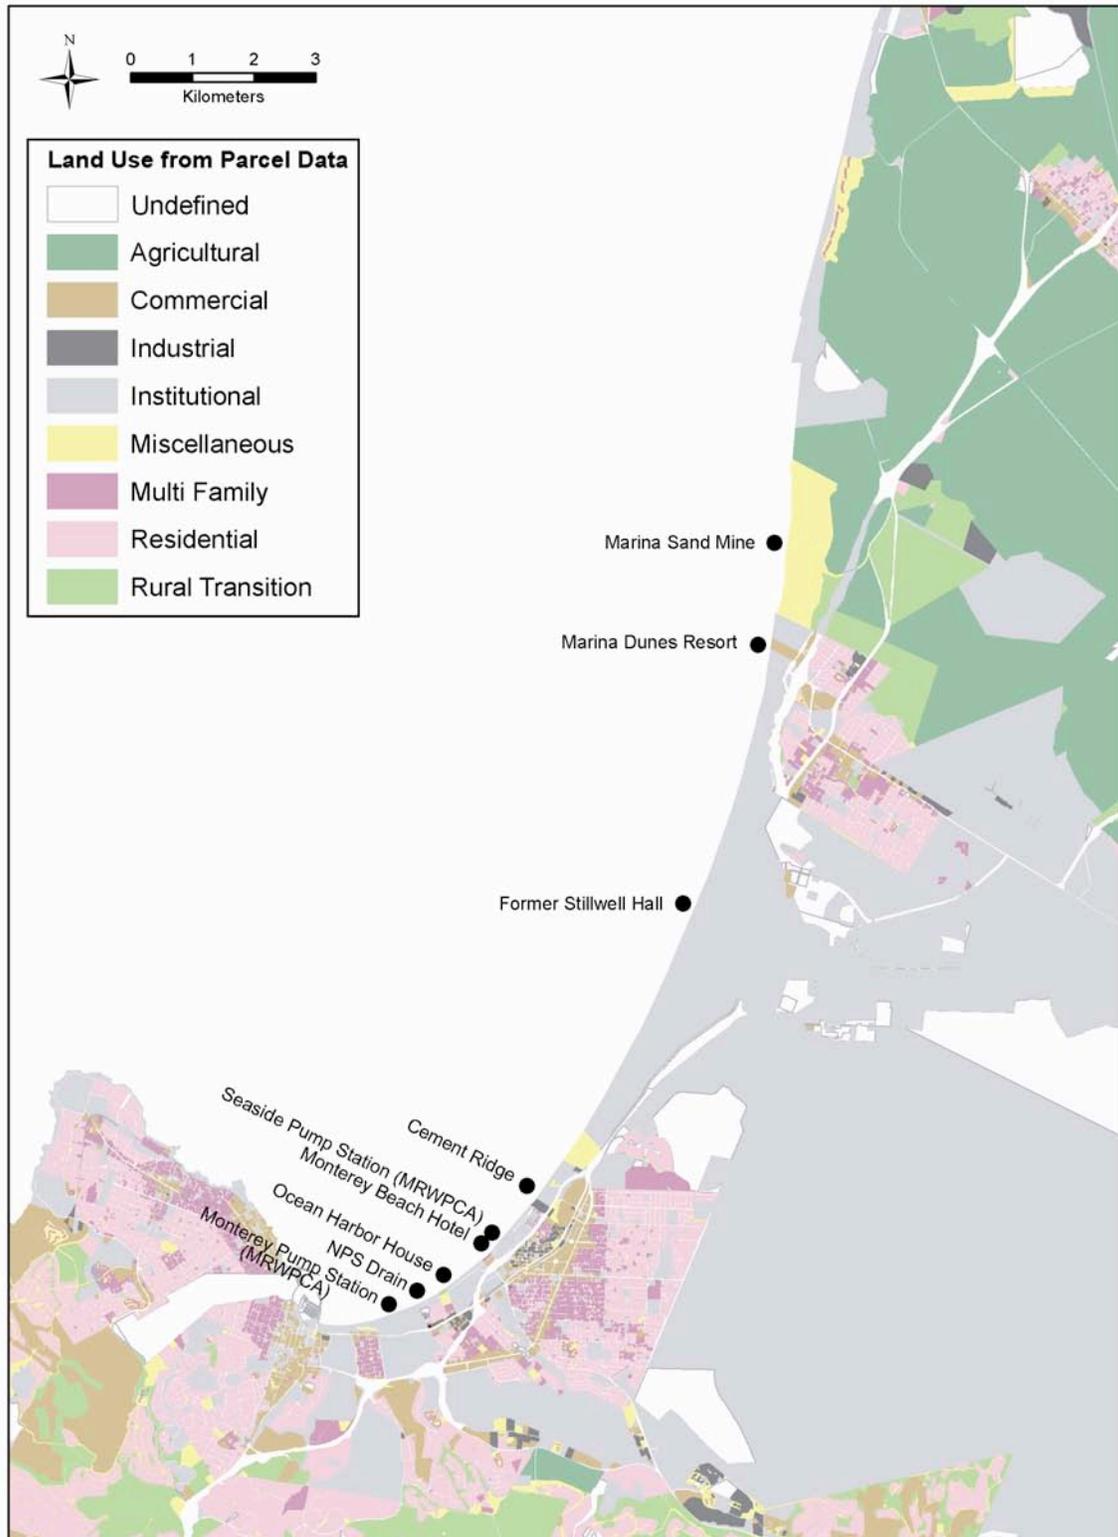
Figure 5.1: Approximate locations of development features along the SMB shoreline. Coastal armoring exists at the sites labeled: Cement Ridge, Monterey Beach Hotel, Ocean Harbor House and Naval Postgraduate School (NPS) Drain. Base layer shows generalized land use derived from parcel data.

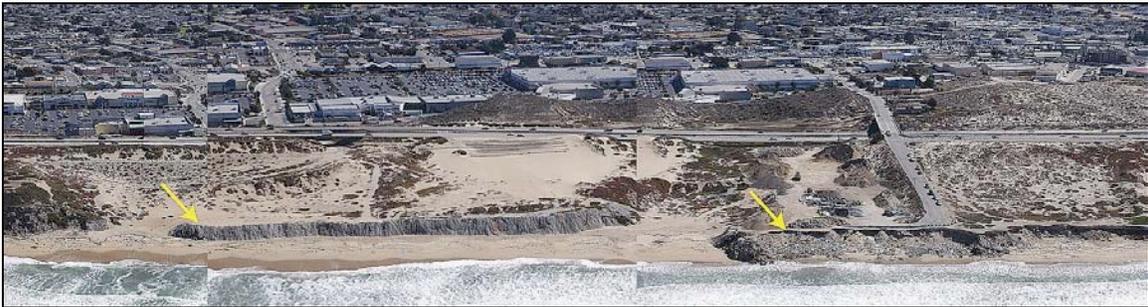
Figure 5.2: Aerial photo mosaic of the concrete slurry “ridge” and other hard structures (indicated with yellow arrows) at the end of Tioga Road in Sand City, California. Photographs taken October 2004; copyright © 2002 Kenneth & Gabrielle Adelman (<http://www.californiacoastline.org>).

Remnants of a cement mixing facility are located at the end of Tioga Road in Sand City that forms make-shift coastal armoring (Figures 5.1 and 5.2). Concrete slurry was dumped here in a linear, shore-parallel pattern. The ridge formed by this cement is over 200 meters long and acts much the same way as a seawall (Thornton et al. in press). The impacts of this structure are similar to that of engineered coastal armoring in terms of blocking access, preventing natural shoreline retreat, and losing beach area both for recreation and as a habitat (HKA 2003a). The structure is an eye-sore to the community. In addition, riprap, composed mostly of un-engineered cement blocks, has been emplaced on the seaward side of Tioga Road as it turns parallel to shore.

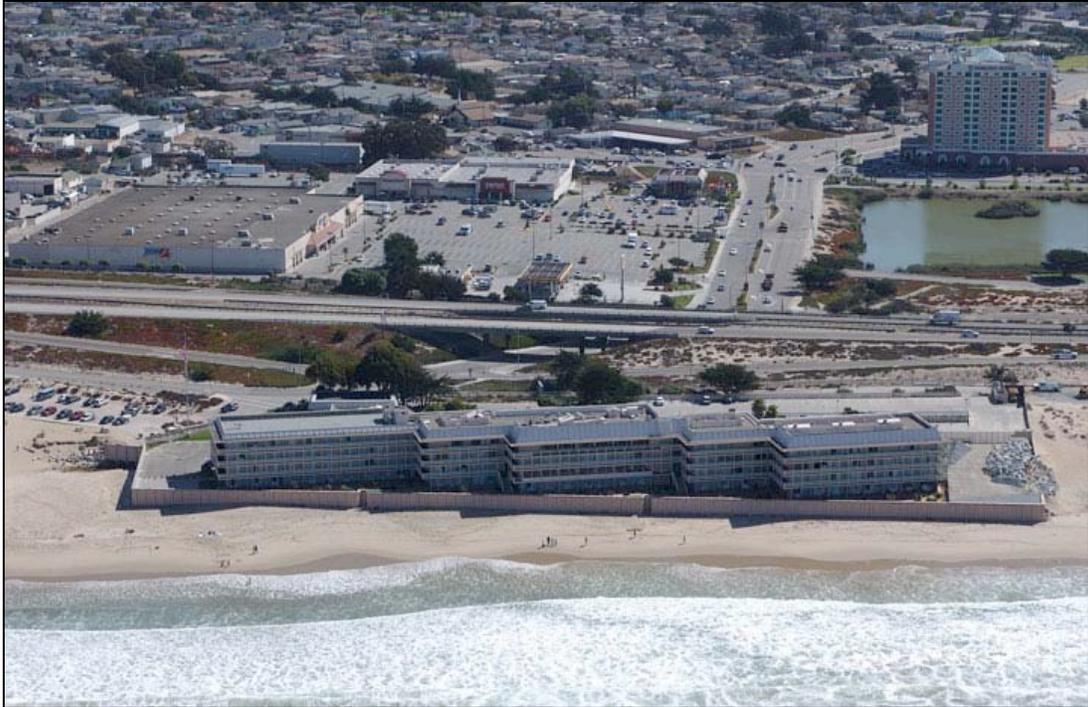
Figure 5.3: Aerial photograph of the seawall and riprap (at the far right end of the seawall) protecting the Best Western Monterey Beach Hotel in Seaside, California. Photograph taken October 2004; copyright © 2002 Kenneth & Gabrielle Adelman (<http://www.californiacoastline.org/>).

In 1968, a 196-room, 4 story hotel was built directly on the beach in Monterey, which included a large, 100-m long seawall along three sides of the building (Griggs et al. in press; Thornton et al. in press) (Figures 5.1, 5.3, 5.4 and 5.5). The wall is composed of 6-foot wide keyed concrete panels that are jettied into place and anchored into shallow concrete mat slabs on which the hotel building itself is founded. Therefore, the stability

Given that this is known to be an eroding coast, it is not surprising that the Monterey Beach Hotel seawall came under attack in the early 1980's. In fact, the extreme waves of the 1982-83 El Niño event undermined the concrete and lead to a loss of fill behind the wall. More recently, storm waves coinciding with high tides during the winter of 2002 broke through the south wall and forced the hotel to place emergency riprap in the gap to prevent further damage (Figure 5.4). Large scour holes formed on the inside of the wall, as water penetrated between the panels. Excessive corrosion has occurred because of this damage. The hotel is becoming a prime example of the "peninsula effect:" while the adjacent coastline is retreating due to natural erosion, the seawall has fixed the coastline and is creating an artificial headland out of the hotel (Figure 5.5). As the hotel becomes further isolated, it will experience more and more damage from wave action. In addition, the fronting beach, which is a major attraction of the hotel, will be lost due to this passive erosion.

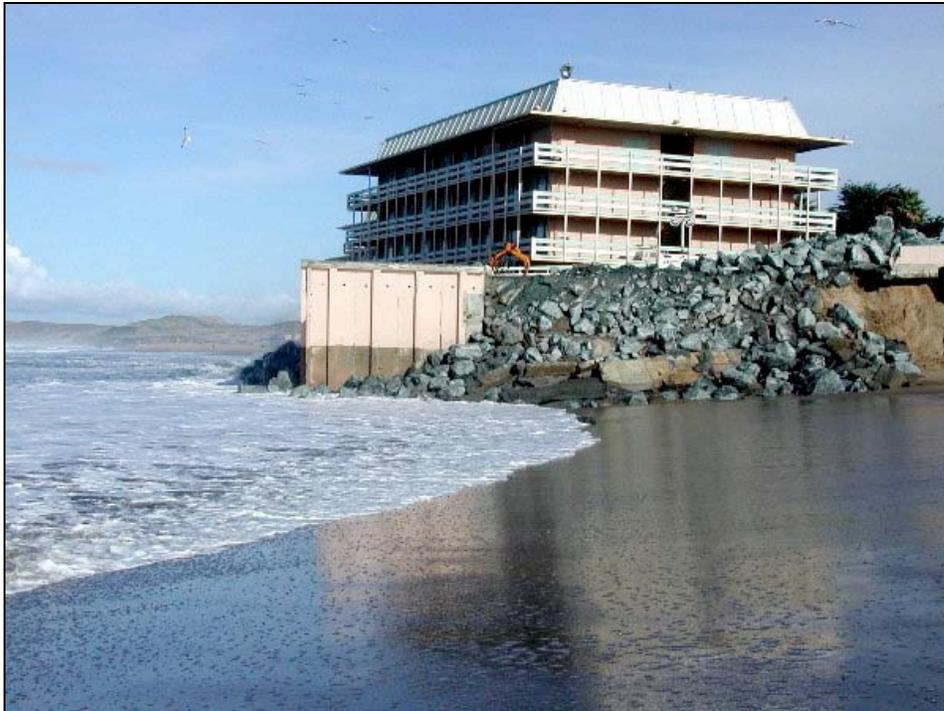
Figure 5.4: Wave run-up against the Monterey Beach Hotel seawall and riprap during the winter of 2002. Lateral access is cut off because of this coastal armoring. Photo: Doug Smith, CSUMB.

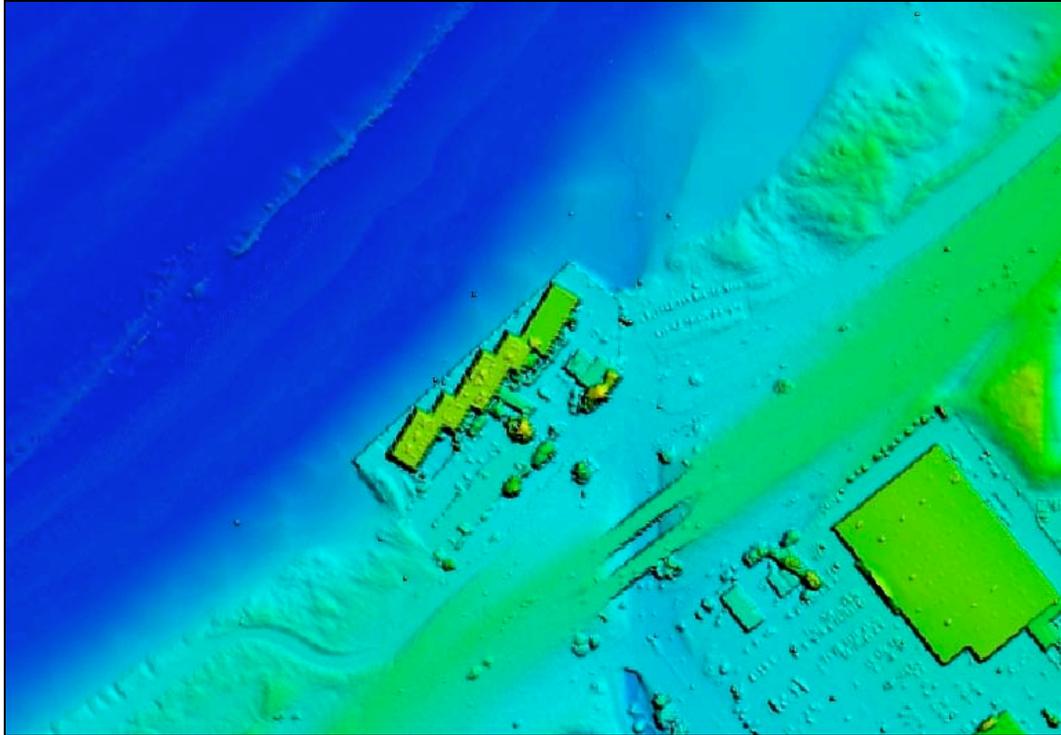
Figure 5.5: LIDAR elevation image of the Monterey Beach Hotel in 2003, showing the obvious erosion on either side of the hotel and the resultant “peninsula effect.” Image: Doug Smith, CSUMB.

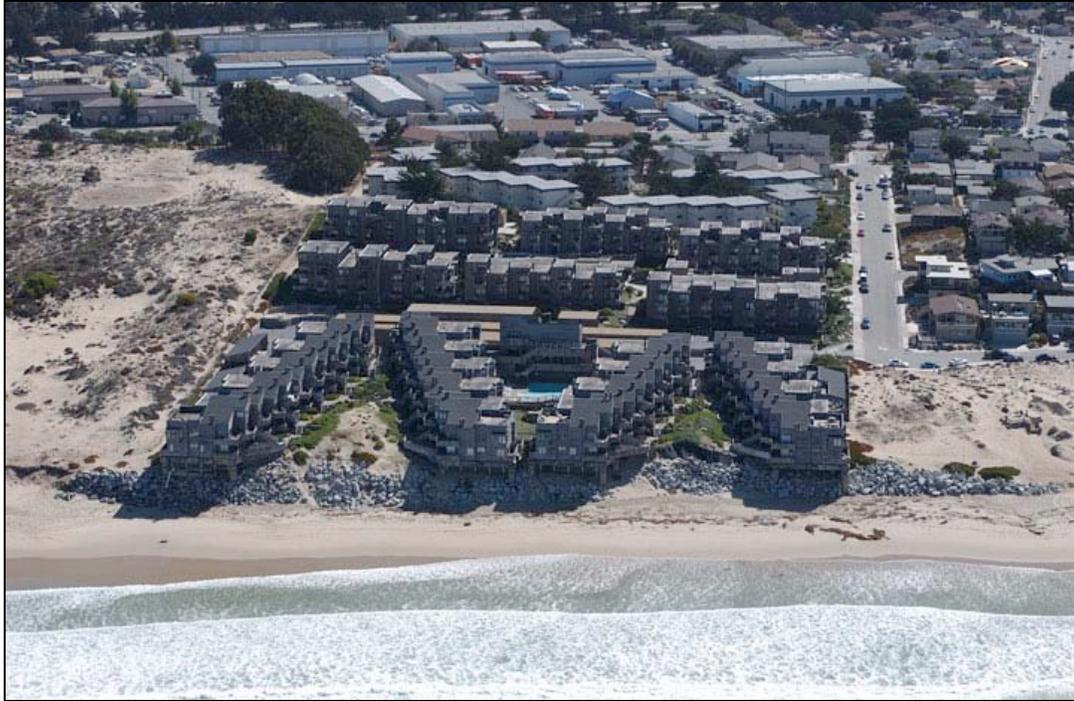
Figure 5.6: Aerial photograph of extensive riprap in front of the Ocean Harbor House Condominiums in Monterey, California. Photograph taken October 2004; copyright © 2002 Kenneth & Gabrielle Adelman (<http://www.californiacoastline.org/>).

time, Ocean Harbor House was converted to condominiums, increasing the number of stake-holders from 1 to 172. Coastal retreat continued and, despite the reinforcements, additional riprap was needed to protect the front condominium units after the 1997-98 El Niño winter (Griggs et al. in press). The riprap is once again on city property and impacts the habitat and beach users in a variety of ways. In addition, the riprap emplaced in the late 1990's appears to be failing, as rocks settle into the sand and disperse (Figure 5.6 and 5.7).

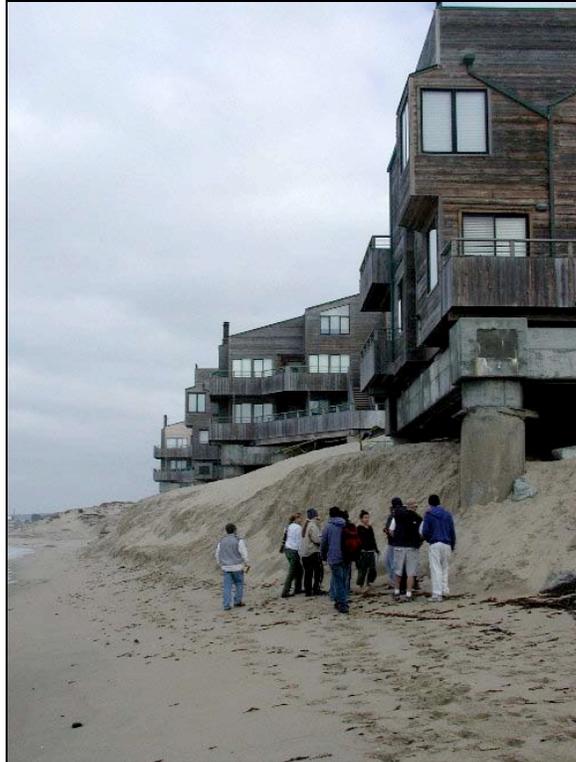
Figure 5.7: Exposed pilings at the Ocean Harbor House condominiums in Monterey. Photo: Doug Smith, CSUMB.

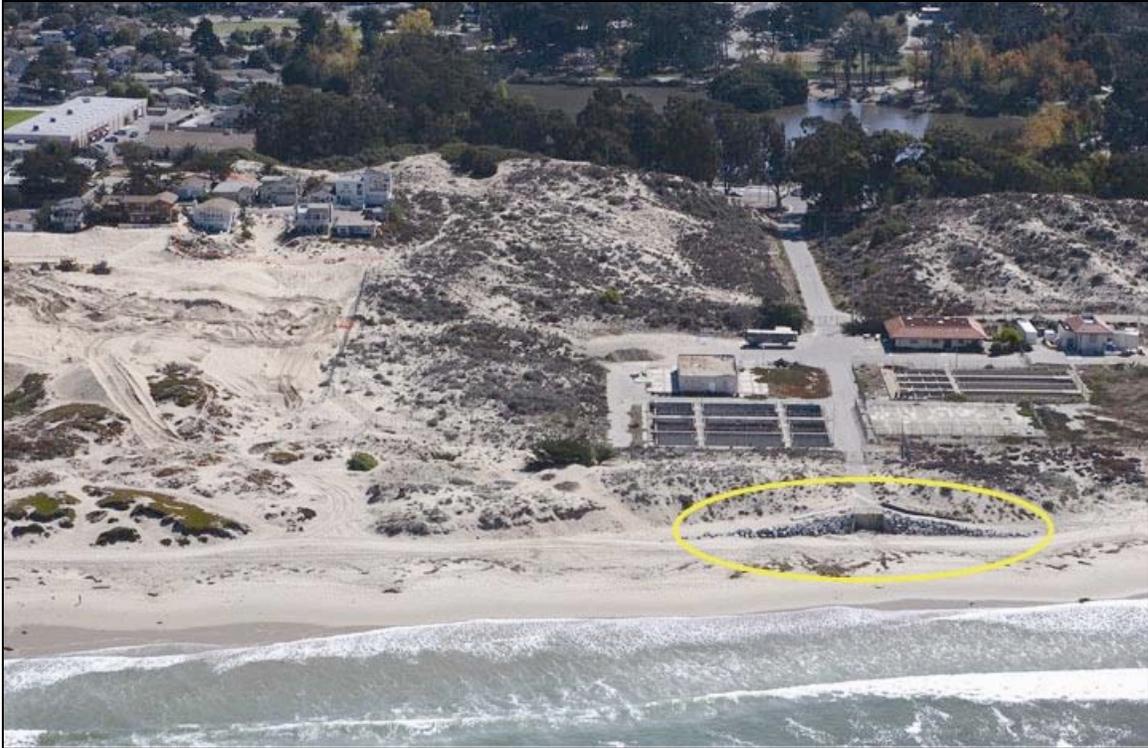
Figure 5.8: Aerial photograph of riprap on either side of a storm drain for the Naval Postgraduate School in Monterey, California. Photograph taken October 2004; copyright © 2002 Kenneth & Gabrielle Adelman (<http://www.californiacoastline.org/>).

A storm drain on the Naval Postgraduate School (NPS) grounds in Monterey has required emplacement of approximately 50 m of riprap to prevent wave damage (Figures 5.1 and 5.8). There is very little documentation on the history or future of this structure.
