**Upper Pajaro River
Sediment Assessment**

February 2004

FALL CREEK ENGINEERING, INC.

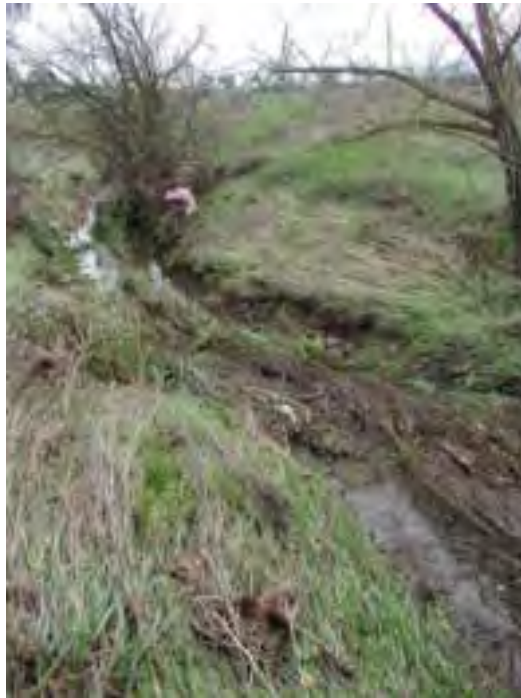
The following figures are graphical representations of properly functioning, moderately functioning, and non-functioning systems in the study area. Figure 4.1 is a picture of Little Arthur Creek, a stream system identified as proper functioning in the stream assessment program. Figure 4.2 is a picture of Tennant Creek, a stream system identified as moderate to non-functioning in the stream assessment program. Figure 4.3 is a picture of Jones Creek, a stream system identified as non-functioning in the stream assessment program.

Figure 4.2. The stream assessment identified Tennant Creek as an example of a Moderately Functioning system.

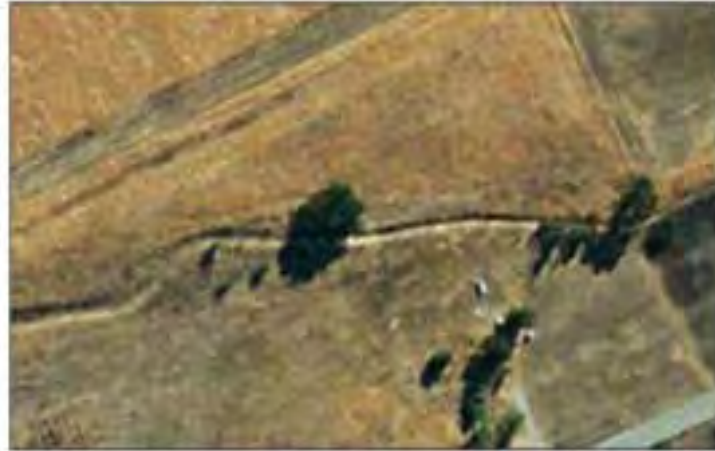
Figure 4.4. Example of a stream reach with a low vegetation density that does not provide SRA or root mass capable of withstanding erosion during high flow events.

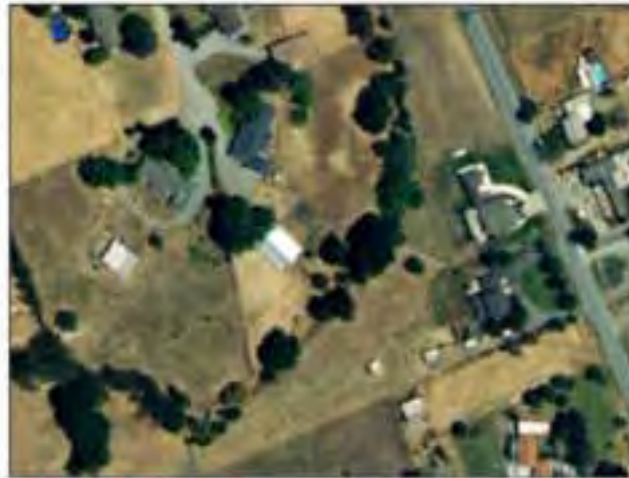
Figure 4.5. Example of a stream reach with a moderate vegetation density that provides intermittent SRA.

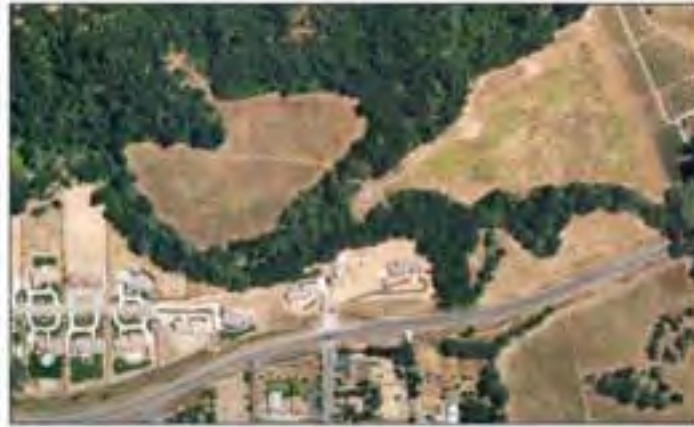
Figure 4.6. Example of a stream reach with a high vegetation density that provides continuous SRA and root mass capable of withstanding erosion during high flow events.

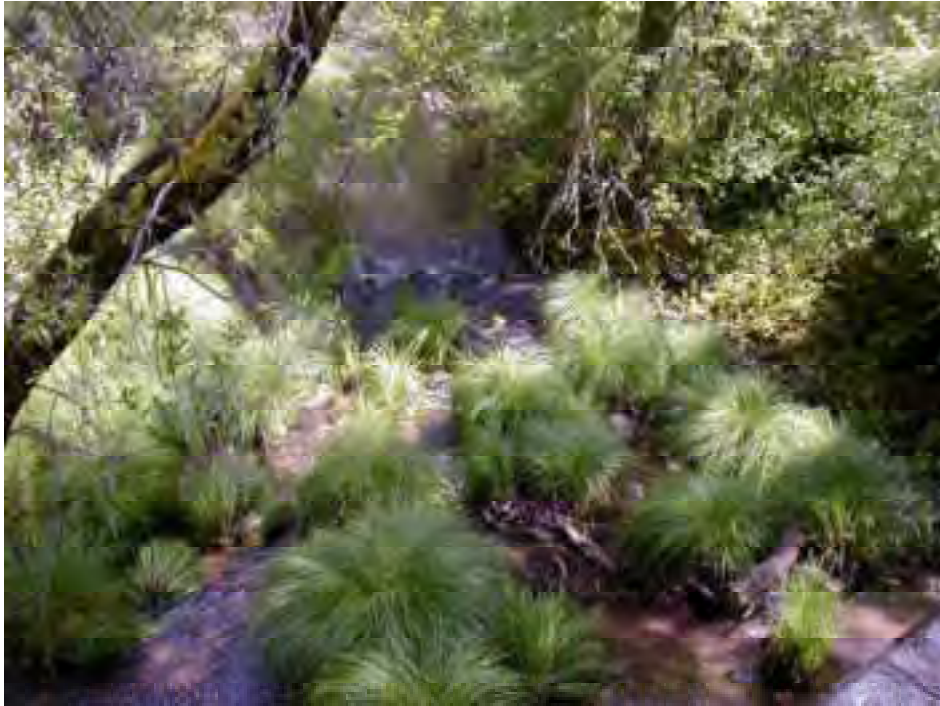
The third location on Redwood Retreat Road, approximately 13,510 feet west of Watsonville Road, also has very good vegetation density, with established channel and bank vegetation, and intact SRA. The channel has developed pool-riffle sequences, and the only surface cover disturbance was observed along the bridge wingwalls where some erosion was observed.

Figure 4.8. A view of Little Arthur Creek taken from the third observation point on Redwood Retreat Road.

Observations of Erosion and Sedimentation. The visual assessment of Little Arthur Creek showed little signs of excessive erosion or sedimentation occurring in the creek system. Erosion on Little Arthur Creek was observed adjacent to a bridge on Redwood Retreat Road where exposed and loose soil was observed. The channel bed generally appeared armored with coarse gravels and cobbles with substrate materials consisting of fine to cobble material.

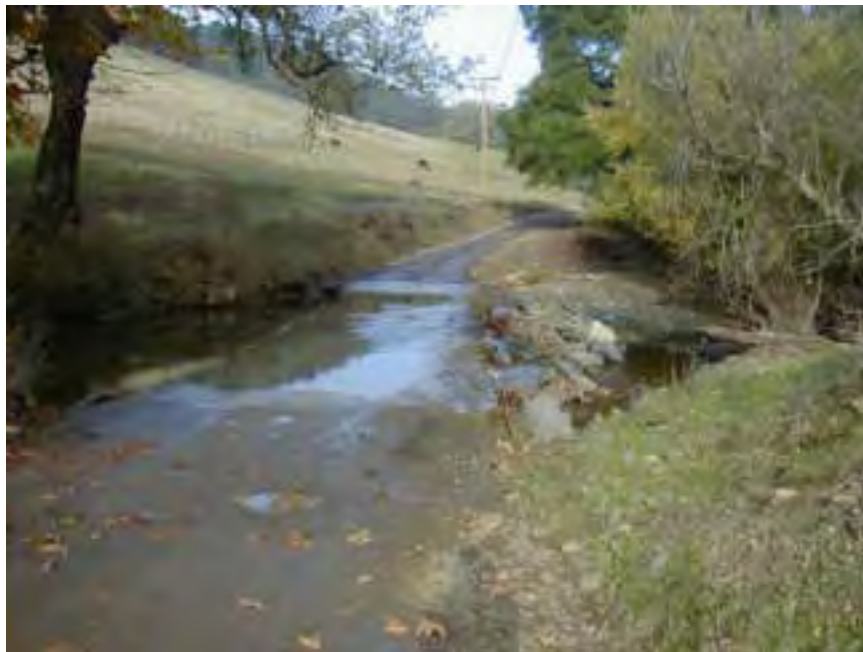
The upper watershed of Llagas Creek along Casa Loma Road is very well vegetated in a coastal redwood canyon. Animal grazing was observed along much of the riparian corridor and floodplain in the lower portions of the sub-area. The creek also appeared to have some localized incision, likely induced from the proximity to the road and the steep landscape position. An in-stream road crossing was observed in one location, with riprap positioned downstream of the crossing. Clearing of bank vegetation was also observed adjacent to one residential property.

Figure 4.9. In-stream road crossing with animal grazing in the background, on Upper Llagas Creek.

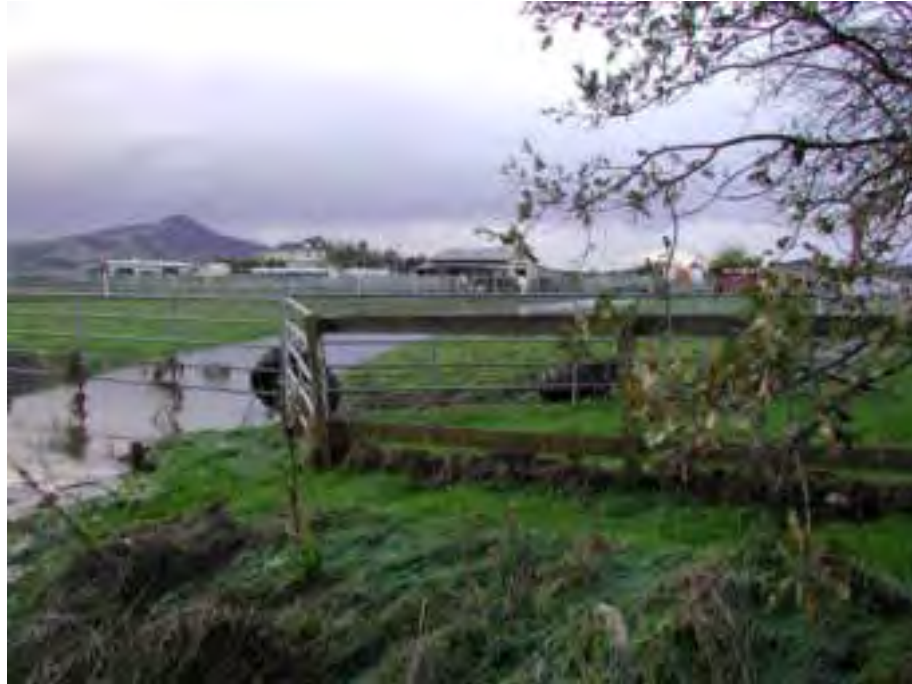
East of the Southern Pacific Railroad Track the East Little Llagas Creek channel meanders through agricultural fields and a trailer park community. In discussions with stakeholders it was learned that this location is also known as an area of regular flooding. The channel in this reach has a low vegetation density and concrete debris has been placed on channel banks for armoring in some locations. Levees have also been built up to prevent flooding into fields. West of Llagas Avenue, East Little Llagas Creek passes through a residential property with equestrian facilities. The creek channel bisects a number of pastures and the animals are not prevented from accessing the channel. The channel has a very low profile and vegetation density and diversity. In some locations in this reach the channel banks are bare and incised approximately one (1) foot, potential sediment sources.

Figure 4.12. East Little Llagas Creek in pastures west of Llagas Avenue.

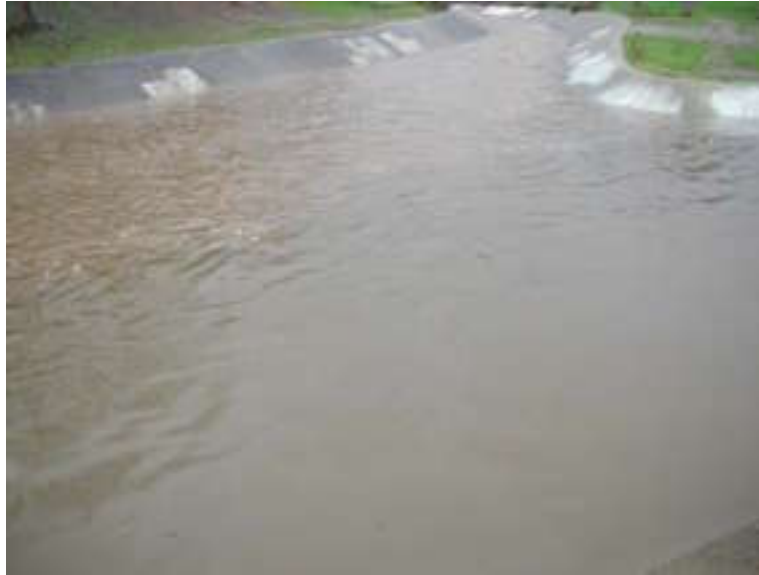
The upper watershed of Edmundson Creek is agricultural and rangeland in the process of converting to large residential developments. The creek channel has a low vegetation density, likely a result of previous land use. At Edmundson Road, there are signs of channel incision where vegetation was sparse the banks appeared vulnerable to erosion. Downstream of Edmundson Road approximately 1,200 feet Edmundson Creek enters a modified engineered channel as the creek enters an urban residential neighborhood. This channel continues east, across La Crosse Drive to the confluence with West Little Llagas Creek. The channel is mostly grassed with large woody vegetation on the banks of the wider modified channel. The vegetation on the creek channel appears to be maintained regularly. The center of the channel has a sinuous low flow channel and the banks have a foot and bike path accessible to the adjacent neighborhoods. At the confluence with West Little Llagas Creek the channel is lined with concrete approximately 200 feet upstream of the confluence.

Figure 4.14. Confluence of Edmundson Creek with West Little Llagas Creek.

Observations of Erosion and Sedimentation. Erosion on Edmundson Creek was observed as channel incision and bank failure where flows were channelized and bank vegetation was poor. The channel bed generally consisted of fine to gravel material.

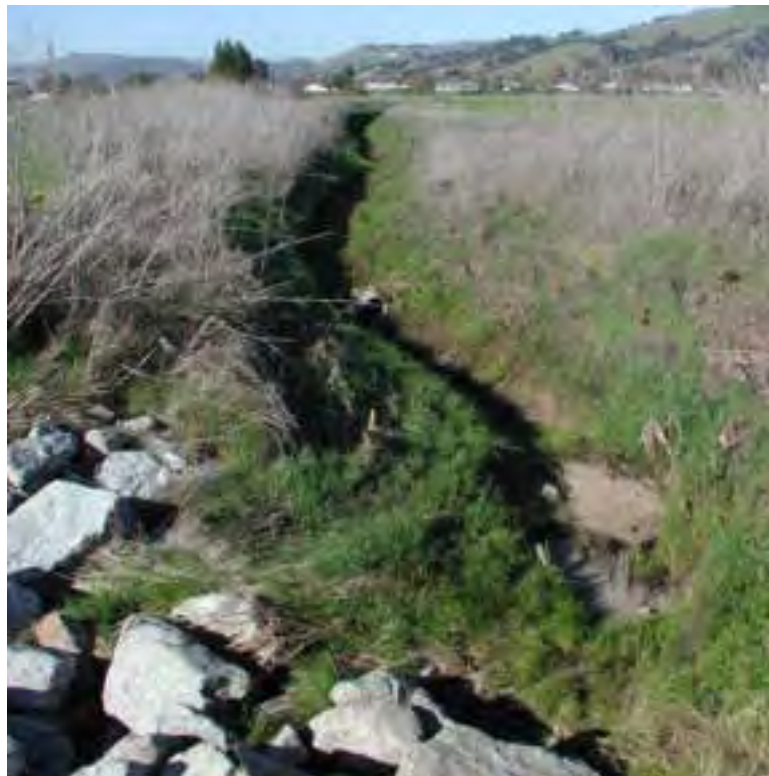
Between East Dunne and Maple Avenues Tennant Creek crosses Barrett Avenue, Tennant Avenue, and Hill Road. The most notable of these access points is Barrett Avenue. During high flows at Barrett Avenue it was observed that water from Tennant Creek backed up and over Barrett Avenue. The cause of the back up could be restrictions downstream of the Barrett Avenue culvert in combination with increased flow volumes originating from a residential development to the east of the Tennant Creek channel on Barrett Avenue. The confluence of Tennant Creek with Foothill Creek is east of the intersection of Fisher Avenue and Hill Road.

Figure 4.15. Tennant Creek upstream of Barrett Avenue.

Observations of Erosion and Sedimentation. The Tennant Creek channel shows evidence of some mild incision (1-2 feet) and localized bank failure, particularly adjacent to road crossings and at knick-points developed from channel transitions. Evidence of erosion was also observed along the bare portions of the Tennant Creek road ditch and adjacent to agricultural fields and access roads that encroach on the channel. The channel bed generally appeared armored with coarse gravels with substrate materials consisting of fine to cobble material.

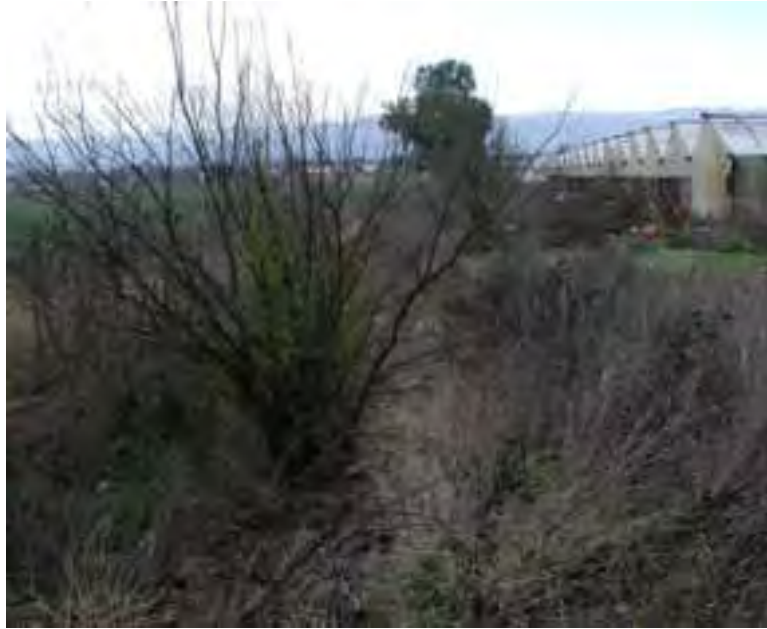
The first reach of Foothill Creek is relatively undisturbed and well vegetated. In the second reach, row crop fields are on both sides of the channel, but it appears from the aerial photograph that the vegetation density remains high. Closer to Foothill Road the creek channel has been channelized between property boundaries. In this reach the channel has been straightened adjacent to a nursery and row crop fields. The channel in this reach is sparsely vegetated and there is evidence of bank failure adjacent to the greenhouse. During the wet season, in the fields to the north of the creek channel, there is evidence of a channel that develops in the fields. It appears that this channel was possibly the original creek channel, prior to the creation of the existing channelized channel. What is assumed to be the original channel is bare of vegetation and sinuous. The straightened portion of Foothill Creek is approximately 2,160 feet long and is mostly covered with grass and thistle with some mature vegetation remaining along the channel.

Figure 4.16. Foothill Creek adjacent to a nursery west of Foothill Road.

Observations of Erosion and Sedimentation. Upstream and downstream of Foothill Road, the channel shows approximately six inches to one foot of channel incision. The reach of Foothill Creek downstream of Foothill Road (described as reach three) shows signs of bank failure, likely associated with stream access or crossing locations. Channelization of the creek, immediately upstream and downstream of Foothill Road, does not dissipate energy from high flows, which increases the possibility for channel erosion. The channel bed generally appeared armored with coarse gravels with substrate materials consisting of fine to sandy material.

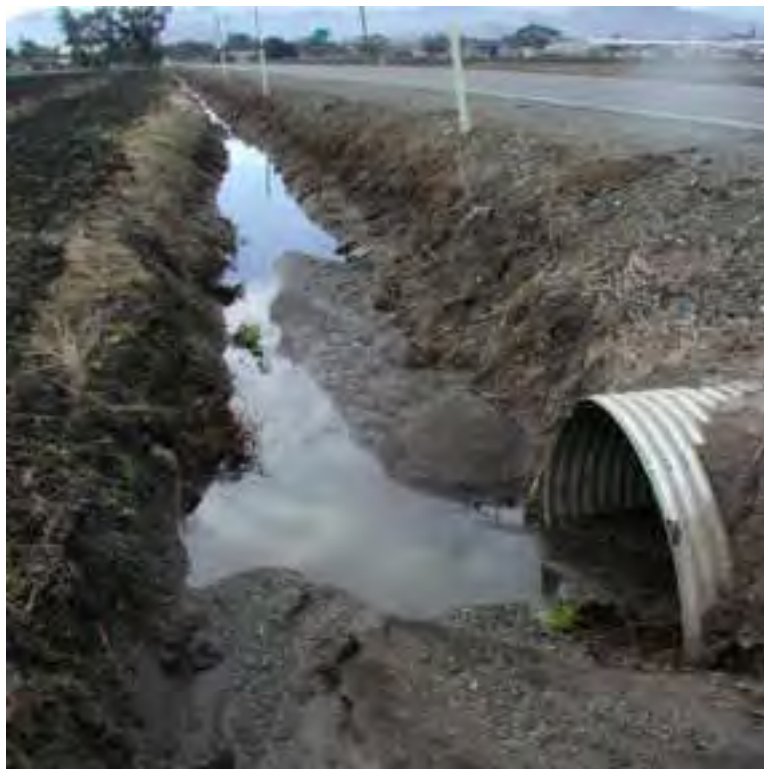
Figure 4.17. The Maple Creek road ditch on Maple Avenue.

Maple Creek to the east of Foothill Avenue appears to be poorly vegetated and channelized around property boundaries. The channel west of Foothill Avenue has been completely destroyed with little evidence of the original channel. The road ditches adjacent to Maple Avenue and Center Avenue are mostly bare with some non-native grass cover. The road ditches appear to receive regular maintenance from the Santa Clara County Road Maintenance Crew.

Sedimentation was observed inside and downstream of road culverts on Maple Avenue. There was also evidence of sedimentation where water was pooling in the agricultural field west of Center Avenue. At this location the water velocity decreased because of an increased channel width. As a result, the carrying capacity of the water decreased and suspended sediments were deposited. Sedimentation was also observed upstream of the culvert on Center Avenue, likely because the downstream pooling created a backwater effect that also decreased the velocity and carrying capacity of the water allowing sediments to be deposited.

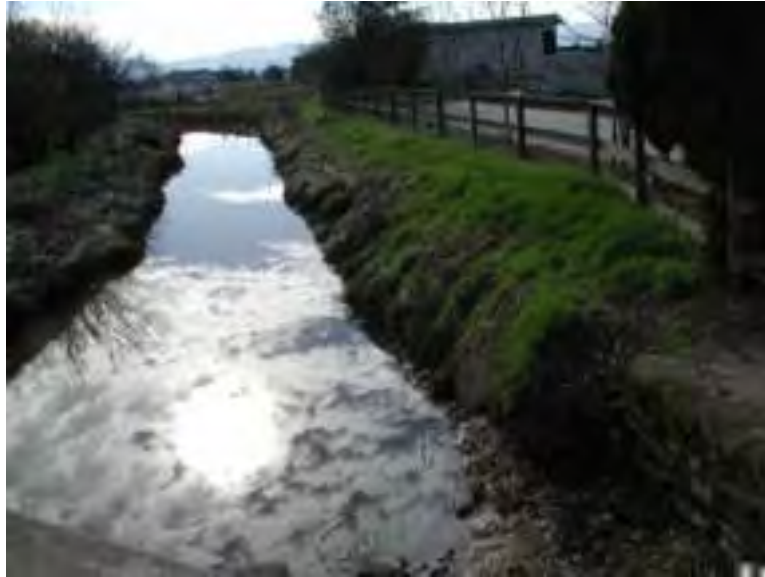
Figure 4.18. Corralitos Creek downstream of Columbet Avenue.

West of the residential developments, Corralitos Creek is surrounded by agricultural fields and smaller residential developments. These developments and fields often encroach upon the channel, leaving less than 10 feet of space from the low flow channel. General observations along Corralitos Creek included; remnant in-stream crossings, yard cuttings disposed of on creek banks, and concrete and/or roof tile debris placed in the channel to prevent channel erosion. From the observation points, the channel has an approximate low flow channel width of four feet and is mostly sinuous though the last 3,130 feet before the confluence of East Little Llagas and Corralitos Creek is channelized around property boundaries.

Observations of Erosion and Sedimentation. The most common observation of erosion occurred adjacent to crossings and in-stream channel modifications, specifically in scour pools downstream of road culverts and where concrete debris had been placed in the channel. The scour pools were generating downstream bank instability and also erosion adjacent to culverts. Where concrete debris had been placed in the channel, bank failure and downstream channel incision was observed. At one location the concrete was failing and downstream bank failure was occurring, likely derived from incision and bank steepening. There were also observations of erosion at in-stream foot crossings

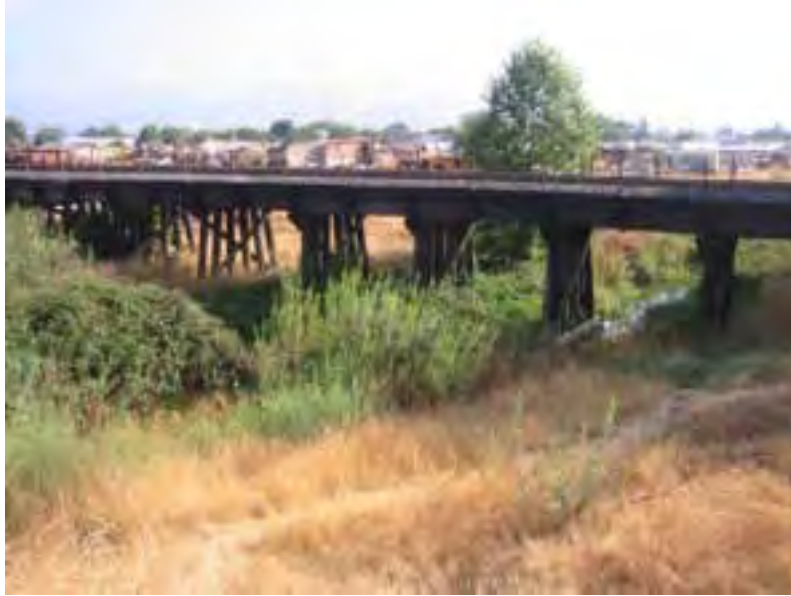
Figure 4.19. Llagas Creek east of Santa Theresa Boulevard at the Southern Pacific Railroad trestle.

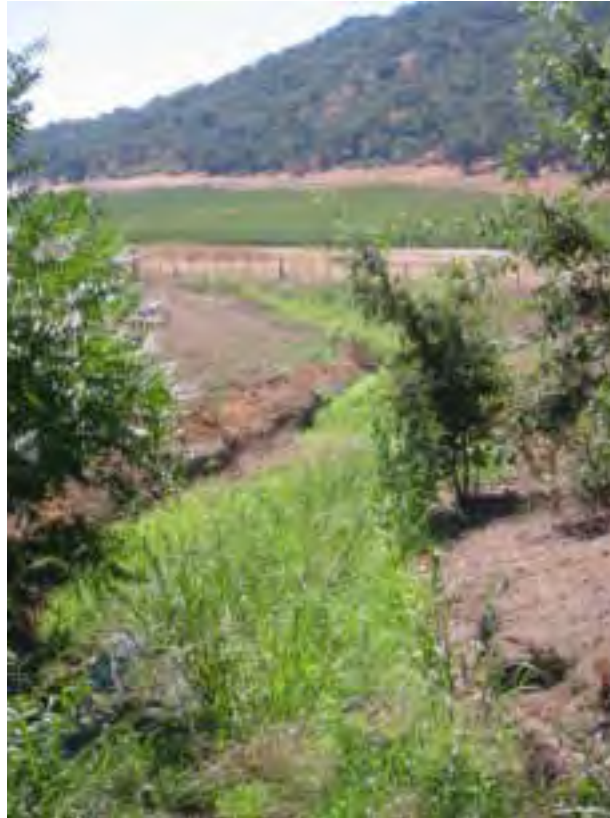
channel is adjacent to a new winery development. During the construction of the facility, or prior to it, the Hayes Creek channel was realigned and modified. The modified channel is low profile with access to the floodplain above bankfull stage. At the time of the survey the vegetation density was low, and grass was observed in the channel and some younger shrubbery on the channel banks. Bare and loose soils were observed along the channel banks in this channel reach.

Figure 4.22. Hayes Creek downstream of Watsonville Road.

Below Watsonville Road, Hayes Creek passes through this newly converted winery property and then into property used for equestrian facilities. Adjacent to the equestrian facilities, one in-stream crossings was observed across Hayes Creek. At this crossing the soil appeared bare and loose, susceptible to erosion.

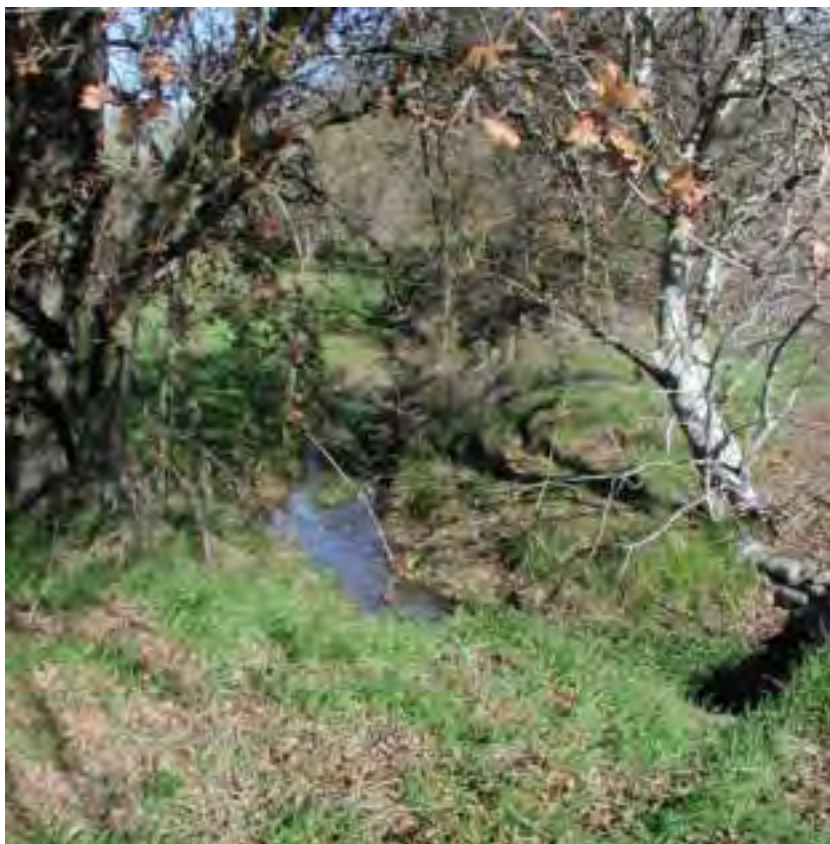
At the time of this survey the upper portion of the Center Creek watershed was being grazed and animals were accessing the creek channel. Animal access in the creek channel had caused bank degradation, slumping and poor recruitment of vegetation. At one location downstream of the ranch lands, concrete retaining walls were constructed on both channel banks and concrete debris had been dumped into the channel. The retaining walls could be the remaining abutments from an old farm road or installed for channel stability.

Figure 4.24. Center Creek in the upper watershed, above San Martin Avenue.

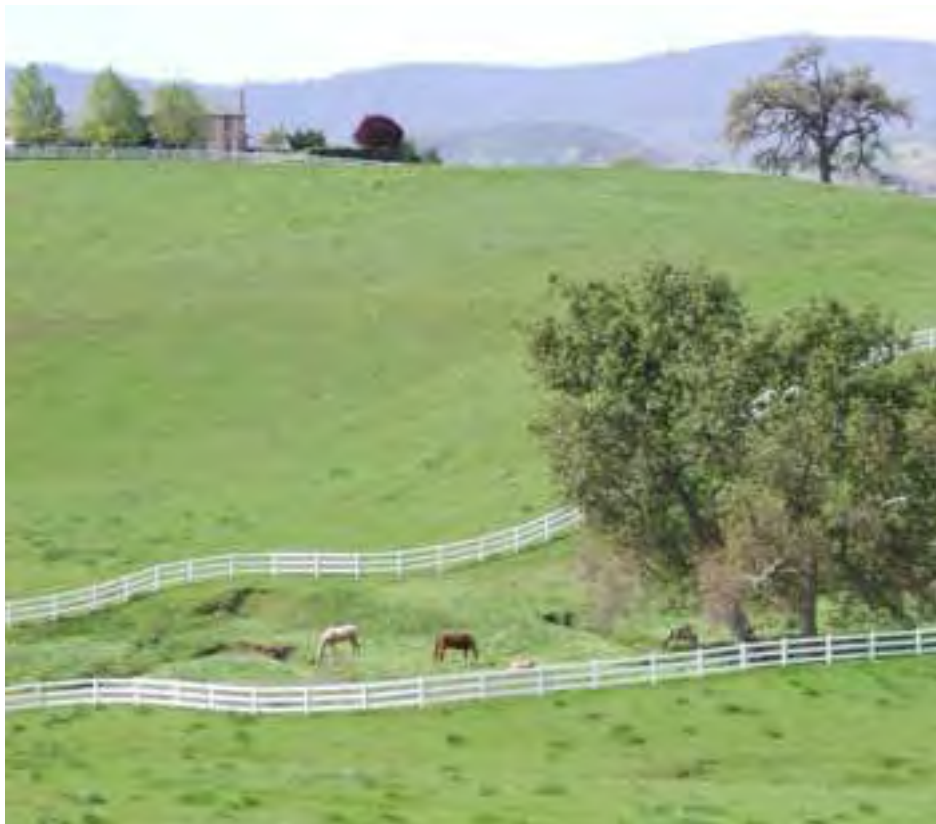
The upper portions of the watershed are rangelands, and had been left relatively undisturbed until recently. In the last 10 to 15 years approximately 15 large residential developments have been constructed in the upper watershed. In these upper reaches the creek channel shows evidence of the impact left by grazing in and around the creek, specifically, slumped banks and a limited riparian vegetation community. In these areas the vegetation consists primarily of grasses with scattered mature woody vegetation and the banks have a low profile with evidence of small banks slumps likely caused by large animal foot traffic. Though the stream channel has been impacted, the sinuosity of the channel remains mostly intact and floodplain access likely occurs during high flow events.

Figure 4.28. Riparian grazing and residential developments in the upper watershed of Skillet Creek.

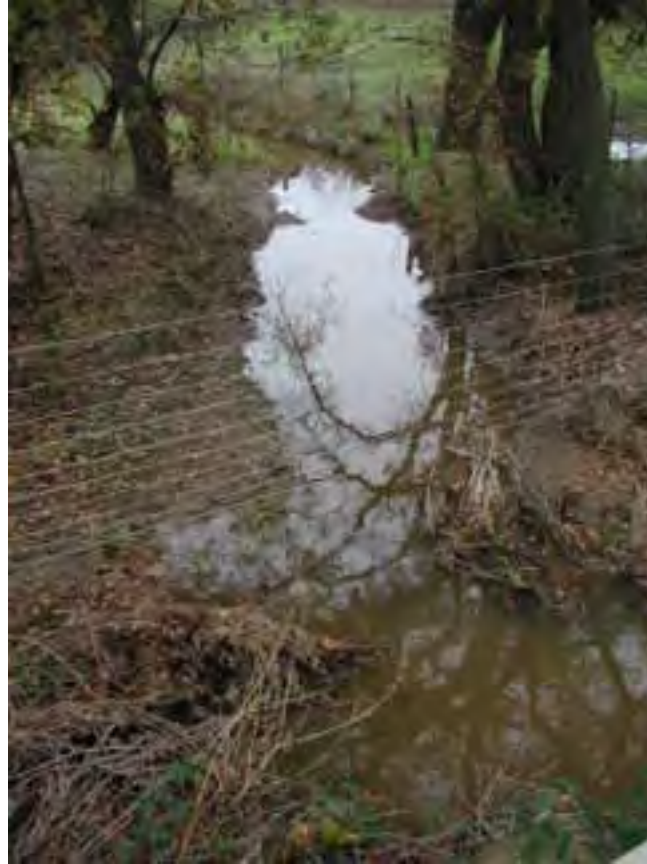
As Panther Creek transitions from the foothills onto the Llagas floodplain, the vegetation density and channel sinuosity decrease. West of New Avenue, Panther Creek passes through agricultural fields, from which all vegetation has been removed from the creek and the channel straightened around the fields. The confluence of Panther Creek with Llagas Creek occurs north of Leavesley Avenue, south of Buena Vista Avenue, east of Marcella, and west of New Avenue. Panther Creek enters Llagas Creek via two large concrete culverts with concrete riprap placed at the outfall into Llagas Creek.

Figure 4.29. Panther Creek south of New Avenue.

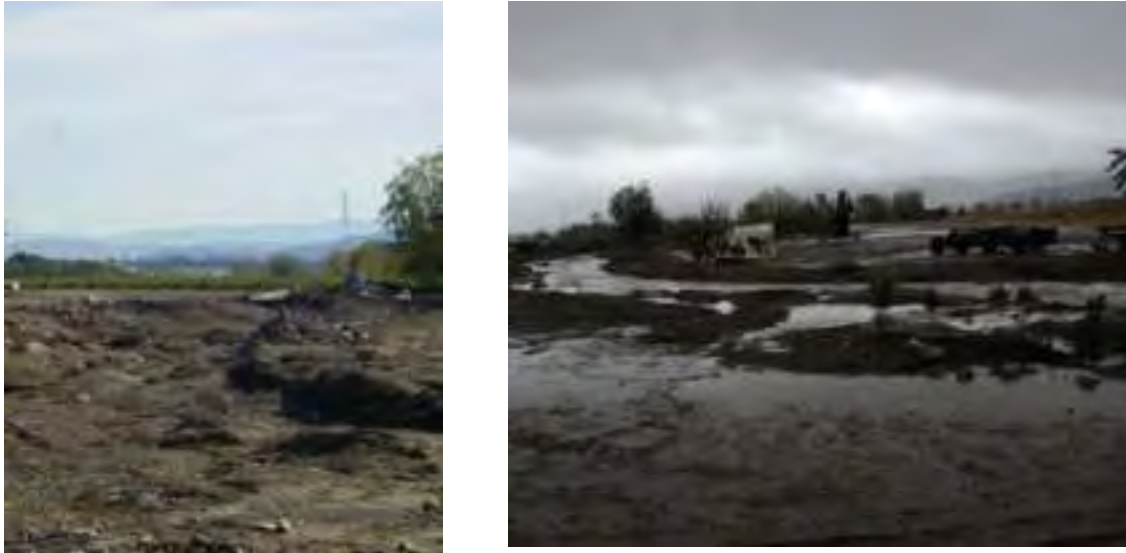
Figure 4.31. Bank armoring on West Branch Llagas Creek in dry and wet conditions.

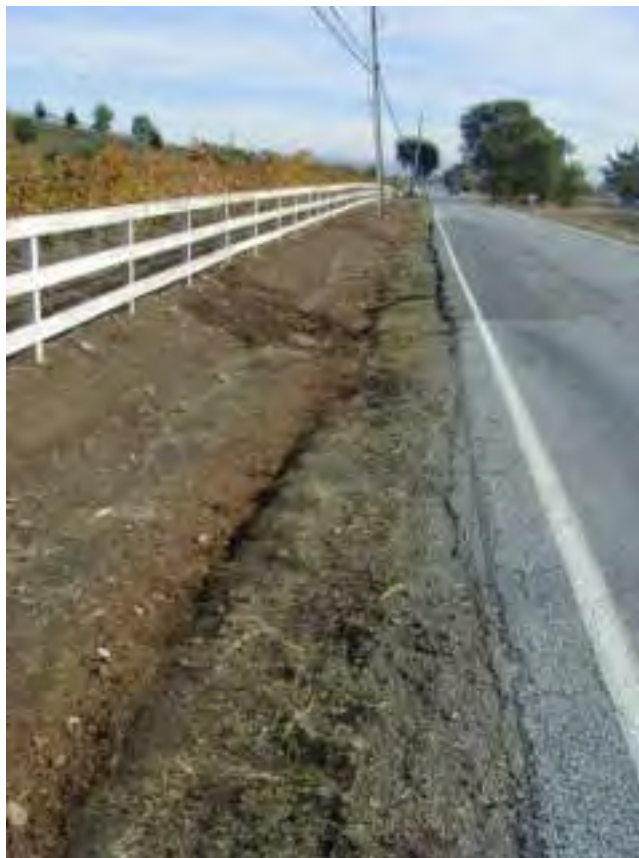
For most of its length Day Creek parallels Day Road. The upper watershed of Day Creek has a low to moderate vegetation density and appears to be an area of historic grazing. Along Day Road, Day Creek resembles a road ditch with no riparian corridor or developed channel geometry. From observations at the time of the survey it appears as though Day Creek is managed as a road ditch; regularly cleared and shaped to conduct runoff from the road and adjacent developments. The channel and banks of the creek were bare and exposed where maintenance had been conducted.

Figure 4.32. Day Creek road ditch on Day Road.

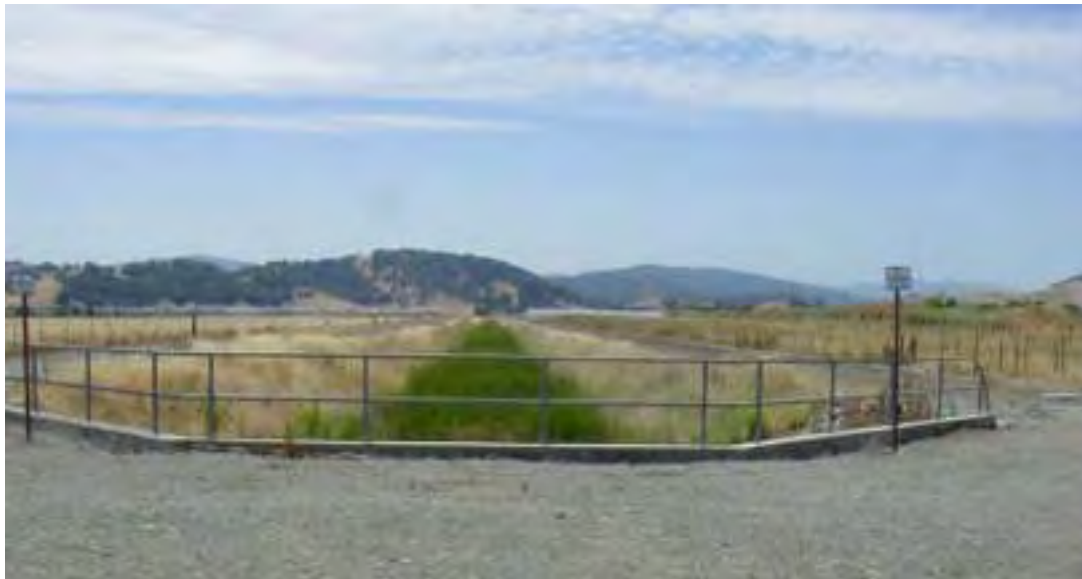
Lions Creek abruptly transitions into a straight engineered and primarily grassed channel approximately 3,800 feet west of Santa Theresa Boulevard. The channel profile resembles the engineered channel on West Branch Llagas Creek to the east, with a low flow channel and adjacent access roads. The general shape of this engineered channel continues until the confluence of Lions Creek with West Branch Llagas Creek approximately 1,050 feet east of Wren Avenue.

Figure 4.33. The engineered Lions Creek channel west of Santa Theresa Boulevard.

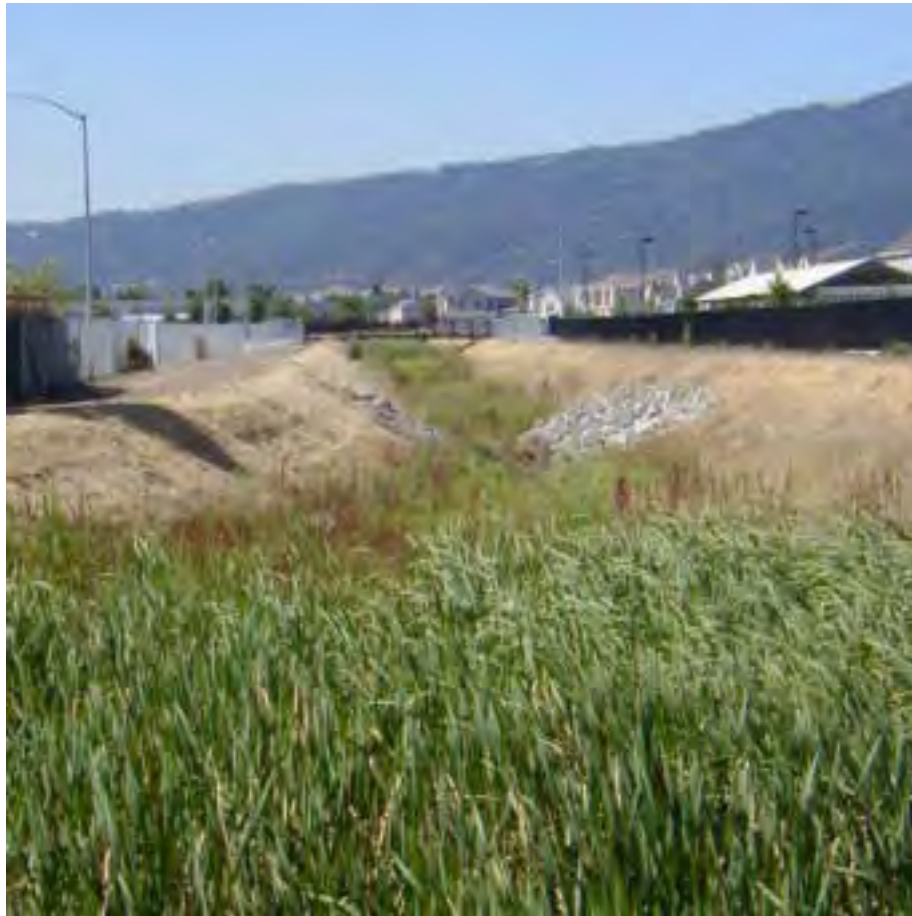
The channel is mostly a series of underground pipes, though the channel does surface, east of Santa Theresa Boulevard. The channel at Santa Theresa Boulevard is straight with a characteristic channel geometry (observed on both Lions Creek and West Branch Llagas Creek), which includes a low flow channel, adjacent access roads, and limited development of riparian vegetation. At the confluence of South Morey Channel and Lions Creek a band of rock rip-rap was placed across the channel and banks.

Figure 4.34. South Morey Channel upstream of the confluence with Lions Creek.

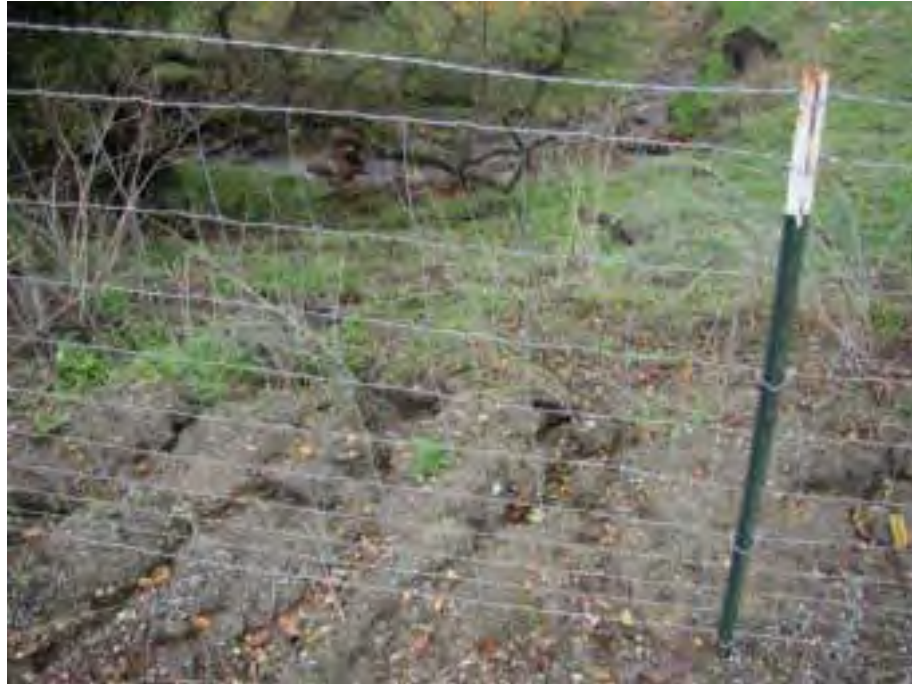
The upper Live Oak watershed is mostly well vegetated with established mature vegetation. In the upper watershed west of Leavesley Road, the creek channel is bordered by Roop Road to the north and an old ranch or mining road to the south. The creek channel has bare steep banks in some locations, adjacent to both of these roads. At some locations adjacent to Roop Road, sheet flow from the road has created rill and gully features on the channel banks. The channel banks also show signs of grazing, either currently or historically.

Figure 4.37. Location where runoff from Roop Road enters Live Oak Creek.

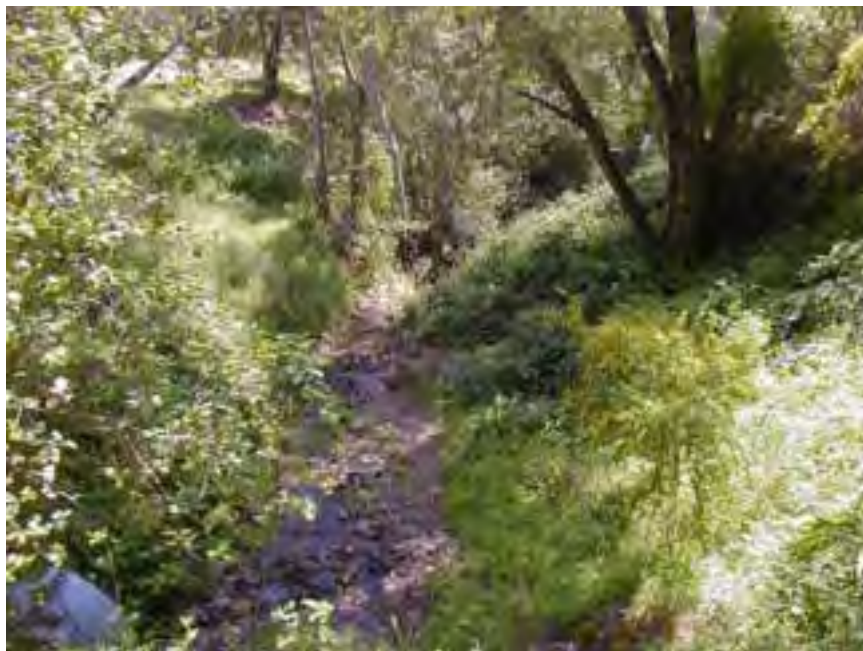
Observations of Erosion and Sedimentation. Erosion on Solis Creek was observed at locations where stream access was possible, and where scour below a road culvert accelerated the erosion on a downstream bank. The exposed bank had some recovery species though the bank angle was near vertical. The channel bed generally appeared armored with coarse gravels and cobbles with substrate materials consisting of fine to cobble material.

Sedimentation was observed as point bar development and in finer sediments deposited in channel pools.

Figure 4.38. A view of Solis Creek taken upstream of Kell Road.

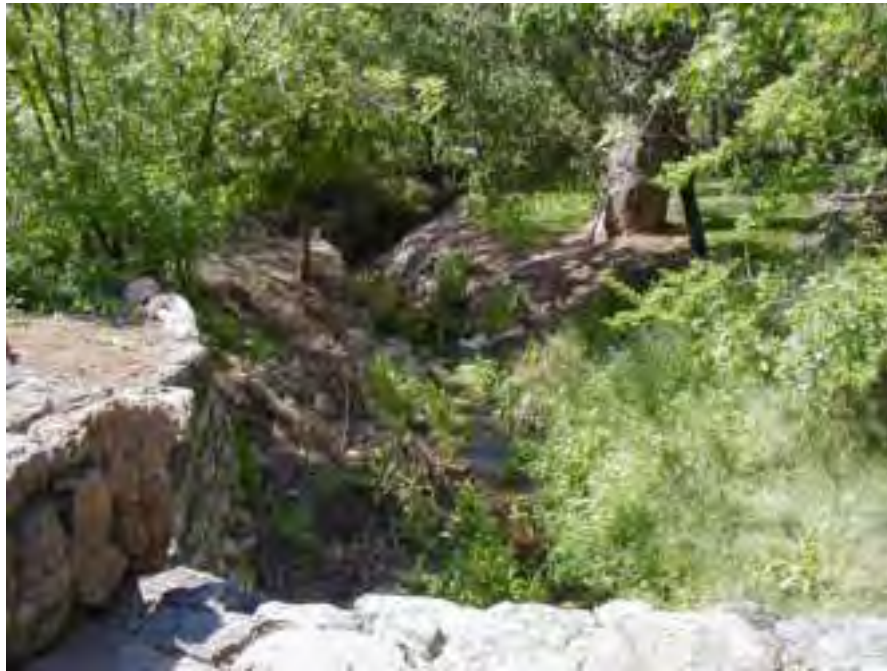
Figure 4.39. A view of Sycamore Creek taken at a site adjacent to Sycamore Avenue.

Observations of Erosion and Sedimentation. Erosion on Sycamore Creek was observed adjacent to residential developments, where animals accessed the channel, and where bare banks had failed. In the upper portion of Sycamore Creek adjacent to Sycamore Avenue channel modification in some locations created easily erodible bare banks. Also in the vicinity of Sycamore Avenue, animal grazing in and adjacent to the channel had caused a depletion of channel vegetation combined with bank slumping caused by the weight and movement of the animals. The channel bed generally appeared armored with coarse gravels with substrate materials consisting of fine to gravel material.

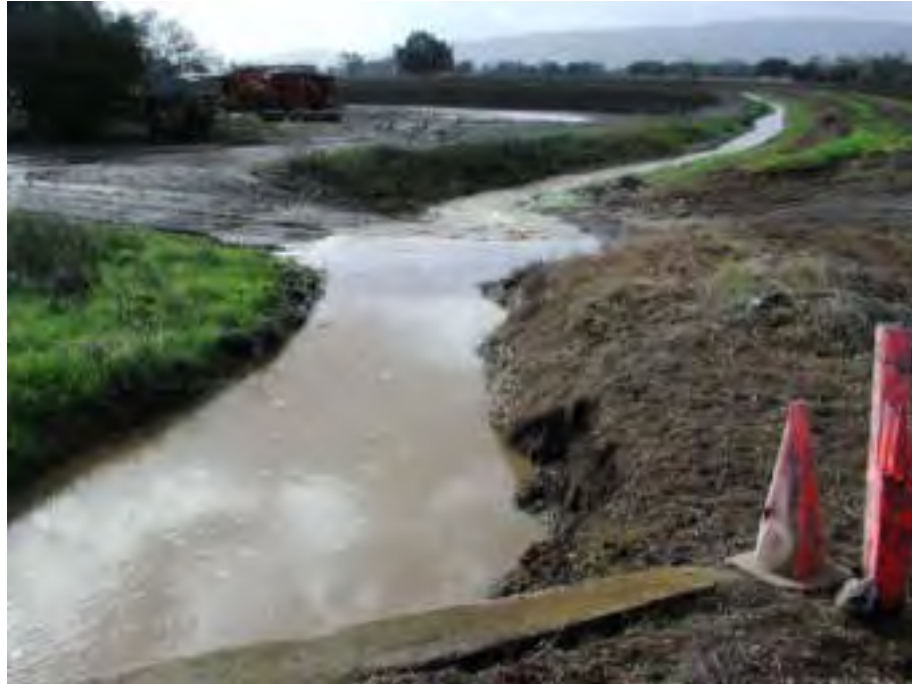
West of Ferguson Road the channel is between row crop fields and Leavesley Road. In this section, of approximately 2,000 feet of stream channel, a majority of the vegetation has been cleared from the channel and in some locations the channel geometry appears modified. The confluence of Alamias Creek and Jones Creek occurs below this 2,000-foot section of cleared vegetation, south of Leavesley Road and West of Ferguson Road.

Figure 4.40. Jones Creek south of Leavesley Road.

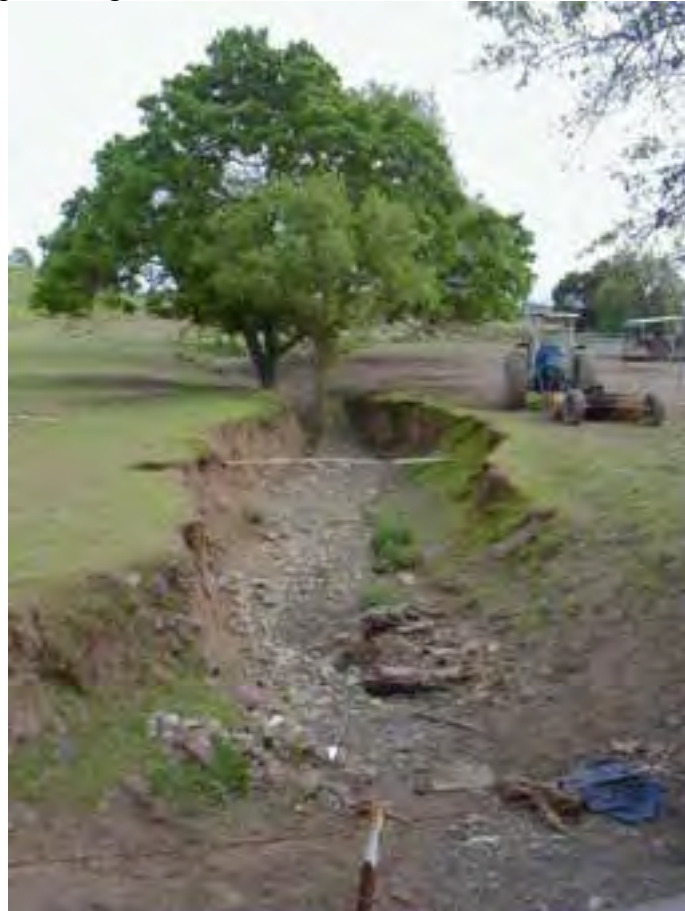
South of Crews Road, Crews Creek enters an animal pasture. The creek channel appears mostly bare with some short grasses. The animals have unrestricted access to the channel, which bisects the pasture. The effects of this channel access included; low angle banks where animals cross the channel, vertical bare banks where the channel has incised and the channel banks have slumped, and a low vegetation diversity. Vegetation includes oak trees in and adjacent to the channel as well as a mixture of grasses with a minimum of residual biomass. Sinuosity in this reach matches that expected in the landscape setting.

Figure 4.41. An equine pasture on Crews Creek south of Crews Road.

Observations of Erosion and Sedimentation. Erosion on Crews Creek was observed adjacent to vertical or near vertical banks where soils had slumped into the channel. Where animal access was observed, the channel and banks of Crews Creek were eroded as a result of animal traffic across the channel. The erosion included both channel incision and bank slumping. The channel bed generally consisted of fine to gravel material.

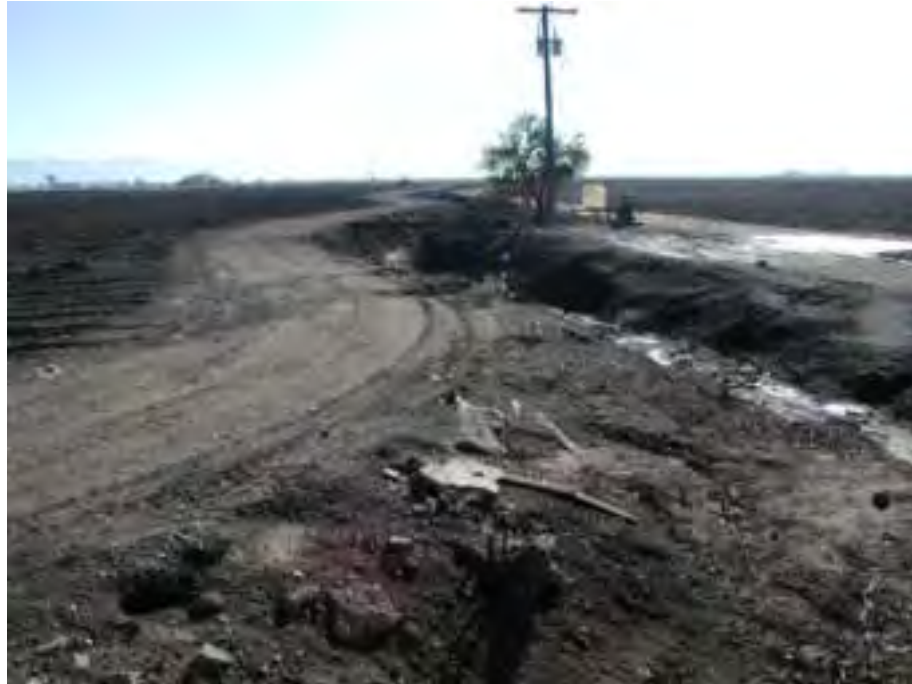
The entire length of Dexter Creek, approximately 7,940 feet, has mostly bare banks and channel. The floodplain consists mostly of agricultural fields with access roads adjacent to the channel above the right and left channel banks. The entire length of the channel appears to have an engineered and regularly maintained channel geometry. The bare soils on the bank and channel had evidence of rill and gully erosion where water from adjacent fields was either conducted into the channel via tailwater ditches, or via overland flow across the access roads. Erosion was also observed where road ditches from Pacheco Pass Road entered the Dexter Creek channel. Other debris and trash was also observed in Dexter Creek from Pacheco Pass Road.

Figure 4.42. Dexter Creek south of Pacheco Pass Road.

Observations of Erosion and Sedimentation. Erosion on Dexter Creek was observed along the channel where water from adjacent fields enters the channel. Water enters the channel either via tailwater ditches or from adjacent access roads. At these locations, concentrated flows appear to form rill and gully erosion in the channel. Erosion was also observed at points adjacent to Pacheco Pass Road where road ditches, or runoff from the road, enters the channel. The channel bed generally consisted of fine to gravel material.

Sedimentation was observed in Dexter Creek above and below the bridge crossing at Pacheco Pass Road. It appears that sediments from the Pacheco Pass Road ditch and from the upstream agricultural fields deposit at this location.

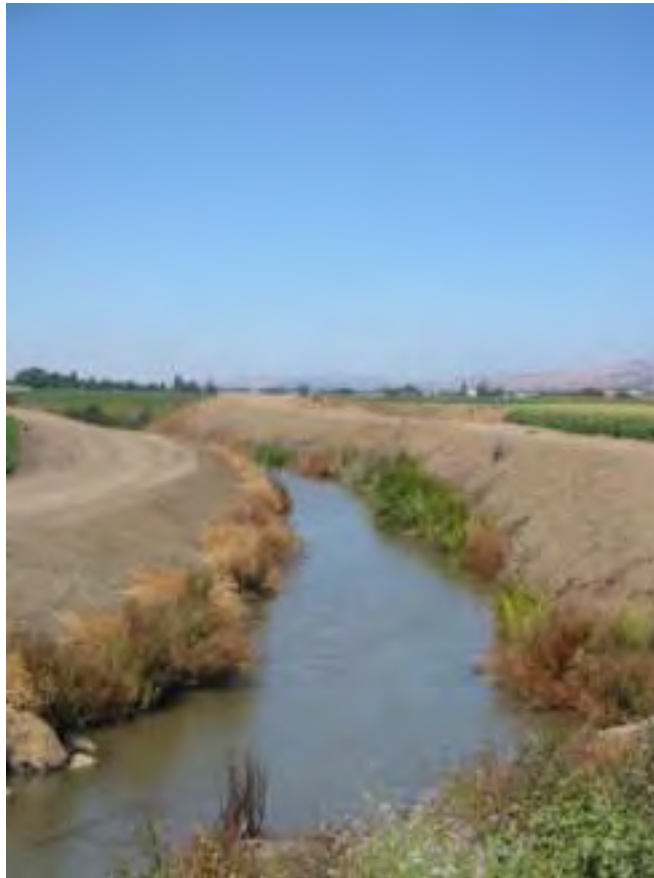
Jones Creek is adjacent to predominantly row crop fields along its entire length until the confluence of Jones Creek and Llagas Creek north of Bloomfield Avenue. The channel has been straightened and channelized around fields and roads along most of its length. In some locations it also appears the channel geometry has been modified and is maintained, or re-shaped, regularly. The vegetation distribution on Jones Creek is variable, and in some locations the channel is devoid of vegetation.

Figure 4.43. Jones Creek in a modified channel adjacent to row crop agriculture.

Observations of Erosion and Sedimentation. Erosion on Jones Creek was observed adjacent to agricultural fields and roads. Erosion adjacent to fields occurs at locations where tail and stormwater runoff drains from fields or adjacent farm roads enter the channel. No substantial rill or gully formations were observed at the time of this survey, though the bare bank and loose soil conditions seemed likely to erode when high flows occurred. At one location it appears the channel profile of Jones Creek had been eroded as a result of agricultural practices and a redirection of flow west of

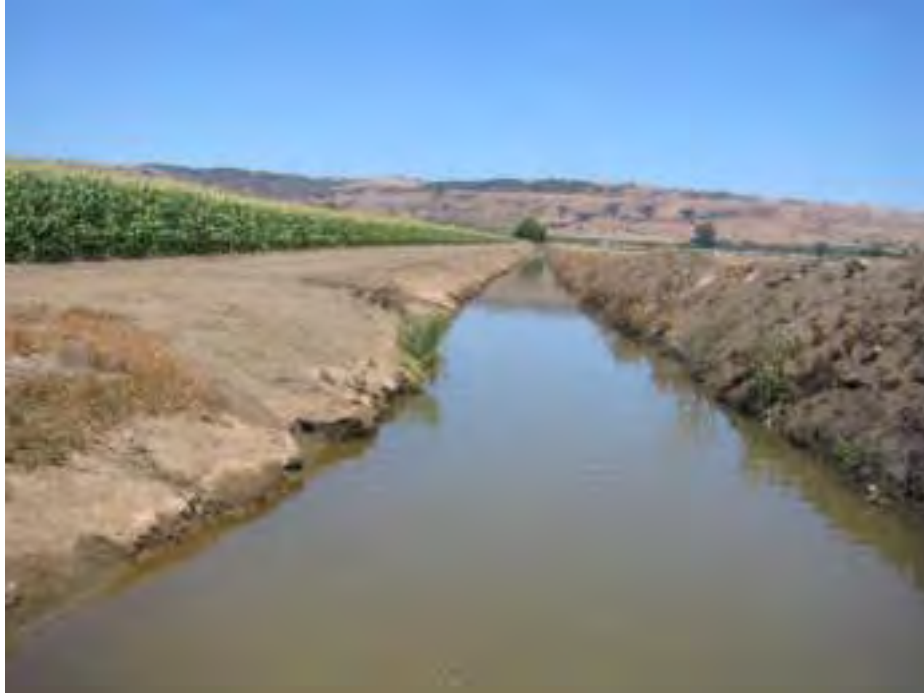
San Ysidro Creek in southern Santa Clara Valley crosses to the south of Canada Road and enters land primarily used for grapes and row crop. Downstream and south of Canada Road, the density of vegetation along the creek and the channel sinuosity decrease. The confluence of San Ysidro Creek and Jones Creek occurs in an agricultural setting. A farm road crosses San Ysidro Creek approximately 15 feet upstream of the confluence, at which point both channels have no established riparian vegetation and the creek banks are mostly bare and appear to be regularly cleared.

Figure 4.44. San Ysidro Creek in a modified channel adjacent to row crop agriculture.

Observations of Erosion and Sedimentation. Erosion on San Ysidro Creek was observed adjacent to agricultural fields, roads, and rural residential developments. Erosion in the vicinity of agricultural fields occurred at locations where drainage from fields or adjacent farm roads entered the channel. No substantial rill or gully formations were observed at the time of this survey, though the bare bank and loose soil conditions seemed likely to erode when high flows occurred. At locations where rural residential developments encroached upon San Ysidro Creek hydromodifications made to the creek channel were observed. At one location these resulted in bare and steep banks adjacent to the property. The channel bed generally consisted of fine to gravel material.
