**Upper Pajaro River
Sediment Assessment**

February 2004

FALL CREEK ENGINEERING, INC.

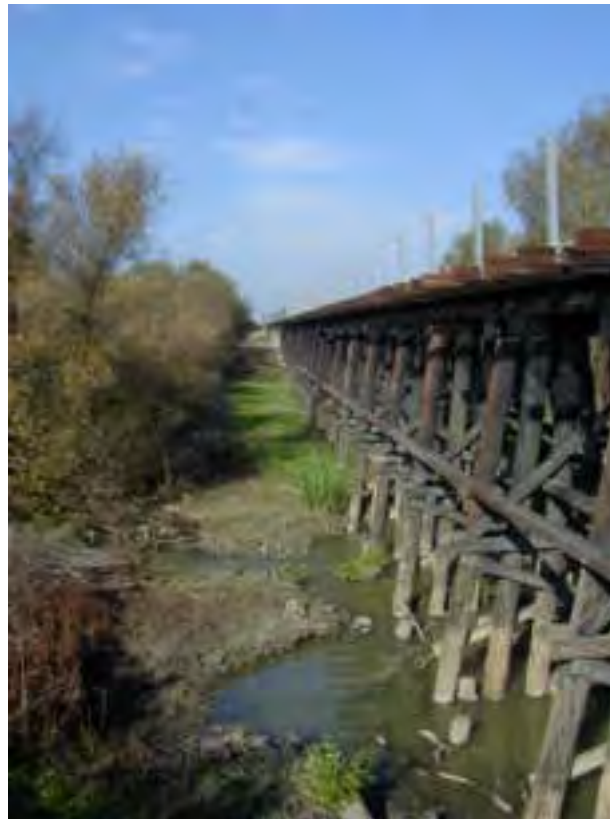
Figure 4.45. The Pajaro River at the Southern Pacific Railroad trestle, south of the confluence with Llagas Creek.

Observations of Erosion and Sedimentation. Erosion was observed on the Pajaro River where tail and storm drains entered the channel banks, creating localized rill and gully formations. The channel bed generally consisted of fine to gravel material.

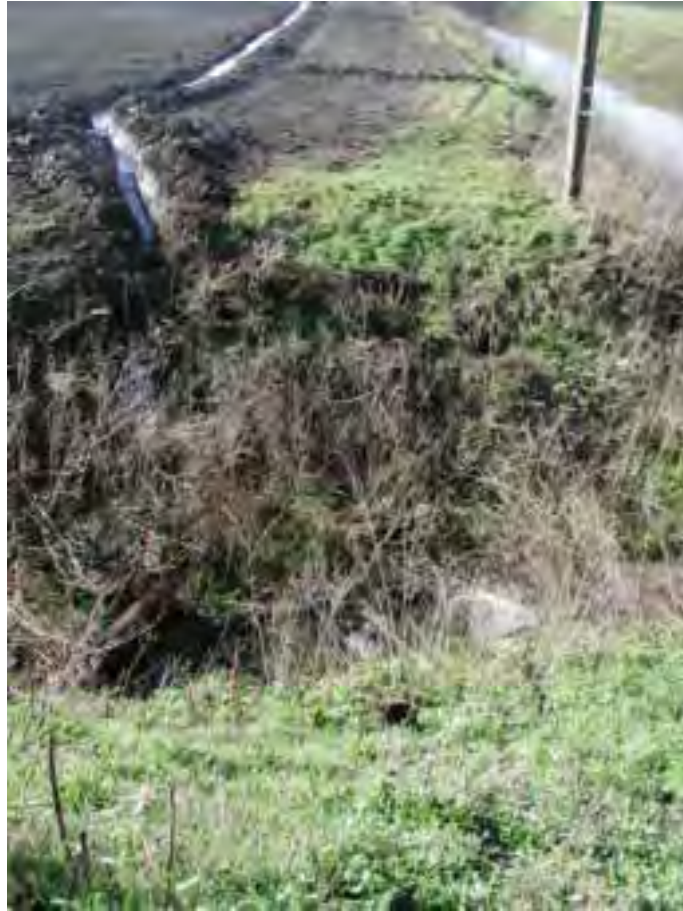
Figure 4.46. Water draining into Millers Canal via tail and stormwater drains.

Observations of Erosion and Sedimentation. Erosion was observed on the Pajaro River where tail and stormwater drains entered the channel banks, creating localized rill and gully formations. The channel bed generally consisted of fine to gravel material.

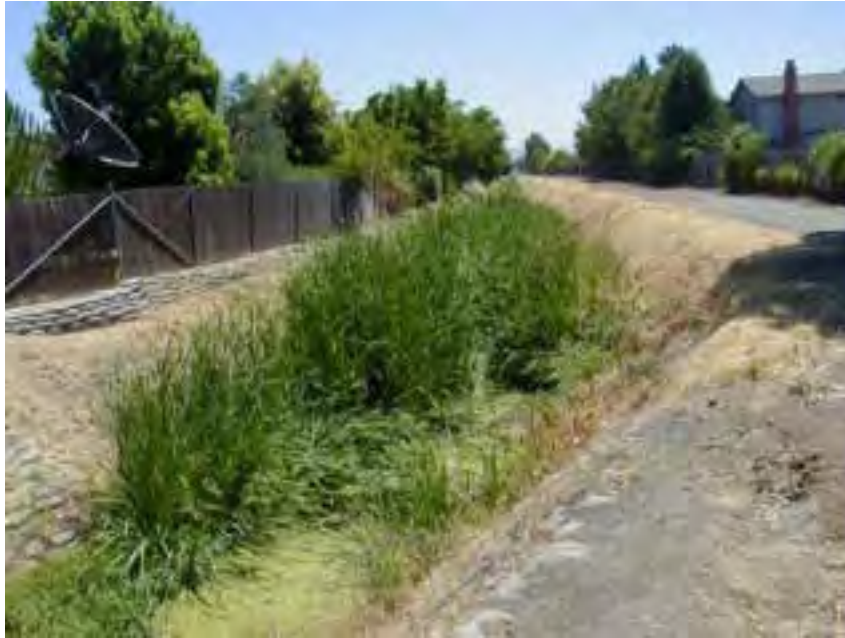
The channel is encroached upon by residential developments and is regularly maintained to maximize flow conveyance. The bank vegetation is regularly cut and at the time of the survey in-channel vegetation, cattails and grasses were thriving within the creek channel, though these are likely cut once a year as part of routine channel maintenance. Concrete sandbags had also been placed in some locations along the channel, to reinforce banks, particularly downstream of culverts and concentrated storm flows from storm drains, which periodically enter the channel. Algal growth on Princevalle Drain was observed at all locations with standing water.

Figure 4.47. A view of Princevalle Drain taken downstream of Princevalle Street.

The channel geometry resembles a v-ditch with an elevated and maintained access road adjacent to Princevalle Drain along most of the channel length. At Monterey Road rip-rap has been placed on channel banks. A portion of the rip-rap has slumped into the channel and is accumulating at the entrance to the downstream culvert. The exposed banks appear loose and susceptible to erosion. The vegetation in Princevalle Drain does not have the root mass capable of withstanding erosion from high flow events.

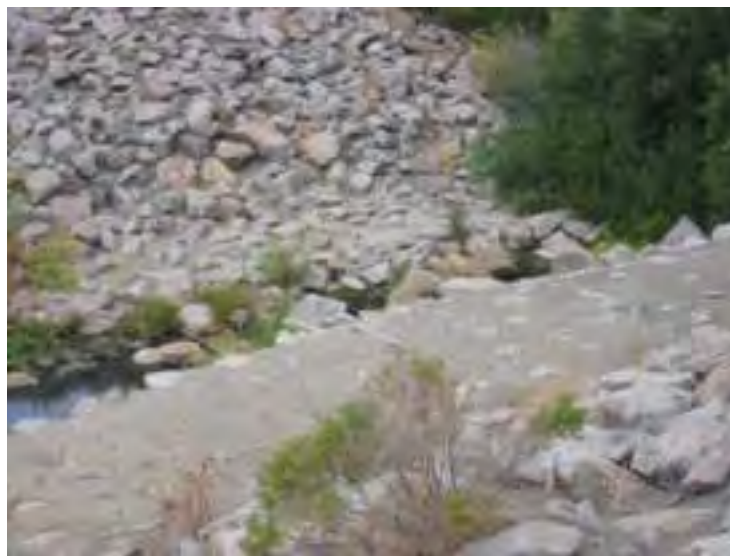
Approximately 1.5 miles upstream from Bloomfield Avenue is the confluence of Ronan Channel and Llagas Creek. Upstream of the confluence it appears that in-stream weirs have been built to create a pool riffle sequence downstream of the third fish ladder observed in the channel. A fourth fish ladder was observed approximately 400 feet downstream of Pacheco Pass Road.

Figure 4.50. One of four fish ladders in Llagas Creek south of Pacheco Pass Road.

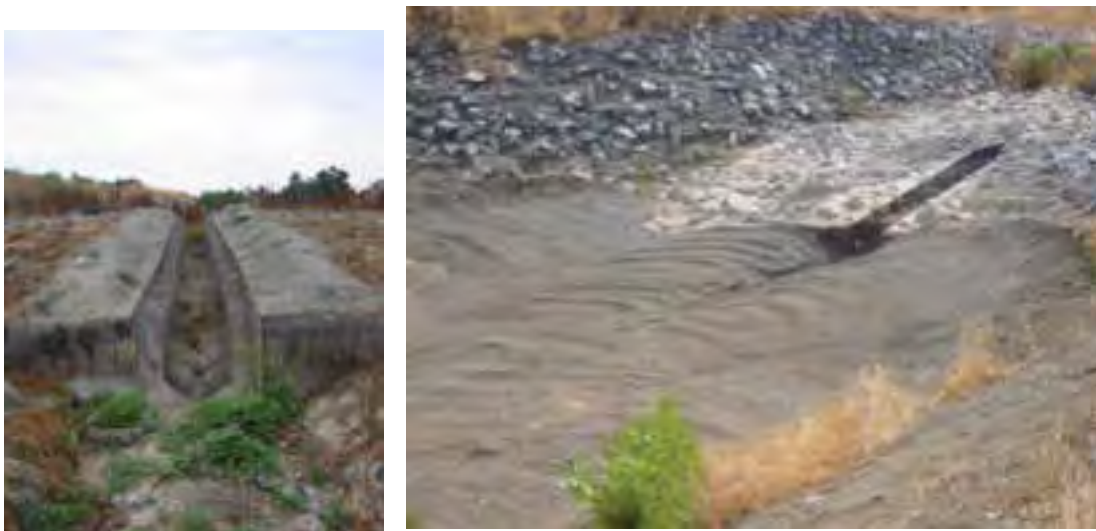
Figure 4.51. Examples of the nine fish ladders, with the sculpted low flow channel, in Llagas Creek north of Pacheco Pass Road.

The engineered channel north of Pacheco Pass Road and south of Buena Vista Avenue continues with a total of nine fish ladders. Each with similar attributes as those described at the first fish ladder. Downstream of some of the fish ladders equipment has been used to shape a low flow channel in the sediments that have accumulated downstream of the fish ladders. The resulting low flow channel is devoid of vegetation and appears loose and at risk of erosion. The channel has some sinuosity and an access road adjacent to the low flow channel appears in some sections of the creek. Riprap has been placed in the channel and on channel banks in some locations.

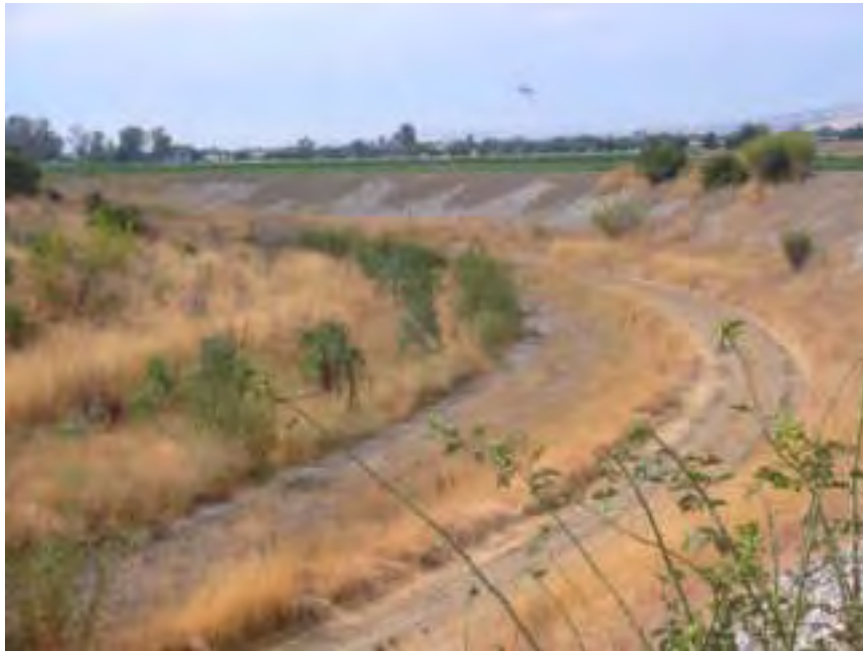
Figure 4.52. Example of engineered Llagas Creek channel with low flow channel, access road, and riprap on channel banks.

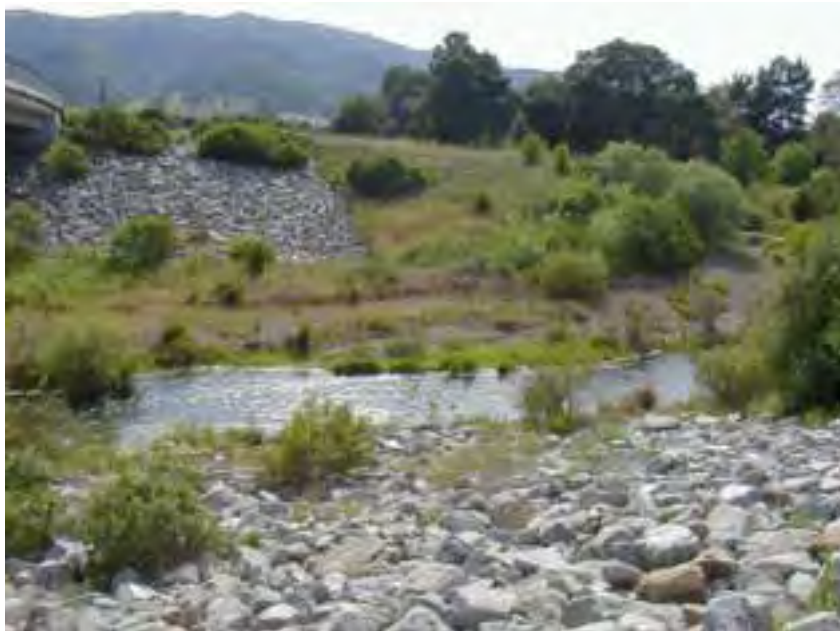
Approximately 5,000 feet southeast of Christmas Hill Park Uvas Creek crosses West Luchessa Road. At West Luchessa Road, the channel geometry and vegetation has been heavily modified with riprap on both channel banks, up and downstream of West Luchessa Road. The riprap prevents the growth of vegetation on the banks, and as a result the riparian corridor is discontinuous where riprap has been installed. A low flow channel exists in the channel at this location, and showed signs of incision at the time this survey was conducted.

Figure 4.53. Riprap and low flow channel observed on Uvas Creek upstream of West Luchessa Avenue.

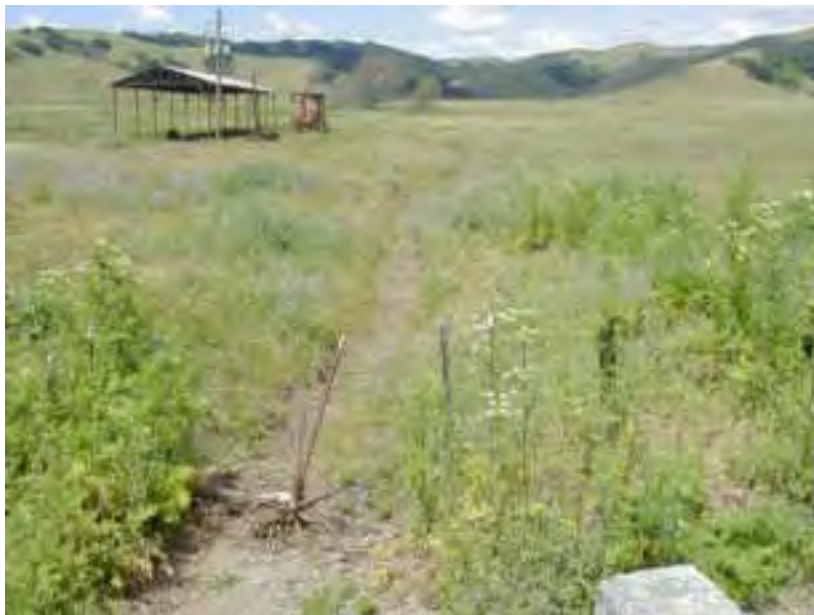
The upper portions of the Tick Creek watershed are densely vegetated. Below this vegetated reach, in the foothills of the Santa Cruz Mountains towards the valley and adjacent to the creek are rangelands. Where animals access Tick Creek the channel is shallow and narrow and the vegetation density and diversity are low. The vegetation in this reach of Tick Creek primarily consists of grasses and provides no shaded riverine aquatic habitat. The sinuosity of the channel upstream of Old Monterey Highway appears to match that expected for the geomorphic setting.

Figure 4.54. Tick Creek west (upstream) of Old Monterey Highway.

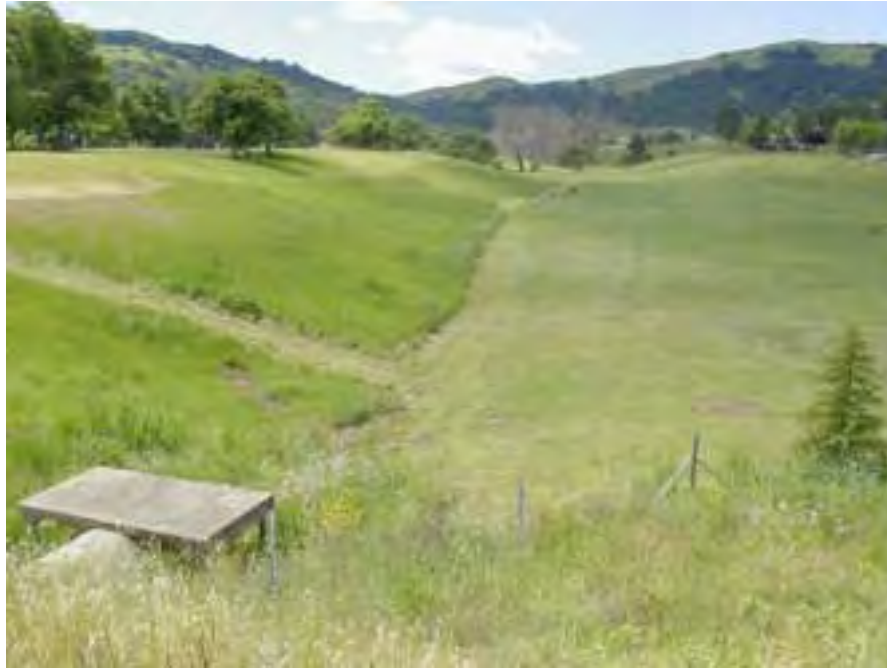
indiscernible from the golf course landscaping. The channel profile is very low and the vegetation consists mostly of grass with intermittent stands of large woody vegetation.

Figure 4.55. Farman Creek in the golf course west (upstream) of Santa Theresa Boulevard.

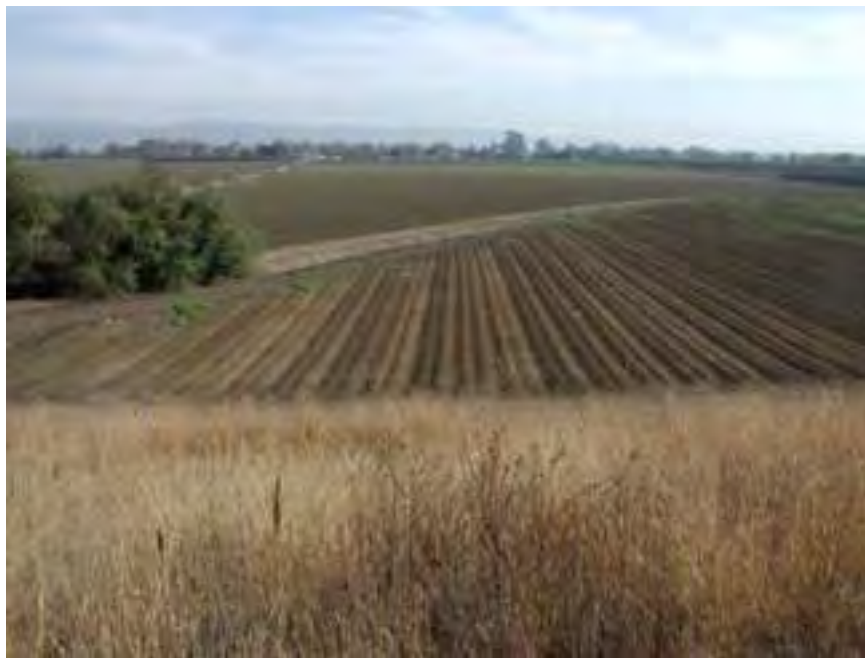
East of Santa Theresa Boulevard, Gavilan Creek passes through an infrequently used agricultural field. At this location the channel has incised approximately five feet and the banks are bare and vertical or near vertical in most locations throughout this approximately 460 foot stretch. Gavilan Creek then passes south beneath Mesa Road and begins a very well vegetated stretch of the creek, approximately 2,560 feet long. The adjacent land use in this reach is primarily row crop agriculture planted in the creek floodplain.

Figure 4.56. Gavilan Creek transitioning between a well vegetated and poorly vegetated section, east of Santa Theresa Boulevard.

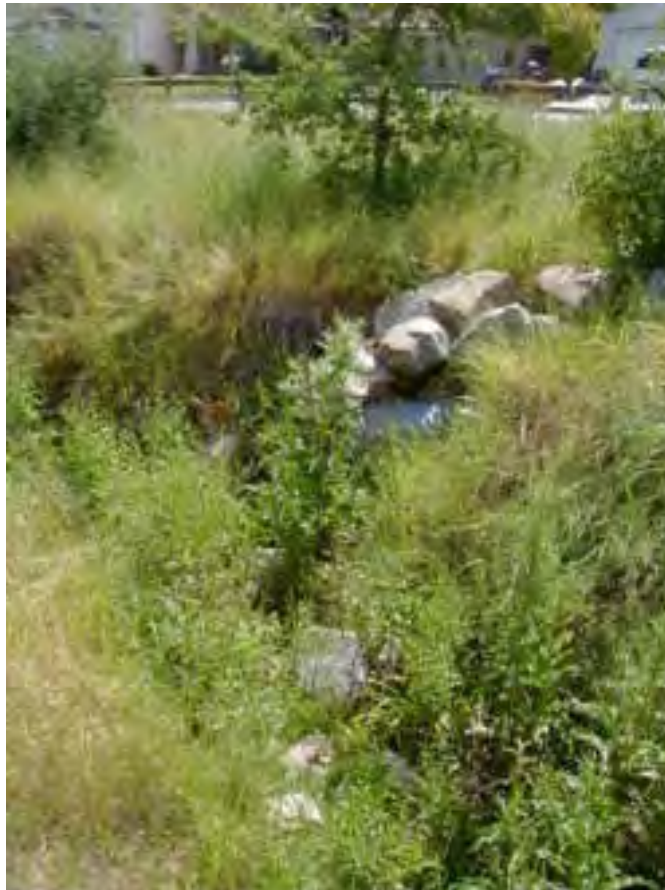
Vegetation in Babbs Creek Park Preserve varies in density and type. Young oak trees have been planted on the floodplain as part of the park revegetation effort and a variety of exotic species appear in the channel and the banks. Large cobbles and boulders have also been placed in the channel at some locations, specifically downstream of urban stormwater outfalls.

Figure 4.57. Babbs Creek in the Babbs Creek Park Preserve where young oak trees have been planted on the channel banks and riprap has been placed downstream of stormwater outfalls.

The channel in Babbs Creek Park Preserve showed evidence of channel incision and is more than ten feet below the elevation of the adjacent road surface, the floodplain is therefore rarely accessed and as a result the majority of high flows are concentrated within the channel. The channel had no

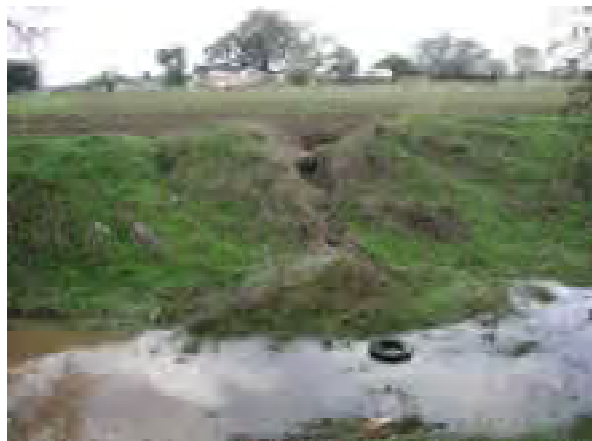
Figure 5.1. Agricultural Source

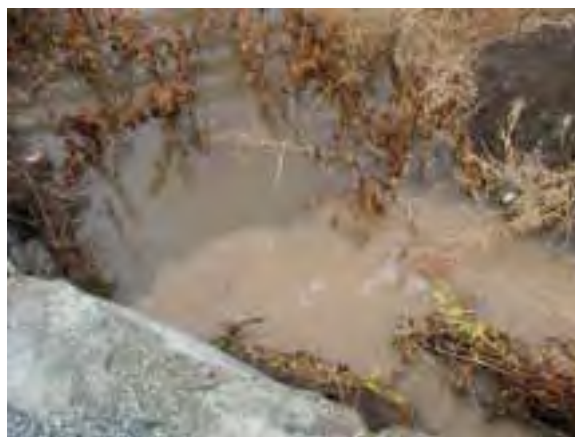
Figure 5.2. Rural Residential Source

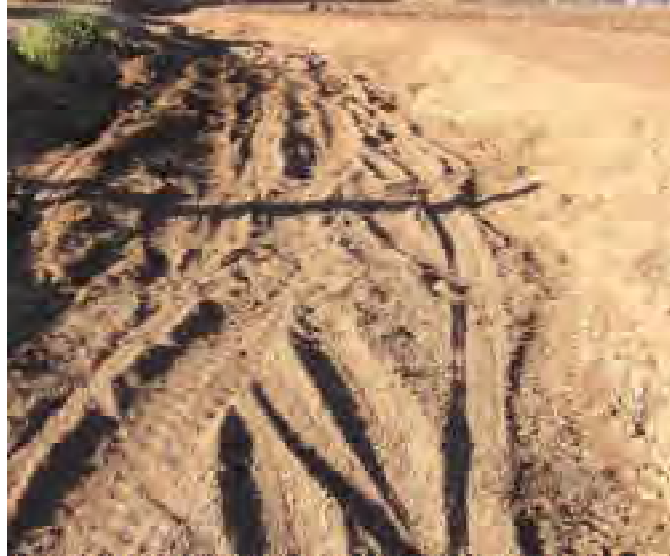
Channel bed disruption – Channel crossings, sediment removal practices and, in a few exceptional cases farm or related equipment operation in creek channels reduces and disturbed armoring and increases channel and bank instability. In the worst case, significant lengths of natural channels were found to have been tilled routinely or at least appeared to have been recently disturbed at the time of the survey.

Figure 5.3. Example of Channel Bed Disruption related to Agricultural Hydromodification.

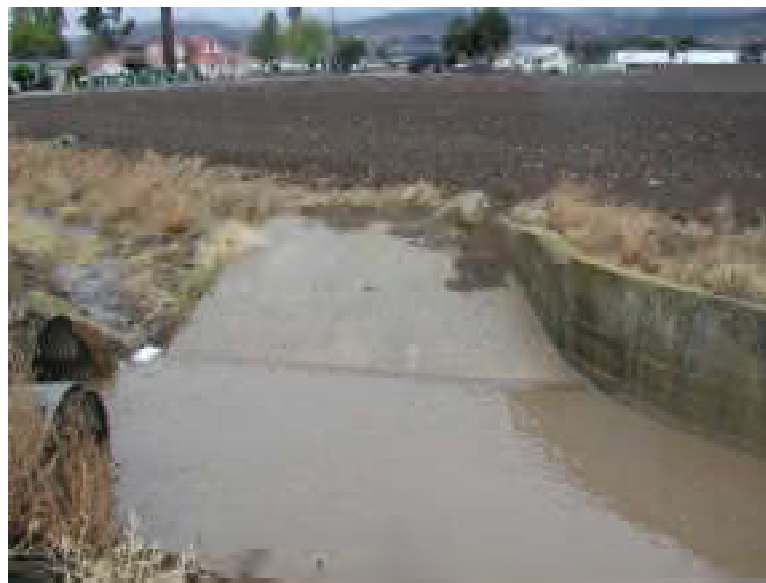
Riparian vegetation removal – Historical and current riparian vegetation removal is common. At some locations banks are kept clear of all vegetation by herbicide application and hoeing. The more common condition is poor or patchy vegetative cover that does not provide adequate protection to banks from erosive effects of stream flow.

Figure 5.4. Example of Channel Modification and Vegetation Removal related to Agricultural Hydromodification.

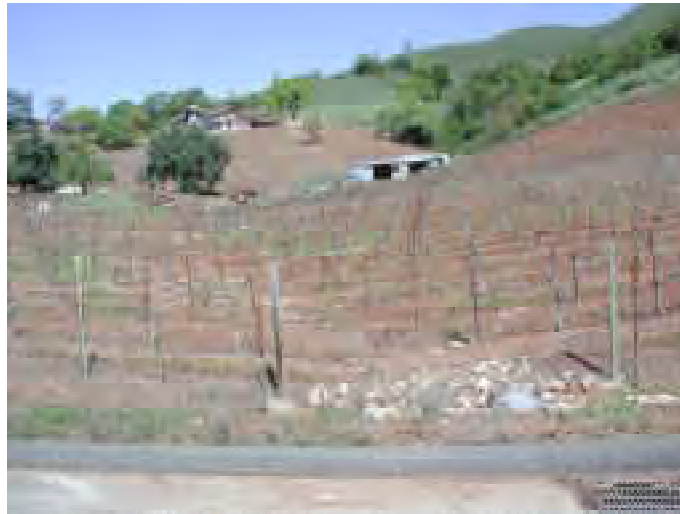
Hillside planting in ephemeral channels – This condition is most commonly observed in rangeland, orchard (mostly residential/hobby), and vineyard lands. Planting across even insignificant ephemeral channels increases soil detachment and increases the velocity and erosive power of runoff.

Figure 5.5. Example of Hillside Planting in an Ephemeral Channel related to Riparian Encroachment of Agriculture.

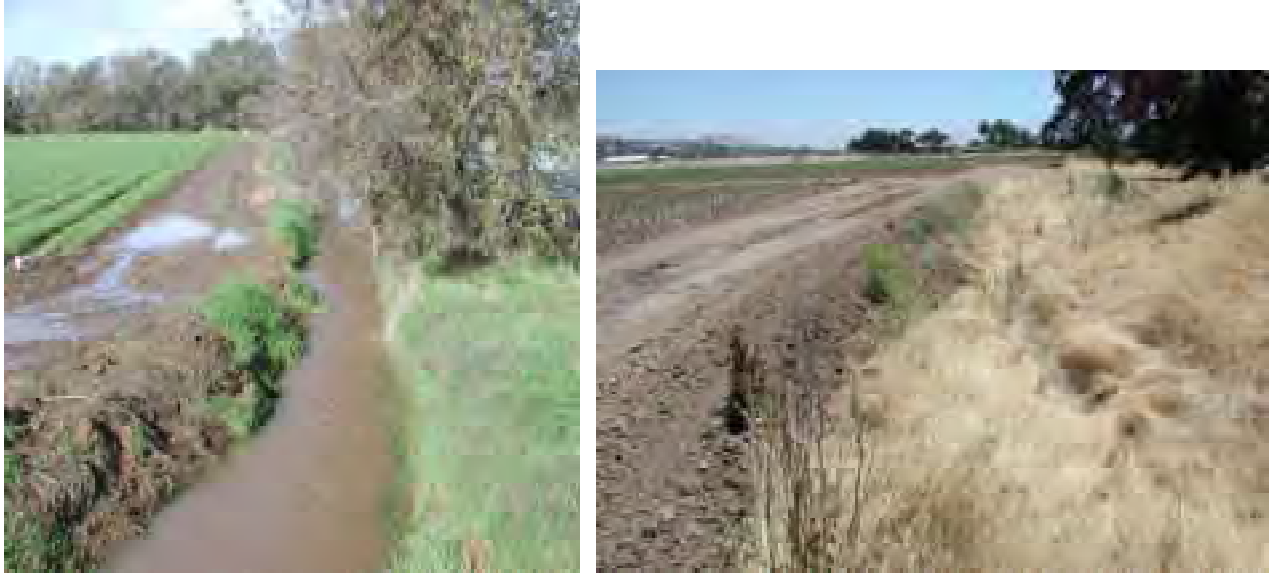
Soil tillage and access roads – Soil disturbance immediately adjacent to channels can lead to disturbed soil deposited on bank surfaces, covering existing herbaceous vegetation, or eventually reaching the channel itself. Roads are commonly at field margins and the routine maintenance (scraping or blading) of these roads may lead to soil entering channels directly or subsequently being transported into the channel via road runoff. Disturbance of the top of creek banks increases bank instability, often leading to partial or substantial failure.

Figure 5.6. Examples of Soil Tillage and Access Roads related to Riparian Encroachment of Agriculture.

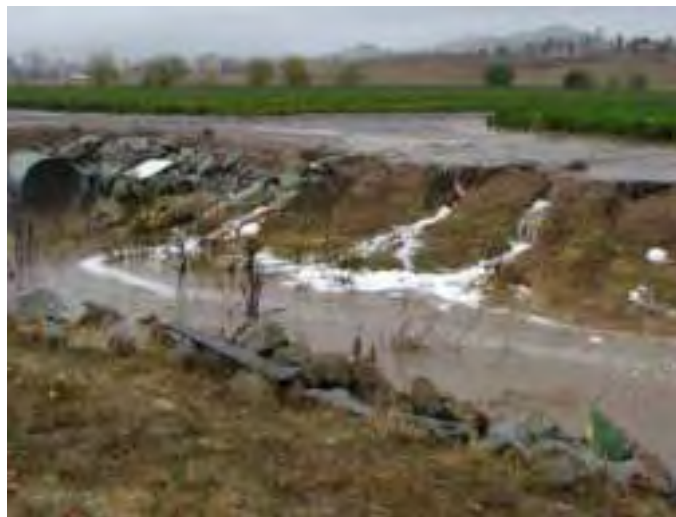
Listed beds, plastic mulched beds - Where planting beds are formed in fall prior to late winter/early spring planting, runoff generated during storm events is concentrated in the furrow (between beds) often with sufficient energy to suspend higher quantities of soil particles than “flat” tilled fields. Plastic mulch increases the total runoff volume and velocity, thereby increasing sediment loss from fields unless runoff is captured or detained.

Figure 5.7. Example of Stormwater Runoff related to Bare Winter Fallowed Fields.

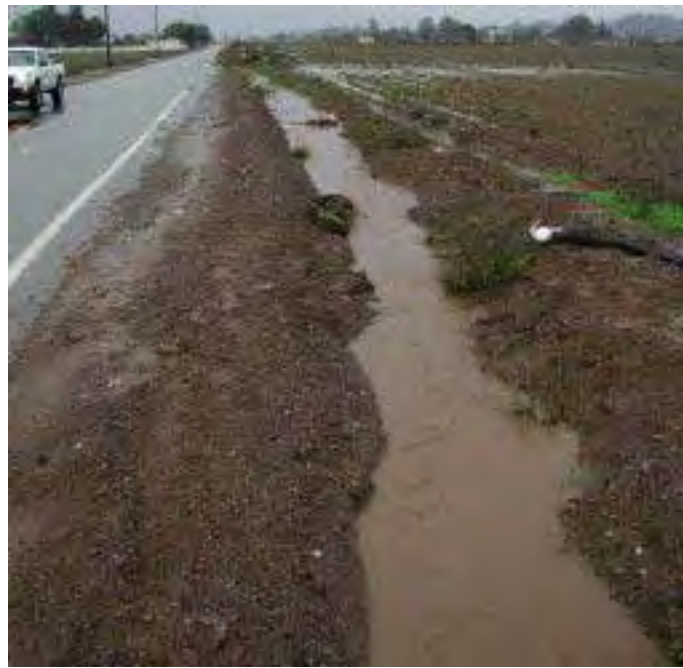
Encroachment on roadway easements – Many fields adjacent to roads may be tilled or cropped too close to road shoulders and road ditches. Loosened soil, destabilization of road ditch banks, and/or field runoff increase sediment conveyance.

Figure 5.8. Example of Encroachment to Roadway Easements related to Agricultural Drainage Practices.

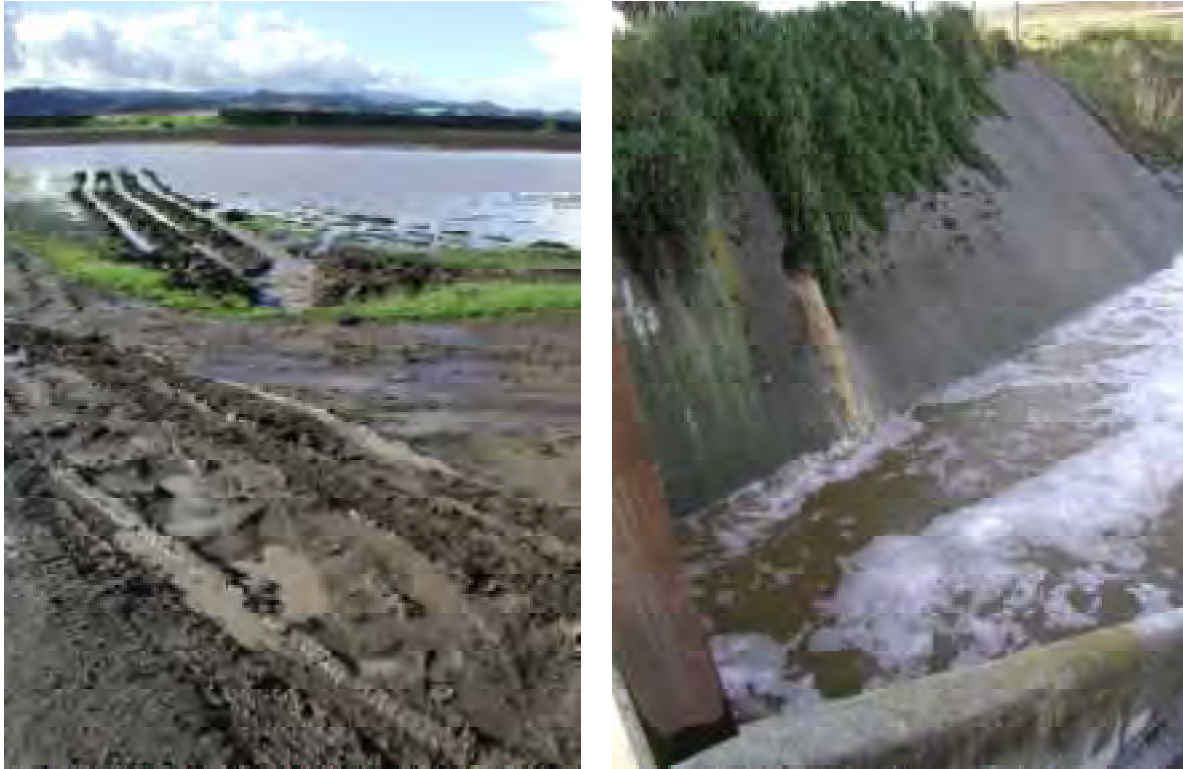
Unlined tail/stormwater ditches – These types of ‘structures’ are temporary and typically have loosened soil with a high erodability potential. In many locations tail and stormwater is conveyed directly to road ditches or other drainage structure with direct connection to creeks, or directly to existing channels.

Figure 5.9. Examples of Runoff from Unlined Tail or Stormwater Ditches related to Agricultural Drainage Practices.

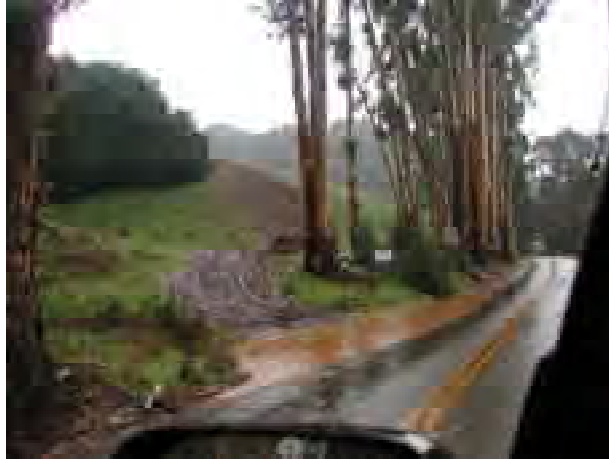
Non-surfaced roads - In-slope grading typically directs runoff into ditches, which may often convey water to culverts that conduct concentrated flows downhill. Culvert outfall locations, when not armored may cause accelerated sheet or rill erosion and in the worst instances initiate gully formation. Unstable or slumping in-slope banks (particularly poorly vegetated), non-vegetated road ditches, and bare down slope road shoulders have been observed as sediment sources.

Figure 5.10. Example of Runoff from a Non-Surfaced Rangeland Road.

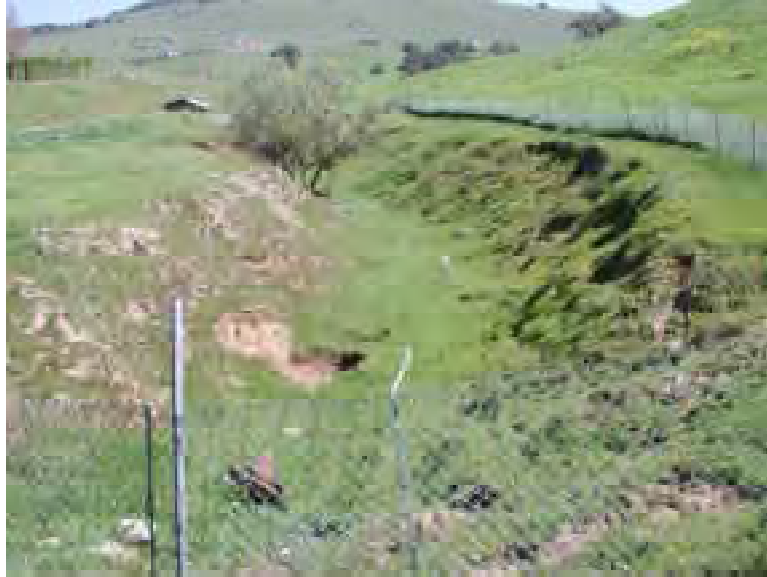
Riparian access/grazing – Where animals have access to graze, drink, or simply walk in the riparian zone, the degree of disturbance may become significant enough to induce bank loss or channel scouring. Localized bank instability and evidence of accelerated erosion were noted in some locations thorough out the study area.

Figure 5.11. Example of Location where Rangeland Riparian Access and Grazing Permitted.

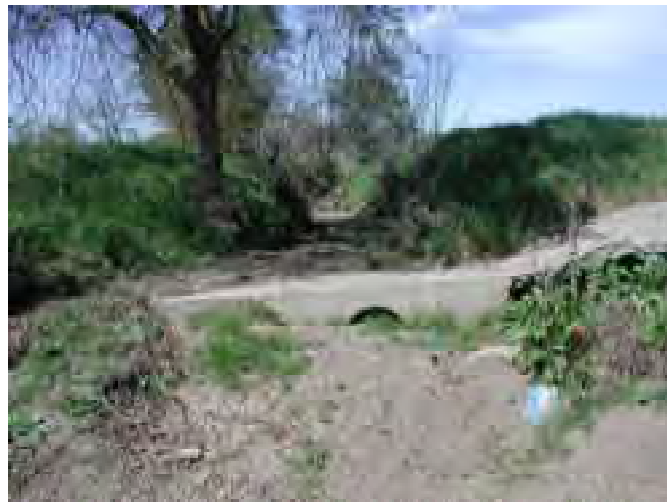
Creek crossings – Based on survey work, with only limited visual access, creek crossings do not appear to be a widespread occurrence. In fact, a few observed crossings exhibited few signs of significant impact. However, it is assumed that some crossings may cause significant localized disruption of channel substrate due to trampling along with increased bank erosion.

Figure 5.12. Example of In-Stream Crossing.

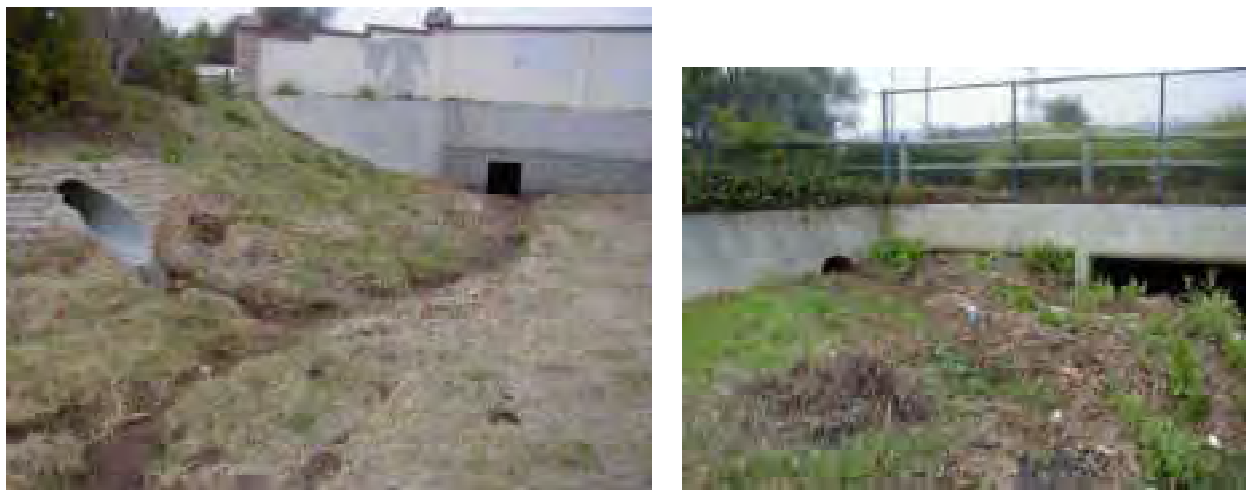
Urban drains and flood control channels – All of the publicly constructed drains in the region share certain characteristics, largely earthen-linings, uniform channel cross-sections (at least initially), straight channels and occasional 90 degree bends, with vegetation (when present) limited to grasses or rank weed growth. While these features enhance the rapid conveyance of drainage waters and reduce flood risk, there are locations that exhibit scour and channel incision, past or recent bank loss/instability, or sedimentation related to high flows and increased erosive energy.

Figure 5.13. Example of Urban Drains and Flood Control Channel Hydromodifications.

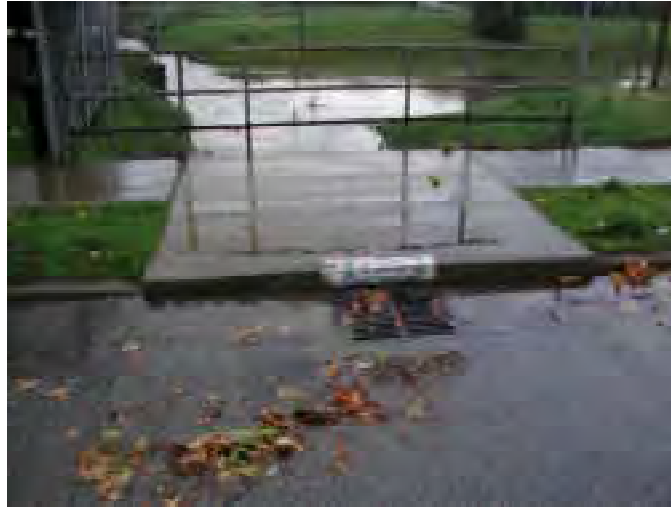
Building setbacks – While current urban building codes require an adequate buffer between channels and buildings, work or parking areas, there are many locations where channel integrity continues to be compromised by encroachment of urban development. At these locations creeks or drainage ditches may have limited or no floodplain adjacent to the bankfull channel, limited vegetative cover,

or the channel width is constrained by concrete retaining walls. Even in certain older urban locations, evidence of current bank instability and channel incision was observed.

Figure 5.14. Example of Urban Riparian Encroachment.

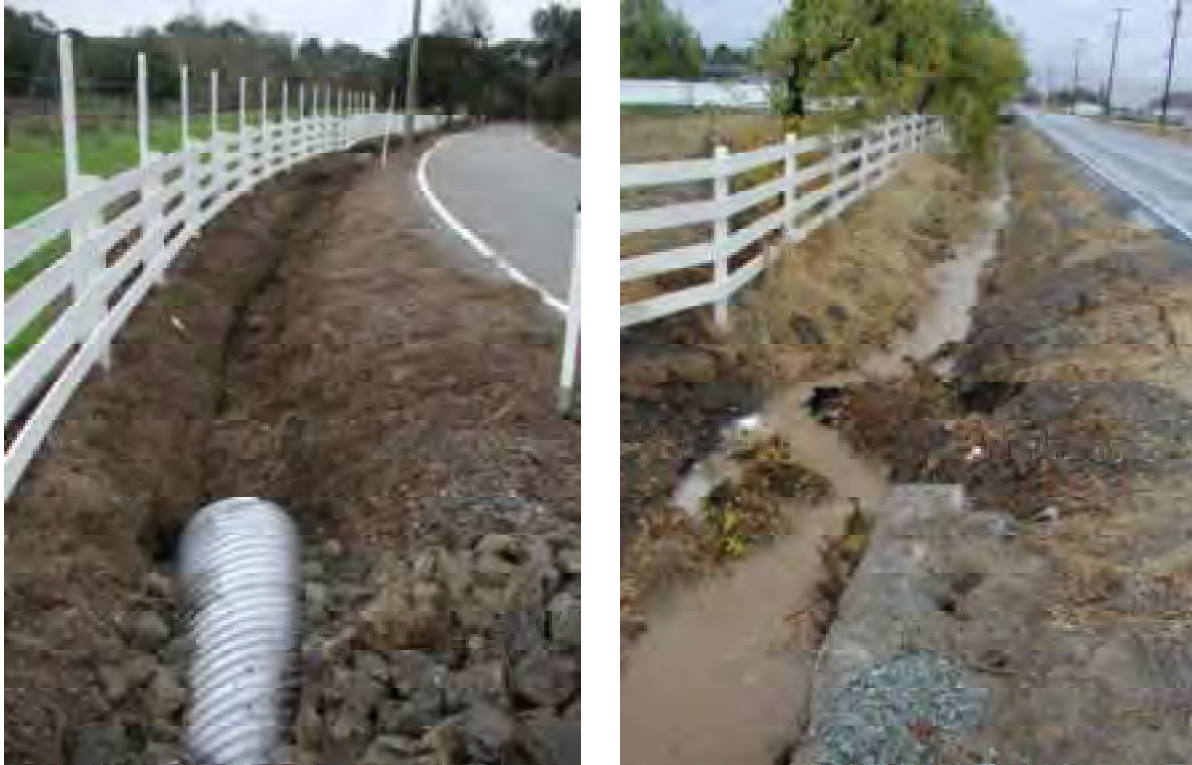
Road ditches – In many of the rural residential areas, roadway ditches may carry road, driveway, even roof runoff waters into existing creek channels. Many road easements have bare-unstable shoulders, undersized or incised ‘channels’ with unstable ditch walls, and/or improper setbacks from residential activities. In some cases road ditches are actually functioning as creek channels carrying natural upland, residential, and roadway drainage waters.

Figure 5.15. Examples of Road Ditches in Rural Residential Areas.

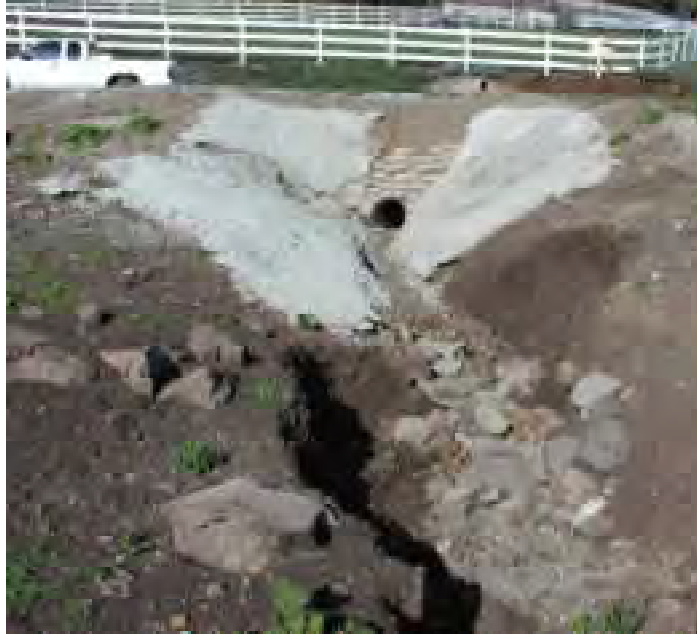
Culverts [CULV]. Given increased runoff volumes, the numerous public and private culverts represent significant sediment sources. Common problems are undersized roadway and creek culverts, poor placement of culverts in hillside locations, excessive scour due to high runoff volumes and velocities, partially collapsed culverts, and poor design and maintenance by residential owners.

Figure 5.16. Examples of Drainage Culverts in Rural Residential Areas.

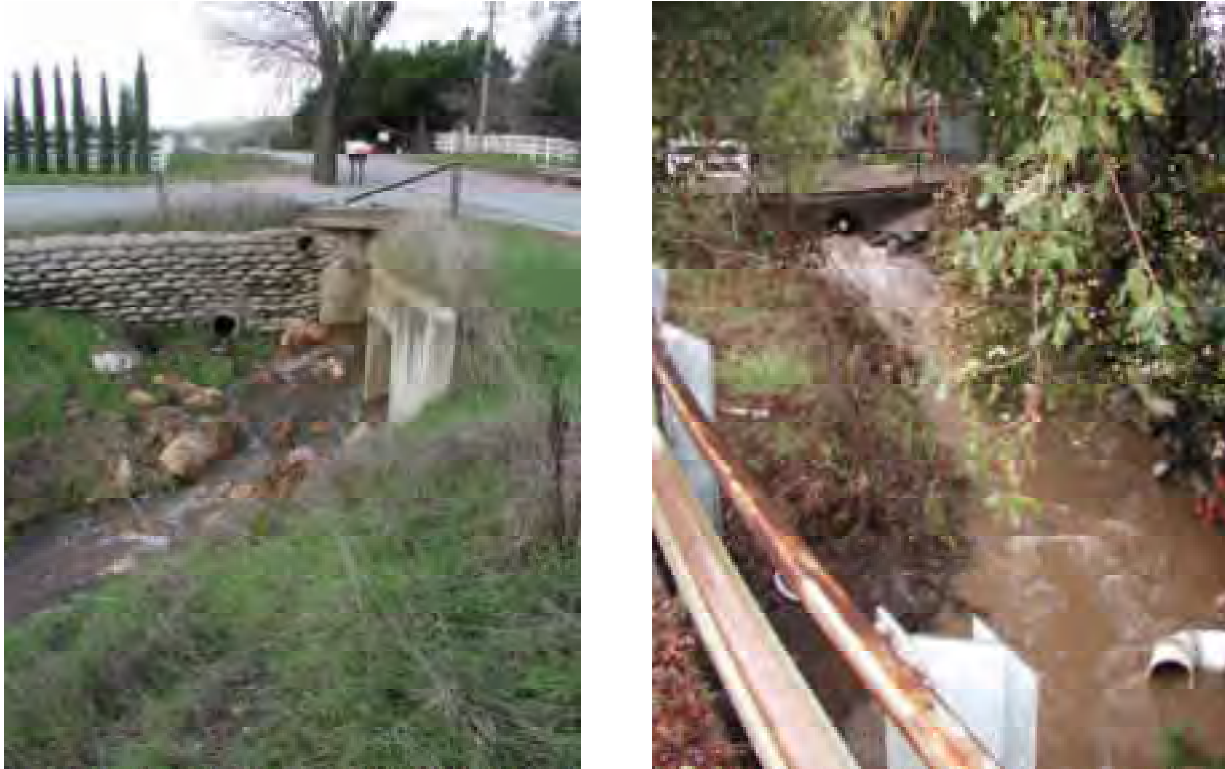
Riparian vegetation removal – Removal of riparian vegetation is common, both historical and under current land use conditions. Often exotic weedy vegetation replaces a natural riparian vegetated corridor, or landscape designs alter the location or channel characteristics for aesthetic reasons. Where vegetation removal occurs due to intensive grazing, landscaping, recreational purposes, etc. this often results in widening or incision of channels with associated increases in sediment generation.

Channel disturbance – While visual access to large portions of rural residential lands was limited, when permission was attained the Study Team found evidence of channel disturbance. Disturbance is most often related to fencing, grazing, drainage, and landscaping activities. Scour pits from poorly designed drainage systems, and poorly sized or placed culverts were observed. Numerous and hasty bank stabilization attempts appear to have led to subsequent failures in other locations of the channel.

Riparian encroachment – Encroachment is very common where recreational uses, landscaping, driveways, animal lots, outbuildings, property line fences, etc. constrains channel width or natural channel meander, alters the natural channel cross-section dimensions, reduce bank stability, and/or increases in scouring and incision.

Figure 5.17. Examples of Riparian Encroachment, Channel Disturbance, and Riparian Vegetation Removal in Rural Residential Areas.

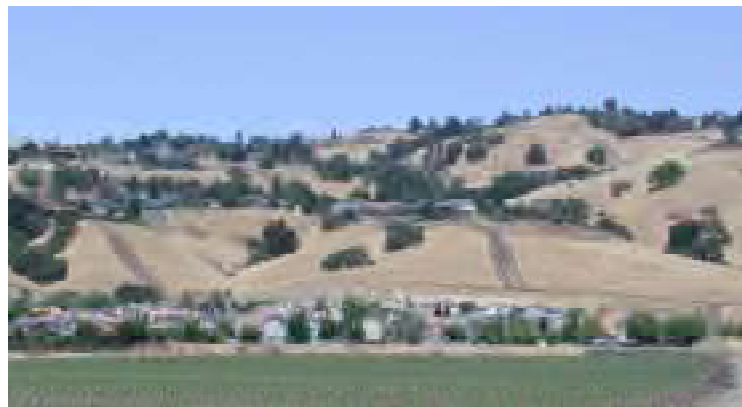
Disked bare breaks - While this was not observed as a common occurrence, it was noted on individual parcels and some small residential developments. Where this practice is employed on sloping lands, and particularly when disking occurs across ephemeral channels, increased erosion potential exists.

Figure 5.18. Example of Disked Firebreaks in Rural Residential Areas.

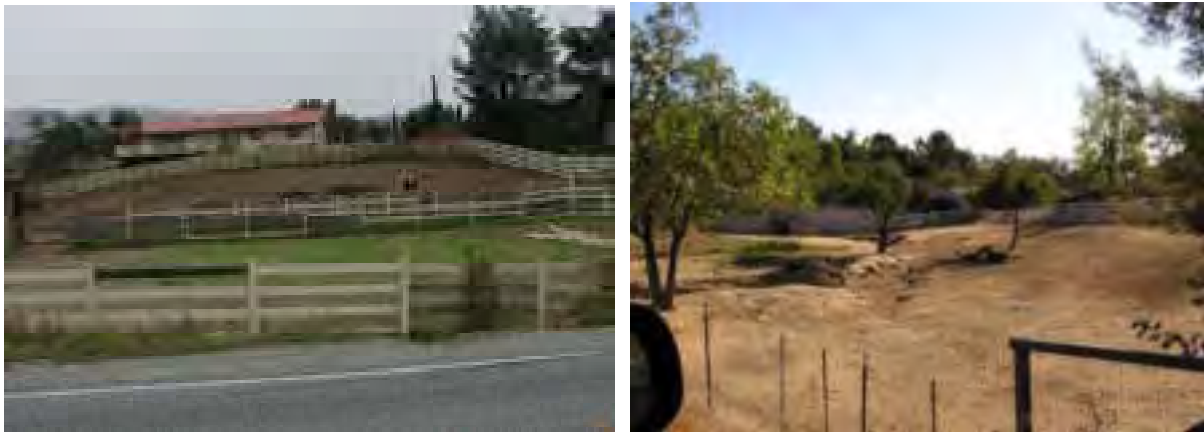
Bare or low residual biomass lots and pastures – This most often occurs in small lot situations when the allotted lot or pasture is too small for the number or size of horses. Numerous instances of completely bare corrals can be found in almost every sub-area. Lots and pastures with low amounts of residual vegetation (biomass) and compacted soil from trampling have high potential runoff and erosion rates.

Figure 5.19. Example of Poorly Vegetated Equestrian Lots and Pastures.

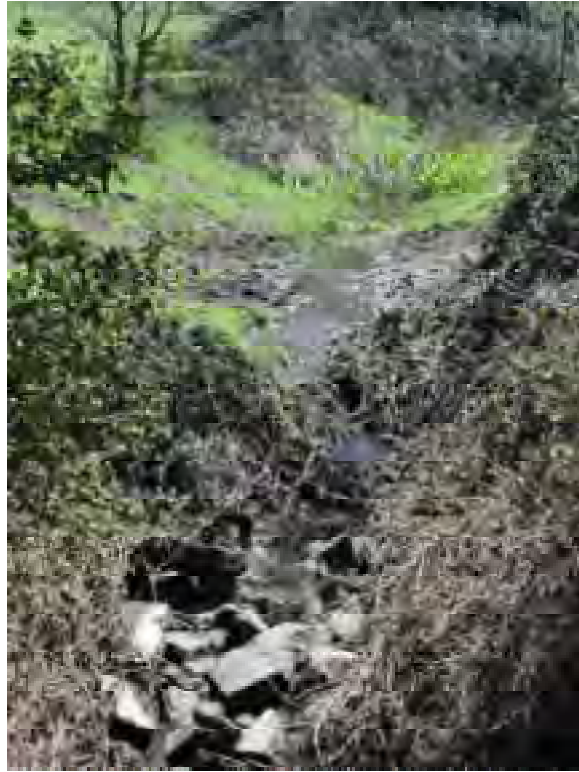
Creek crossings – Based on survey work, equine crossings are not a widespread occurrence. However, where observed most of the crossings had noticeable past and current impacts from hoof traffic. Channel and bank substrate at crossings is disrupted increasing bank erosion potential.

Figure 5.20. Example of Equestrian Creek Crossing.

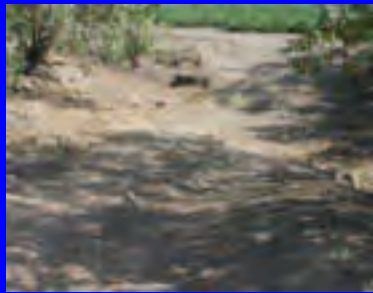
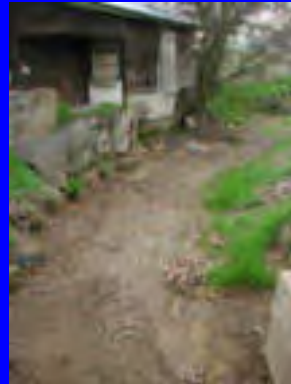
Unstable creek banks

Channel modification, ↑ flows
vegetation removal, setbacks,
creek crossings

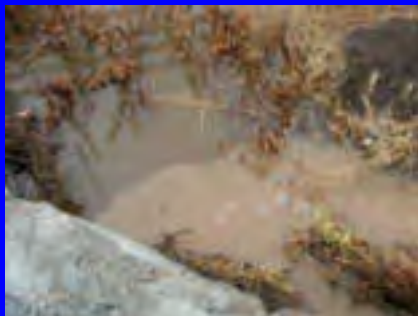
Road and other drain ditches

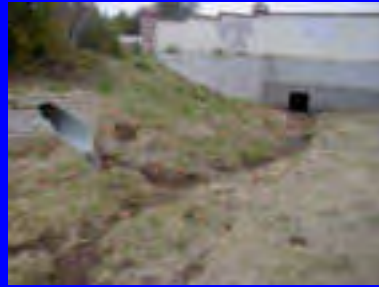
Concentrated flows

Development, impervious surfaces,
poorly designed residential drains

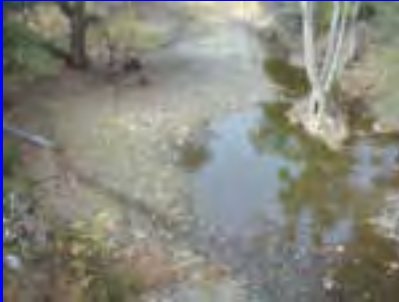
Early October

Llagas Creek at Oak Glen and Uvas Rds.
(above Chesbro Reservoir)

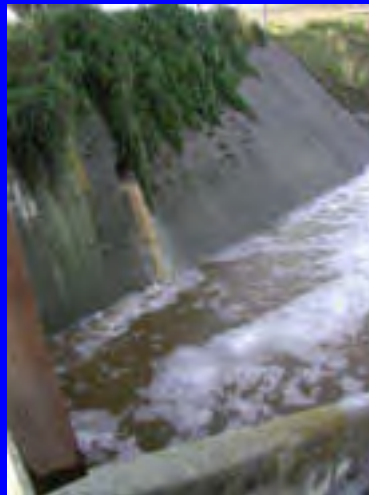
Less than optimal winter stormwater management appears to be a widespread source of sediment

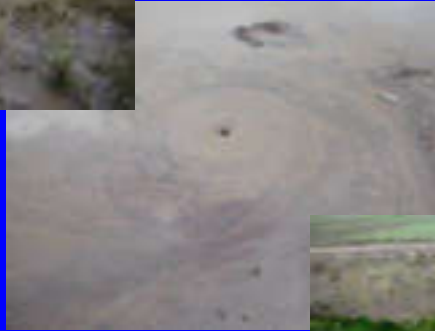
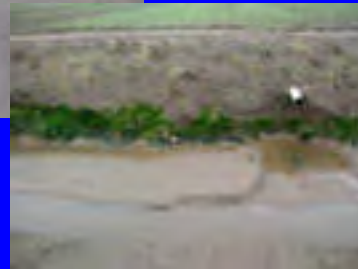
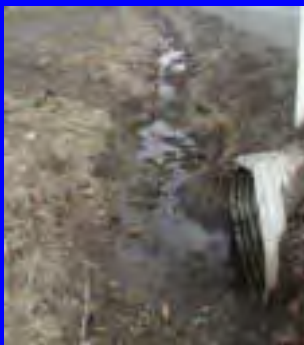
Typical drainage practices are resulting in significant sediment input to creeks

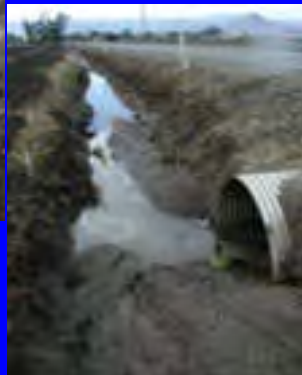
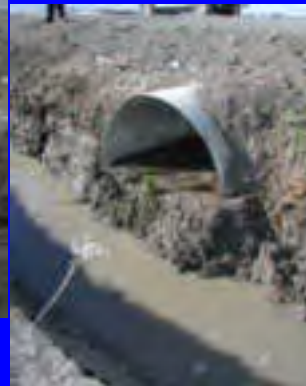
Inadequate setbacks without berms allow soil to fill ditches and/or creek channels

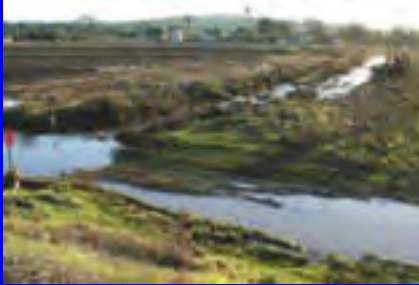
Creek channel and bank modifications

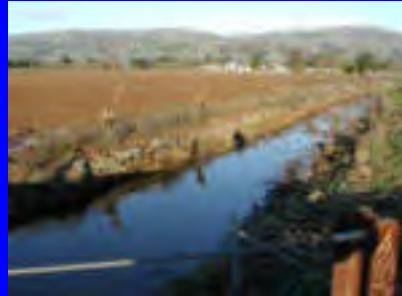
Creek channel was diked down prior to winter rains

Concrete rip-rap flood wall on left bank leads to destabilization of and flooding over right bank

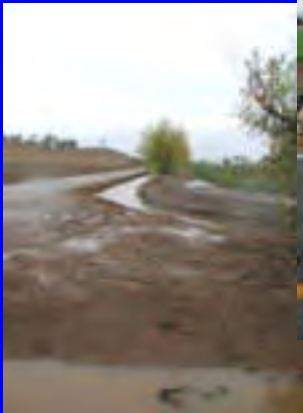
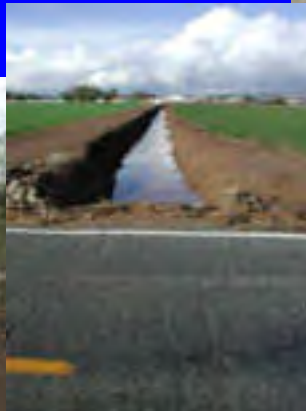
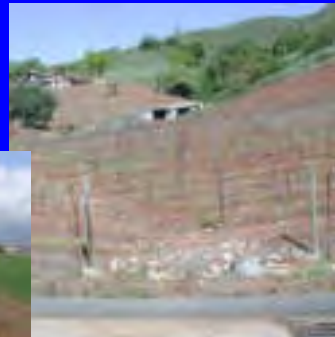
Removal of riparian vegetation and channel straightening increase bank instability and erosion

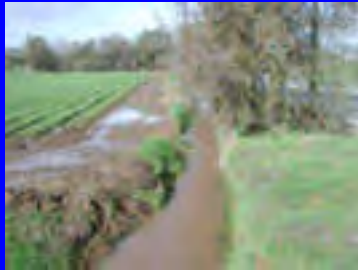
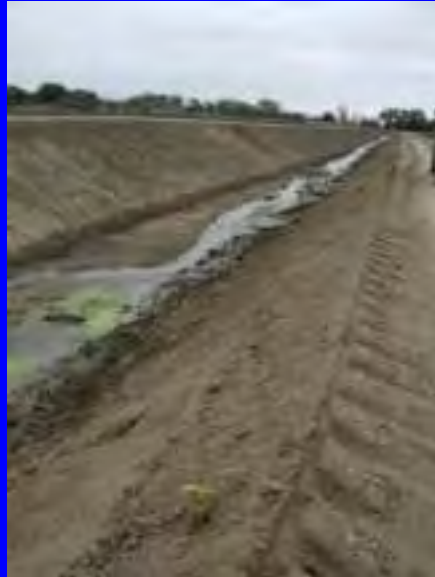
Steep bank angles on drainage ditches, yearly cleanout in late season, and no or sparse vegetation cover provides a continuous source of sediment
