**Upper Pajaro River
Sediment Assessment**

February 2004

FALL CREEK ENGINEERING, INC.

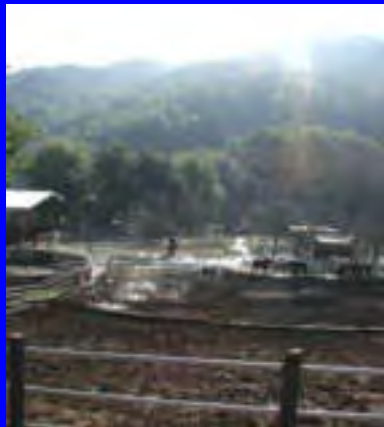
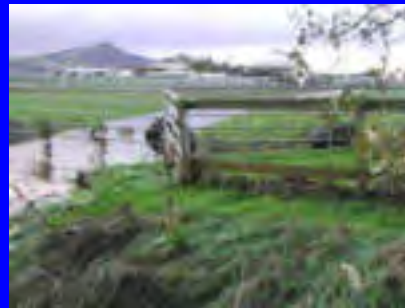
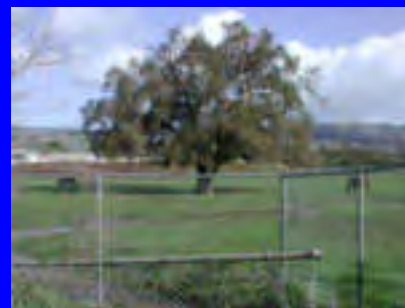
Exposed soil in corrals with little drainage control and riparian access increase sedimentation

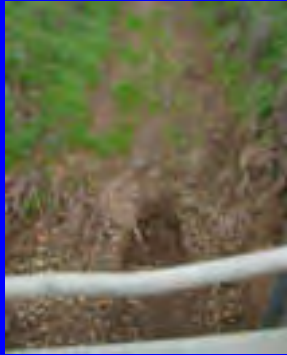
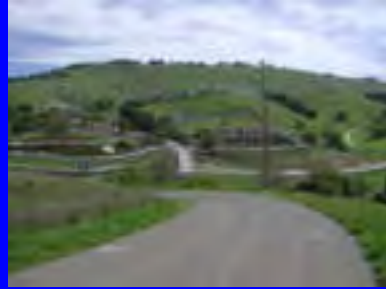
Increasing flow volumes from land use changes creates sediment "hungry" drainage waters

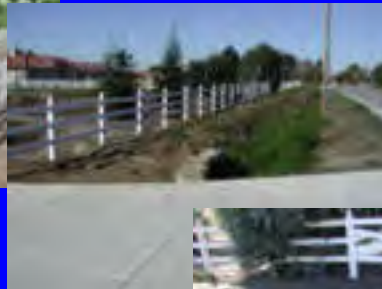
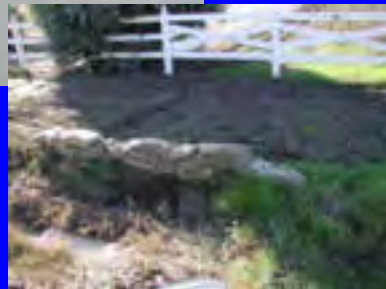
Drainage system is not designed for flow volumes and intensity
